Final Report 5 of 5

SERPENTINE

Crime Risk Assessment, CPTED-Lighting Audit &
CCTV Potential Camera Locations

Date: 13 March 2012
Revision: V.01

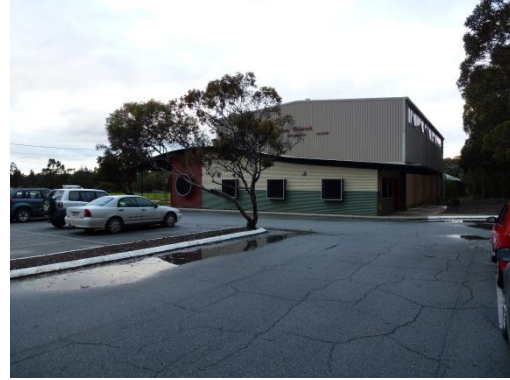
- The car park located adjacent the Recreation Centre appears dated and uneven and requires resurfacing.
- Foliage and vegetation located adjacent the Recreation Centre restricts sightlines and reduces natural surveillance.

Figure 18: Car park appears dated and requires resurfacing

1. Resurface uneven and damaged car parks and driveways located in the Town Centre to increase vehicle and pedestrian safety.
2. Ensure consistent maintenance of foliage and vegetation throughout the Town Centre to enhance natural surveillance, community safety and perceptions of safety. Canopy heights should be raised to a minimum of 3.0 meters and vegetation kept to a maximum of 0.5 meters, in pedestrian areas, to maintain clear sightlines.

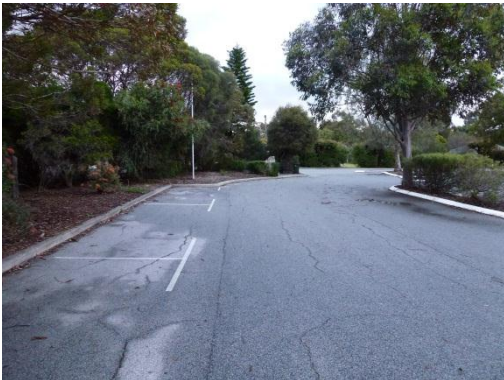
Figure 19: Foliage and vegetation restrict natural surveillance of car park from main street

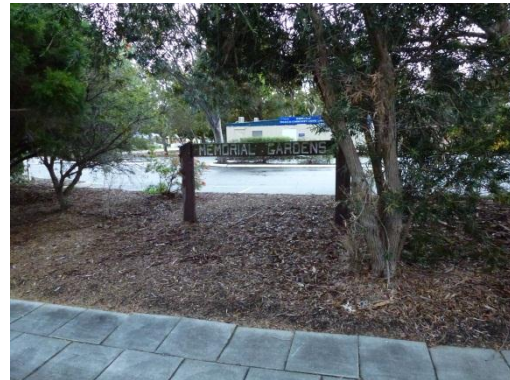
- The Memorial Gardens sign and dedication plaque situated in the Memorial Gardens are poorly located, reducing the opportunity for the community to view the signs.

Figure 20: Signage appears dated and difficult to view

3. Relocated Memorial Gardens sign and dedication plaque to a higher traffic area and ensure consistent maintenance of adjacent foliage to provide a clear entrance statement for the community. Rectify Memorial Gardens signage to enhance a sense of ownership for the community and encourage community pride.

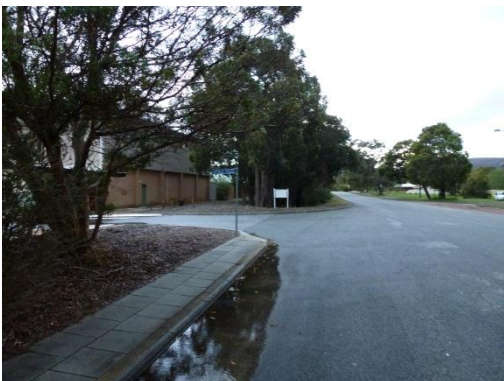
Figure 21: Foliage reduces natural surveillance adjacent Recreation Centre

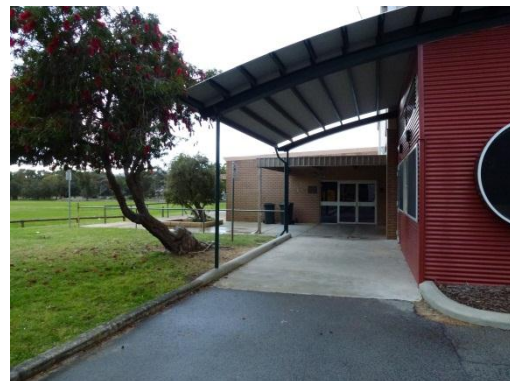
- The entrance to the Recreation Centre is recessed from the car park and receives limited natural surveillance from surrounding areas.
- The width of the pedestrian pathway located adjacent the Recreation Centre on Wellard Street is not conducive to natural surveillance and community safety perceptions.

Figure 22: Entrance to Recreation Centre receives poor natural surveillance from car park and surrounding areas

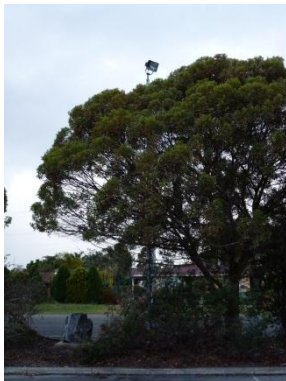
Figure 25: Foliage located adjacent spotlight requires pruning to enhance area illumination

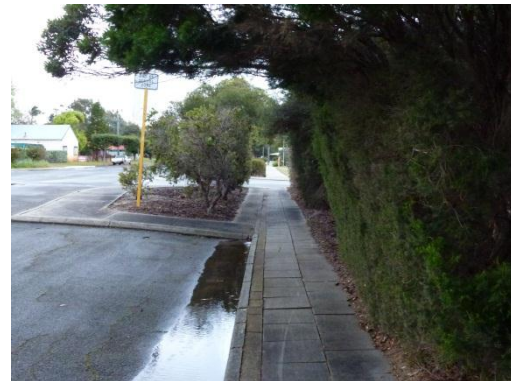
Figure 26: Pathway width not conducive to natural surveillance and community safety perceptions

4. Widen and repave pedestrian pathway located adjacent Recreation Centre car park and ensure consistent maintenance of adjacent foliage to enhance natural surveillance, community safety and perceptions of safety.

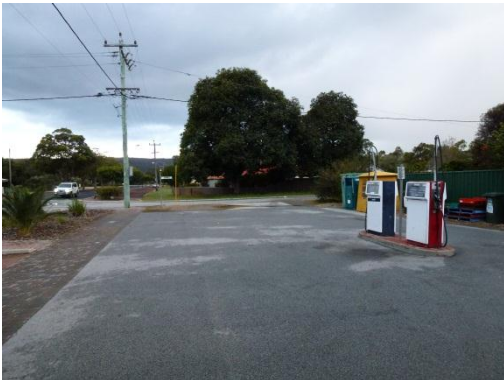
- Climbing debris is located adjacent fencing at the petrol pumps providing natural ladders for offenders to scale the fence.
- Brick paving located adjacent Wellard Street appears uneven and dated, and requires rectification to enhance aesthetics on the main street

Figure 27: Climbing debris and natural ladders located adjacent fencing providing opportunity for offenders. Good natural surveillance adjacent petrol pumps

5. Remove climbing debris located adjacent fencing to deter potential offenders from scaling the fence.
6. Repave pedestrian pathways and brick paving located adjacent Wellard Street to improve aesthetics in the area and enhance a sense of ownership and pride for the community. Utilising consistent materials and straight pedestrian movement lines at pedestrian crossings will increase connection throughout the Town Centre.

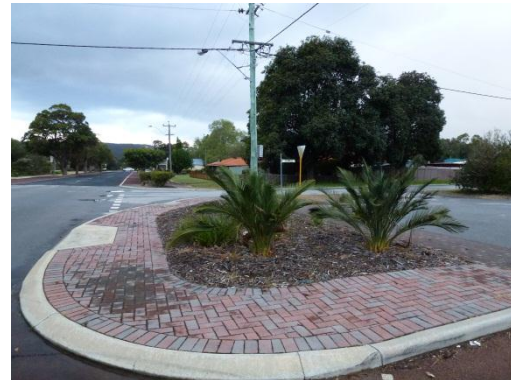
Figure 28: Brick paving appears dated and requires rectification to enhance a sense of ownership for the community

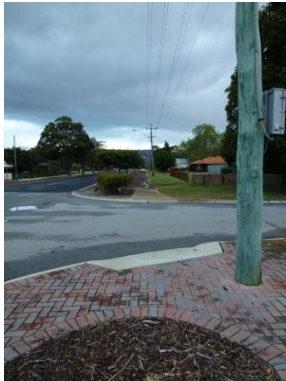
- Pedestrian crossings throughout the Town Centre appear poorly designed and do not utilise consistent materials, reducing connection through the area.

Figure 29: Pedestrian crossings appear poorly designed reducing connection throughout Wellard Street

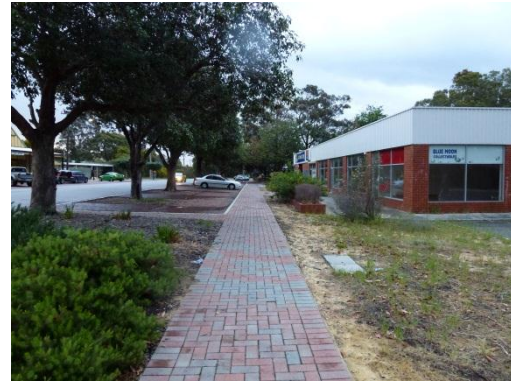
Figure 30: The grass area adjacent the pathway requires maintenance to improve aesthetic in the area

7. Rectify bus stop, numbered 22413, to enhance a sense of ownership for the community and encourage community pride.
8. Ensure consistent maintenance of car park areas adjacent Wellard Street. Well maintained areas can enhance a sense of ownership for the community and increase crime prevention and community safety perceptions.

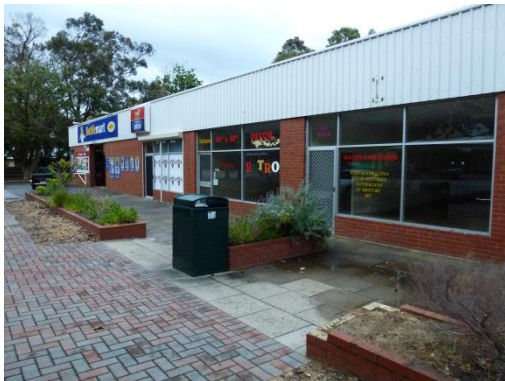
- The brick wall surrounding the garden bed adjacent the bottle shop appears damaged and requires rectification to reduce the opportunity for vandalism and other illegitimate activity.

Figure 31: The brick wall surrounding the garden bed appears damaged and requires rectification

9. Rectify brick wall surrounding the garden bed adjacent the bottle shop to reduce the opportunity for vandalism and other illegitimate activity.
10. Relocated public phone box to a higher traffic area to increase natural surveillance and community safety perceptions.

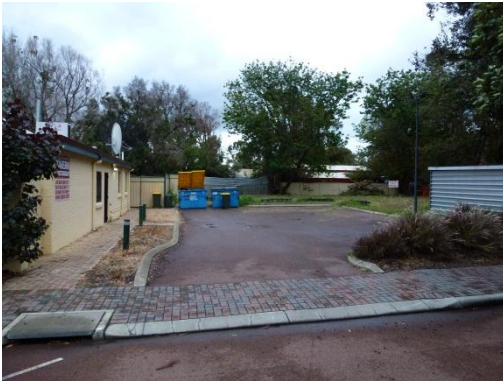
- The bus stop numbered 22413 appears faded and requires rectification.
- Maintenance of car park areas adjacent Wellard Street is required to enhance a sense of ownership for the community and improve area aesthetics. Unmaintained areas can provide congregation points for bored youths and offenders, and increase the risk of damage and other illegitimate activity occurring.

Figure 35: Area requires maintenance to enhance a sense of ownership for the community and deter potential offenders from congregating in the area

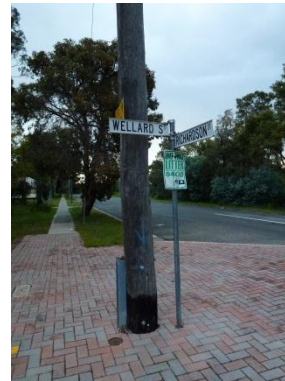
Figure 38: Signage appears damaged and requires rectification

11. Rectify damaged street signage located at the corner of Wellard Street and Richardson Street to enhance a sense of ownership for the community and encourage community pride.

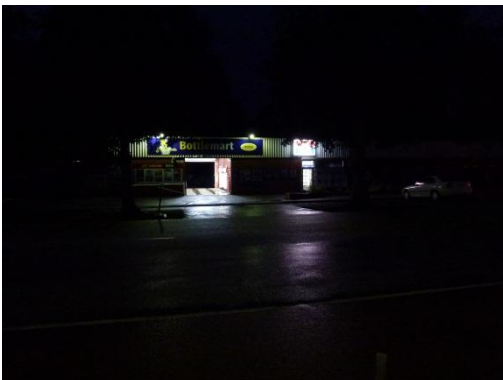
Wellard Street appears adequately illuminated; however illumination of areas surrounding licensed premises requires improvement to enhance natural surveillance and crime prevention and community safety perceptions. Lamps are recessed from the edge of the street reducing area illumination.

Figure 39: Poor area illumination adjacent bottle shop reduces natural surveillance and community safety perceptions

12. Rectify lamps not operating in the Town Centre. Refer Section 3.1 Table 1 Lighting Systems for Serpentine. In our view, a lighting upgrade to Category P6 lighting (21 Lux) using Compact Fluorescent or MH lamps to emit a brighter white light will significantly enhance any future CCTV surveillance capability and image quality, in addition to providing for enhanced crime prevention and community safety perceptions.

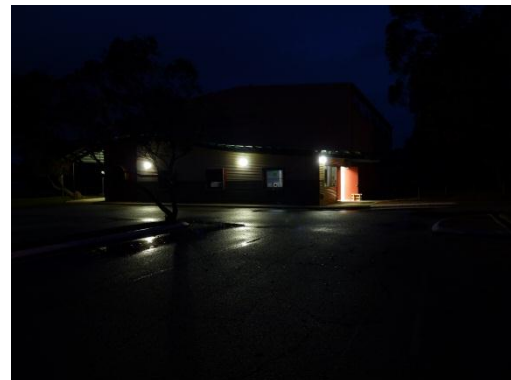
Figure 40: Car park lighting appears poor reducing natural surveillance and community safety perceptions

13. Lighting in car parks should be balanced to a minimum of 20 lux and to 60 lux preferred, to ensure all car parks are sufficiently and consistently illuminated, in particular to reduce crime displacement.
