Road Safety Inspection

| Project: | Jarrahdale road SLK 3.375 to SLK 3.75 |
| Reference: | 2005012-01 |

| Audit Stage: | Existing road Safety Inspection |

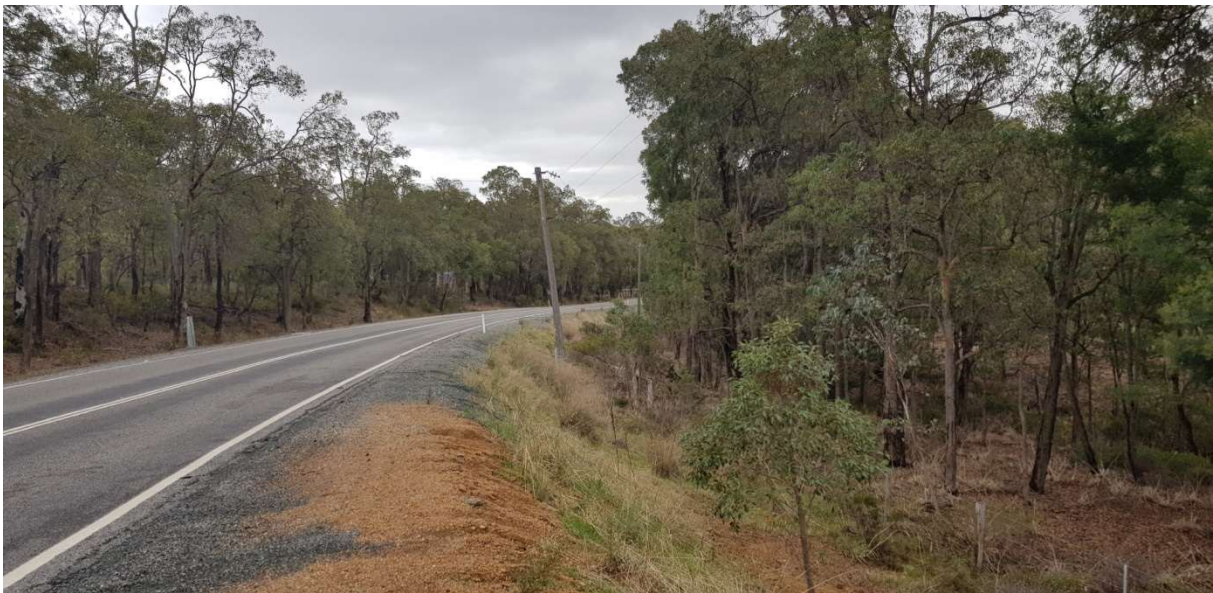
Steep unprotected batter slopes are located adjacent to the carriageway.

Should a vehicle inadvertently leave the roadway in the section of road where there are steep unprotected batters a driver is likely to experience loss of control with the resultant crash causing serious or fatal injury.

- Embankment (fill) slopes – batter slopes between 4:1 and 3:1 is traversable but too steep for a driver to recover, and a slope of steeper than 3:1 is critical as the errant vehicle is likely to overturn.

- Embankment height – the likelihood of vehicle rollover with a high severity outcome increases significantly where the embankment height exceeds 1.5 m and embankment slopes are critical.

Austrroads Guide to Road Design Part 6 provides a warrant for treatment of an embankment on intermediate speed (i.e. 70 to 90 km/h) and high-speed (i.e. > 90 km/h) roads with a traffic volume greater than 2000 vehicles per day. The treatment may include embankment flattening or the installation of a suitable road safety barrier system.

[IMPORTANT | HIGH]

Figure 3: Finding 2.1 - Steep Batter Slopes

Provide safety barrier along the section of road where the batter slopes exceed 4 in 1 and embankment height is greater than 1.5 metres.

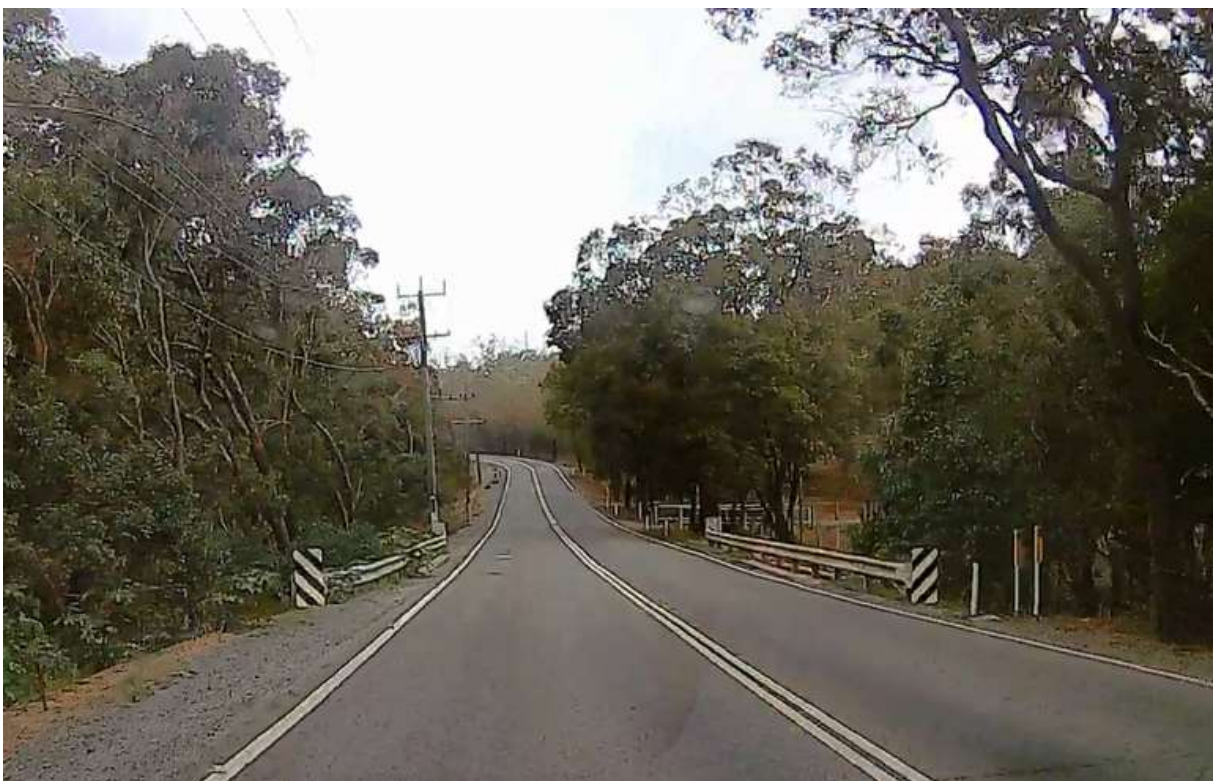
Non-compliant barrier is currently installed adjacent to the bridge at about SLK 3.375.

Should a vehicle inadvertently leave the roadway in the vicinity of the non-compliant leading terminal, the barrier may fail to perform as intended and result in a crash causing serious or fatal injury.

Austrroads Guide to Road Design Part 6 indicates that terminal treatments and crash cushions or impact attenuators are used to terminate a road safety barrier. These devices are specifically designed to ensure that the ends of road safety barriers provide safe conditions for occupants of vehicles that may impact this area of a road safety barrier.

[IMPORTANT | MODERATE]

Figure 4: Finding 2.2 - Non-compliant Barrier

Modify the barrier so as to provide compliant terminals.

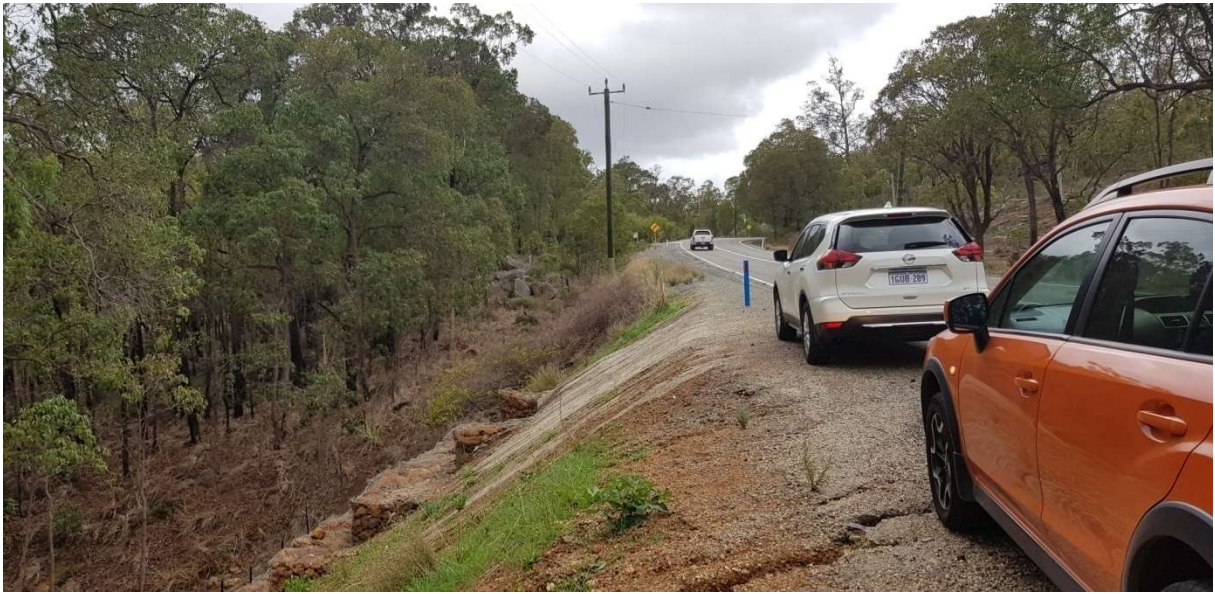
Unprotected culvert headwalls are located adjacent to the carriageway.

Should a vehicle inadvertently leave the roadway in the section of road where there are the steep unprotected culvert headwalls a driver is likely to experience loss of control with the resultant crash causing serious or fatal injury.

[IMPORTANT | HIGH]

Figure 5: Finding 2.3 - Unprotected Culvert

Provide safety barrier along the section of road where culvert headwalls are unprotected and pose a hazard.

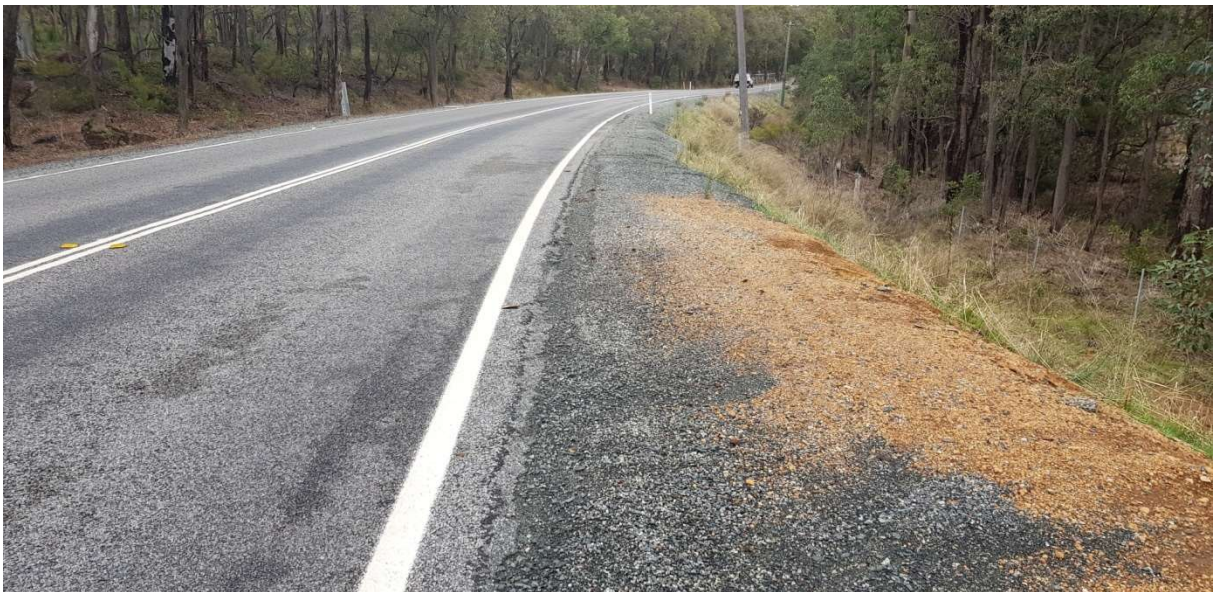
shoulders are unsealed and in places exhibit signs of drop off and edge break.

Should a vehicle inadvertently leave the roadway where shoulders are unsealed and where there is excessive edge break and / or drop off. a driver may lose control and crash with vehicle occupants suffering serious or fatal injuries.

[IMPORTANT | LOW]

Figure 6: Finding 2.4 Unsealed Shoulder

Preferably provide sealed shoulders or at a minimum undertake maintenance to condition shoulders, repair edge break and remove edge drop off.
