Mundijong Sales Yard

Building and incidental structures inspection report

June 2020

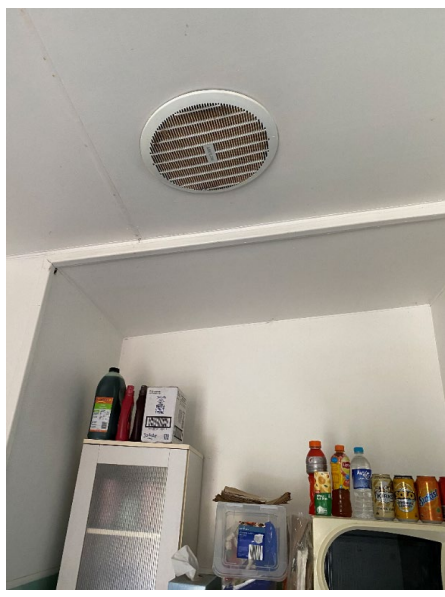
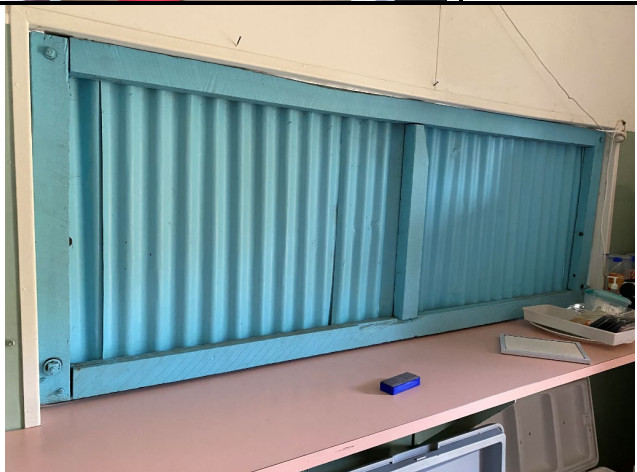
Structure A - Kitchen with server window

Addition of a lean to with Steel posts and timber frame with a sheet metal roof. Additional shade cloth hung from side of building to a tree	
Condition	The building appears to be in good condition, solid timbers roof frame in good condition, internal wall lining (if original) may be asbestos based on age. Server y hatch door is hinged horizontally from the top and opens outwards with the hatch door held in place with a chain.

Build date	1965	
Approval	unknown	
Recommendation	<p>Test internal linings for containment of asbestos. Undisturbed asbestos poses a low risk but should be registered.</p> <p>The server hatch door poses a health and safety risk. As it is held up in an open position on a chain, if it fell it could cause an injury to a customer. Replace with a roller door.</p> <p>Remove Shade clothe attached from building to a tree, consider installing a more appropriate structure if required.</p>

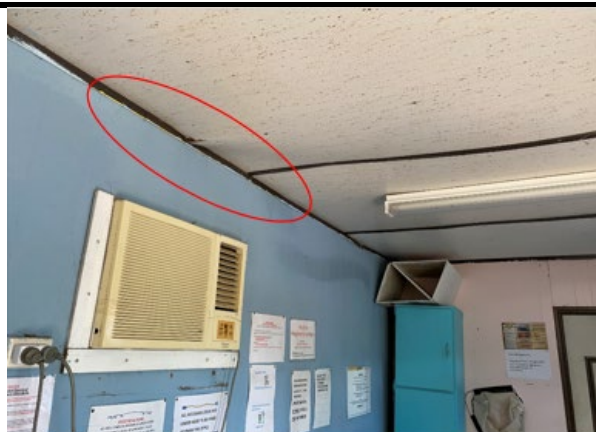
Description	Transportable building of timber frame and Structural steel supports, sheet metal external cladding and timber sheet wall lining internally
Condition	Ceiling is sagging and wall lining is deteriorating in places. The building is non-compliant with present day accessibility standards for a class 5 office. (Door Width: 770mm in lieu of 850mm, the entrance height: 190mm step in lieu of a ramp)

Ceiling sagging

Build date	1995
Approval	None on record
Recommendation	Deteriorated internal wall and ceiling lining to be replaced, requires retrospective building approval. Will likely require the widening of the doorway to 850mm clear and install a step ramp to comply with accessibility requirements for an office.

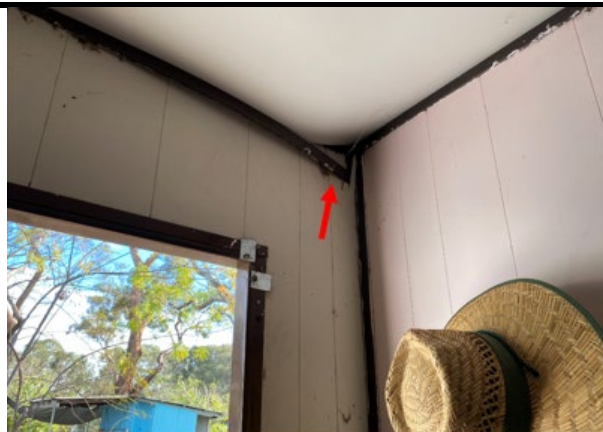
Ceiling sagging and damage

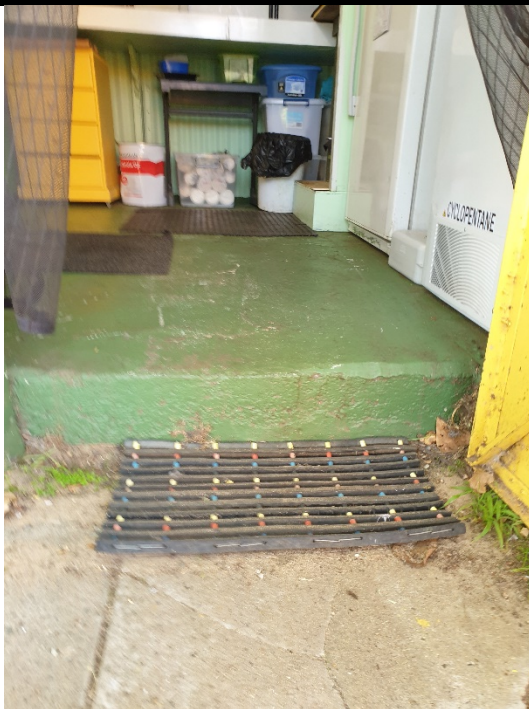
Description	Timber frame shed with sheet metal cladding and concrete slab on ground, possible fibre cement sheet roof or asbestos.
Condition	<ul style="list-style-type: none"> – Concrete slab on ground in poor condition, has multiple cracks through it and it is uneven. This building appears to be a shed converted into a commercial kitchen. As a shed, it is unlikely to have a damp proof membrane beneath the slab so water may permeate the slab from below and cause cracking of the concrete due to expansion and contraction. The slab appears to be unusually thick, it is likely a poured slab on top of an existing slab, the door extends approx. 140mm down from finished floor level to finished ground level. Impervious and uneven floors can lead to unsanitary conditions in a food preparation area. – The ceiling level is below the 2.4m required for a habitable space such as a kitchen. – There is no roof gutters so water run-off will fall to the base of the wall, further adding to the issues of the floor slab. – The server door hinged from the top is opened upwards and held open with steel nuts threaded onto bolts protruding downward from ceiling of a lean to structure. This poses a health and safety risk to customers if the nuts were not tightened properly or the thread failed. – The step and door do not comply with today's accessibility standards but may not have been required at the time of construction if an approval is in place.

Step into building

<p>Server door hinged from the top is opened upwards and held open with steel nuts threaded onto bolts protruding downward from ceiling</p>	
Build date	1974
Approval	unknown
Recommendation	<p>Remove existing floor to ground level if it is found to not be solid concrete and pour a reinforced concrete floor with a damp proof membrane beneath. Finish with a slip resistant linoleum floor covering or washable water resistant coating.</p> <p>Install roof guttering and downpipes which direct storm water to an appropriate disposal method such as a soak well.</p> <p>It is recommended to replace the horizontal hinged server door with a roller door for safety purposes.</p> <p>If retrospective approval is sought then the building would have to comply as a class 6 kitchen by todays standards. The floor, ceiling height and accessibility will require further attention to bring into compliance as well as the installation of a fire extinguisher and consideration to energy efficiency.</p>

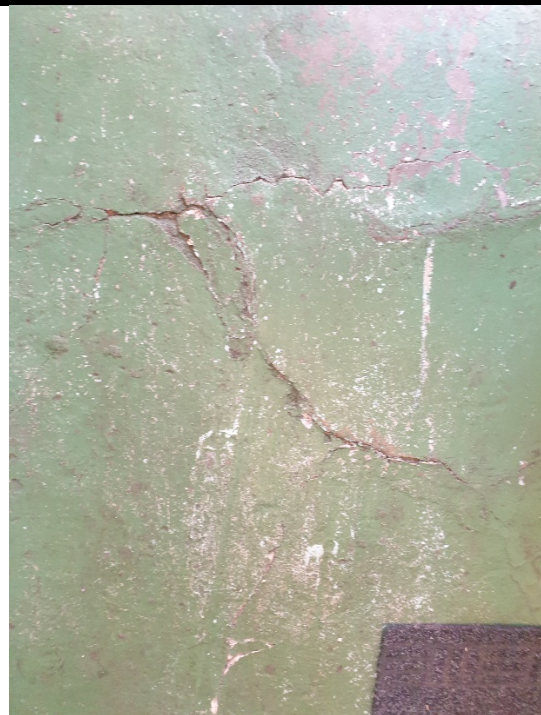
Crack in concrete slab

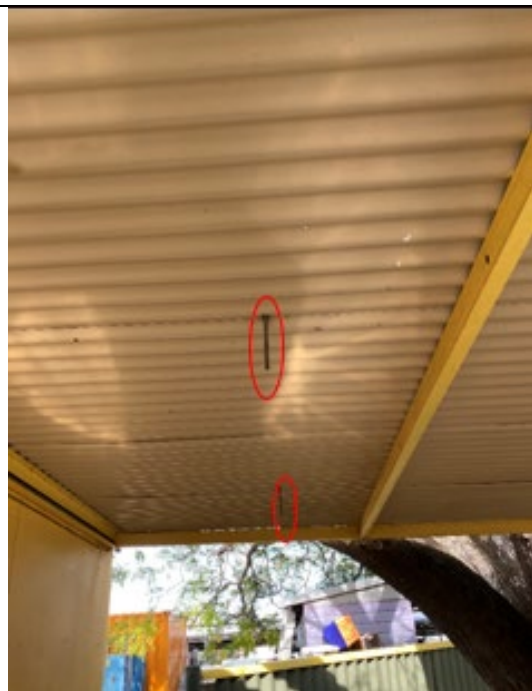
Bolts from roof used to hold up server door

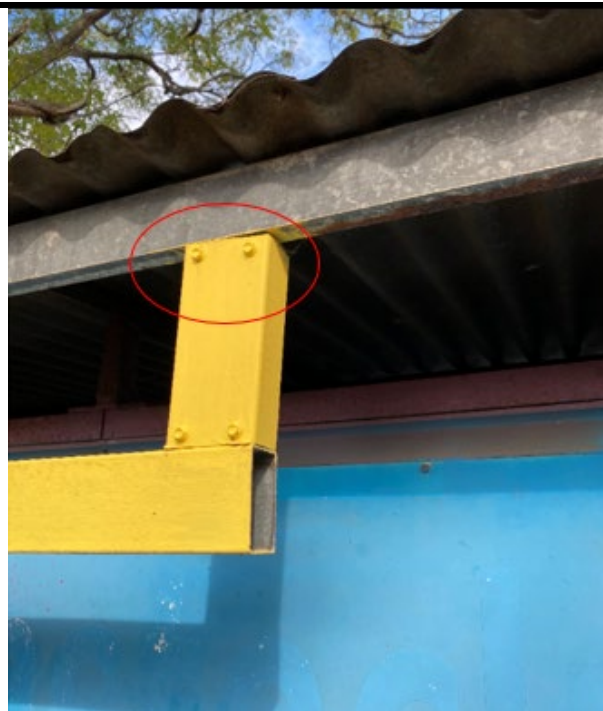
Description	A flat roof steel frame patio with sheet metal roof cladding and approx. 75mm x 38mm rectangular steel hollow patio tube posts. The flat roof patio is attached to the kitchen with server building (Structure C) and also attached to the rear of a stock yard Shed (structure E) by a cantilevered attachment
Condition	The structure appears to be in good condition although the steel tubing used as upright columns is generally used as roof beams or rafters with larger square hollow sections used as posts. Structural beams of structure E where patio is attached by Cantilevered attachment is exposed to weather and continue to deteriorate.

Cantilevered connection to building E

Build date	unclear
Approval	None on record
Recommendation	Engage a suitably qualified structural engineer to inspect and certify the patio structure. Modifications may be required in order to certify the structural adequacy of the patio structure. Install roof guttering to capture storm water run-off and direct it away from the footings of any structures such as to a soak well.

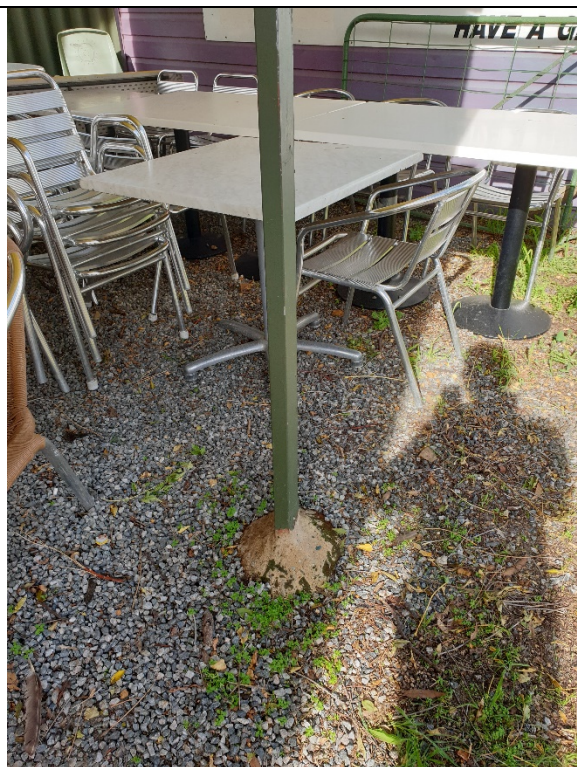
Steel section patio tube posts

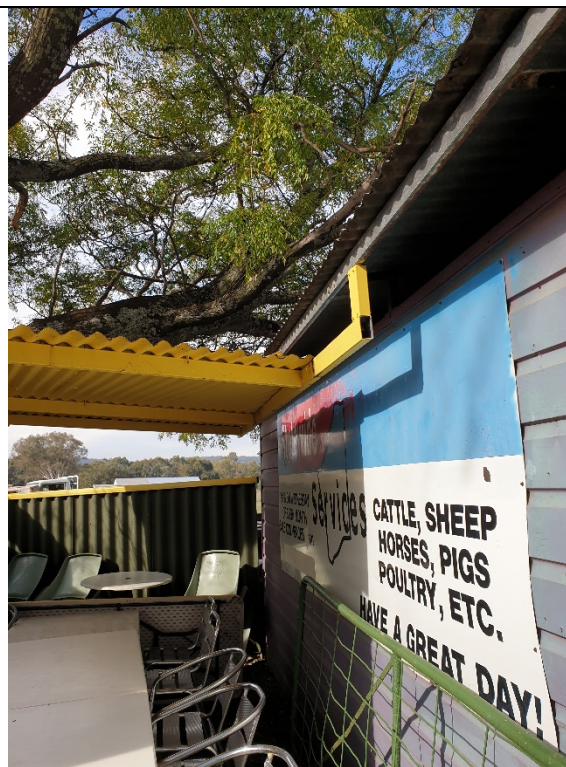
Patio structure attached to the rear of a stock yard shelter

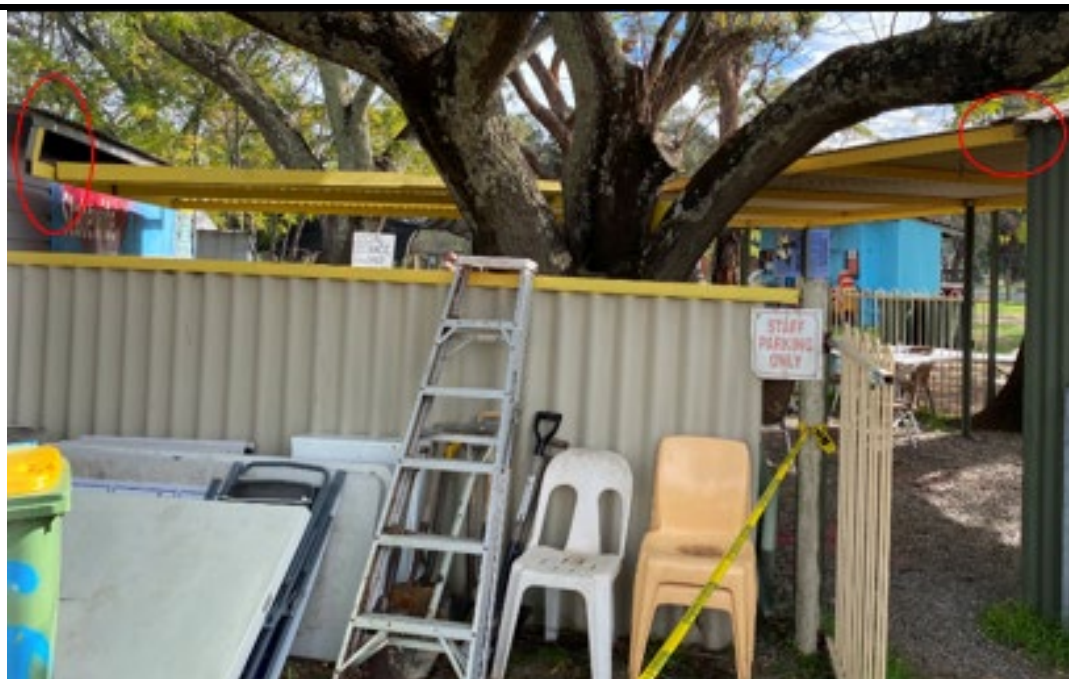
Patio conencted to two buildngs

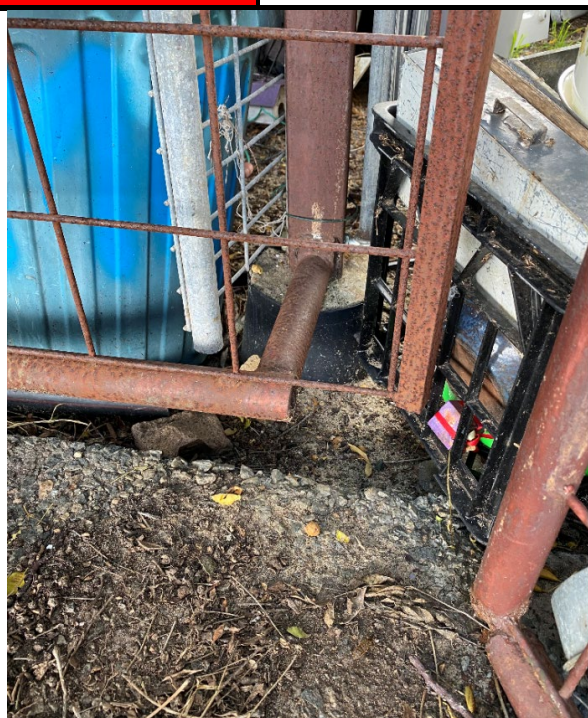
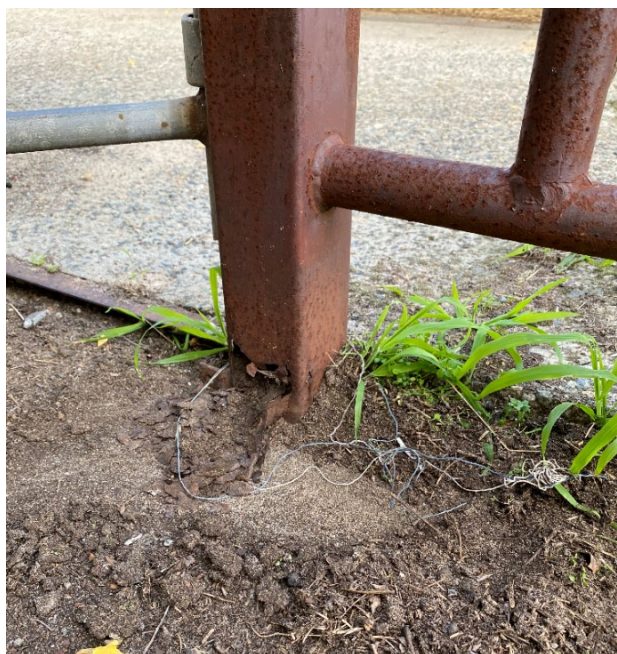
Description	Steel frame semi enclosed Structure with a flat roof, sheet metal wall cladding on three sides and a sheet metal roof. The structure appears to be used adhoc for storage.
Condition	The structural frame of hollow square steel columns and C section beams has no rust protection and is severely rusted. Access was not available to view all structural members due to the items being stored

Structural steel post exposed to weather and corroded from inside
Build date	1974
Approval	unknown
Recommendation	<ul style="list-style-type: none"> – Have a suitably qualified structural engineer recommend the members to be replaced and correct sizing of replacement members – Coat the new steel frame with a corrosion resistant paint

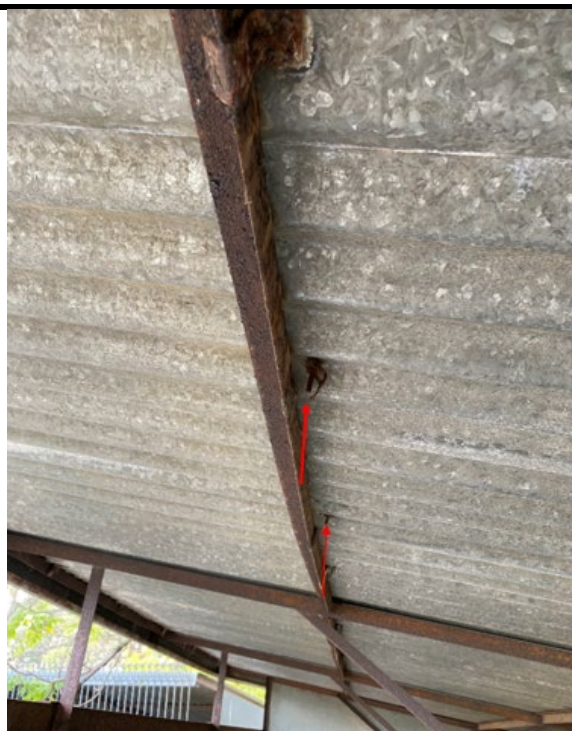
Description	Steel frame semi enclosed Structure with a flat roof, sheet metal wall cladding on three sides and a sheet metal roof. Tiered seating of steel frame with timber bench. Part of structure being used for storage
Condition	The structural frame of hollow square steel columns and C section beams has no rust protection and is severely rusted. The base of the column can be physically busted through by hand, corrosion and flaking of the steel has occurred from within the post.

Attachment of roof sheeting corroded

Build date	1974
Approval	Unknown
Recommendation	<ul style="list-style-type: none"> – Do not allow access to members of the public – Have a suitably qualified structural engineer recommend the members to be replaced and correct sizing of replacement members – Coat the new steel frame with a corrosion resistant paint

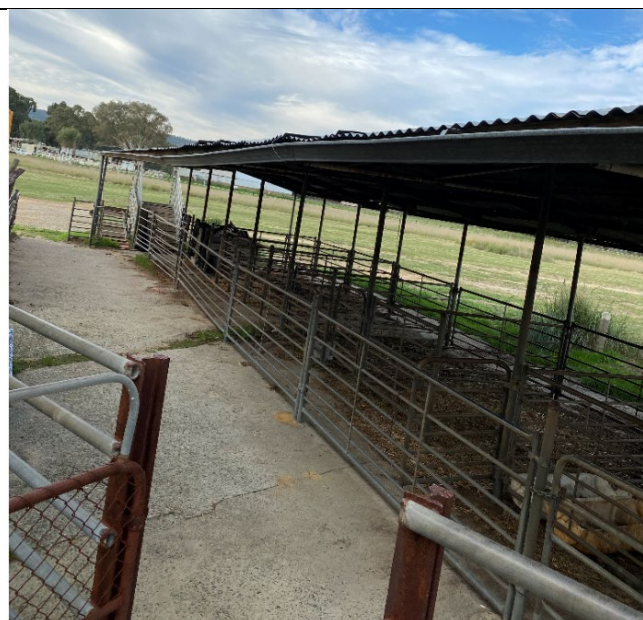
Description	Steel posts, steel truss and timber roof beam structure low pitch gable roof with cantilevered lean-to roof additions, all with sheet metal cladding
Condition	<ul style="list-style-type: none"> – The steel frame live-stock pens and gates are in good condition. – The roof is missing sheets in places, – Roof gutters sagging in places – structural timbers are rotten and deteriorated – it appears some posts and roof truss members may have been installed as replacement members – there is a lean-to type roof structure that is cantilevered 1.37m in length from the post – it is unclear where any wash down of the sales yard concrete pad goes to. There would be animal droppings and urine that would be hosed to a suitable drainage containment point as opposed to direct drainage into the soil

Parts of the roof buckled

Build date	1974
Approval	unknown
Recommendation	<ul style="list-style-type: none"> – Remove any deteriorated roof timbers. – Have a suitably qualified structural engineer inspect the existing steel frame for compliance and recommend sizes of any required replacement members – Check fasteners of sheet metal roof and ensure – Further investigation required into where wash down water is drained to or how animal waste is disposed of

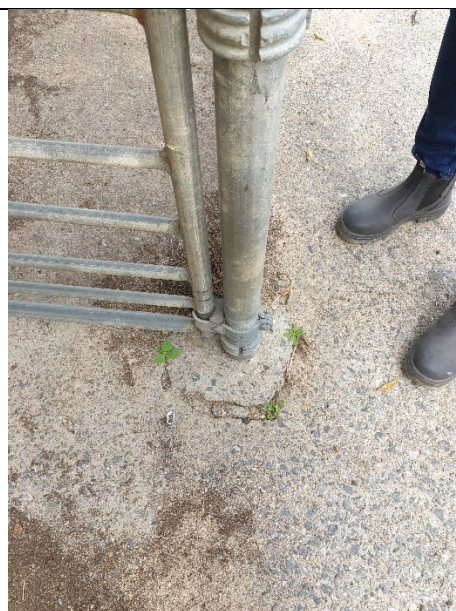
It appears new posts have been installed with new footings

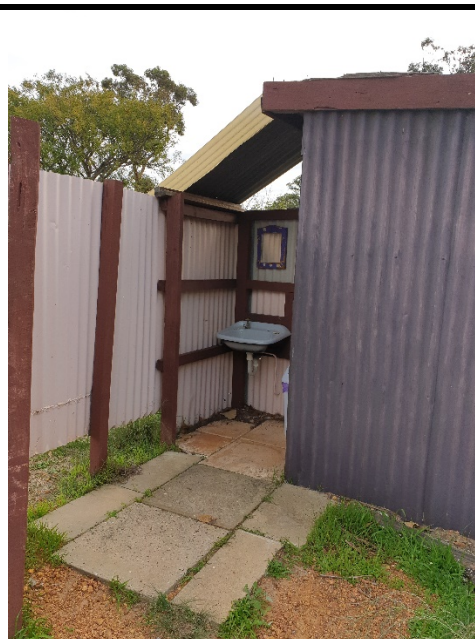
Description	Timber frame corrugated sheet metal walls and roof sanitary facility with plumbed water closet and wash hand basin
Condition	<ul style="list-style-type: none"> – The toilets are in poor condition and are an open outhouse style as opposed to a weather proof building. – some timbers are rotting, – there is a mix match of roof sheeting and the concrete slabs entering the facility and around the wash hand basin are uneven. – The sanitary facility does not comply with accessibility requirements and does not have an accessible path of travel to them. – There is no power or light – The effluent disposal system is functional but it is unknown what condition it is in

Entrance into female toilets and washbasin, uneven concrete slabs

Build date	1965
Approval	unknown
Recommendation	<ul style="list-style-type: none"> – Replace toilet facilities with a compliant accessible sanitary facility – Engage a licensed plumber to inspect the effluent disposal system and verify its condition and if the tanks require pumping out.

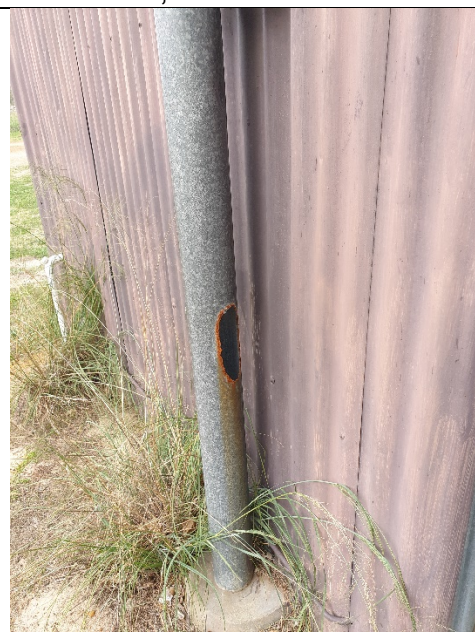
A large hole in what appears to be a ventilation stack

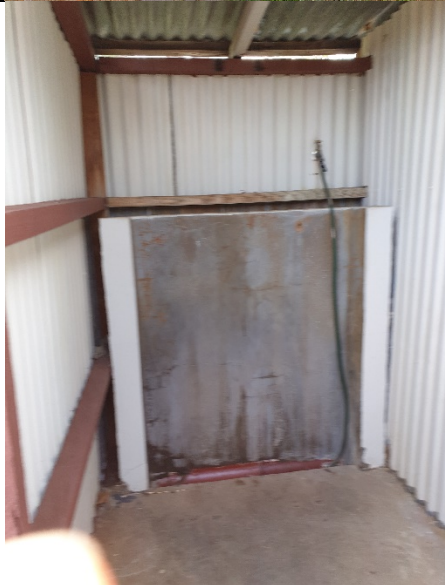
Description	Timber frame corrugated sheet metal walls and roof sanitary facility with plumbed water closet, wash hand basin, the urinal is likely a masonry wall construction with a cement render finish urinal
Condition	<ul style="list-style-type: none"> – The toilets are in poor condition and are an open outhouse style as opposed to a weather proof building. – There are a number of timbers are rotting, – The base of the urinal is cracking and has debris in the drain, there is a garden tap above the urinal with a garden hose connection sitting in the drainage channel in lieu of a flush mechanism, – there is a mix match of roof sheeting – the concrete slabs entering the facility and around the wash hand basin are uneven. – There is no power or light <p>The sanitary facilities does not comply with accessibility requirements and does not have an accessible path of travel to them.</p>

Concrete wall type urinal with hose attachment as flush

Build date	1965
Approval	unknown
Recommendation	Replace toilet facilities with a compliant accessible sanitary facility

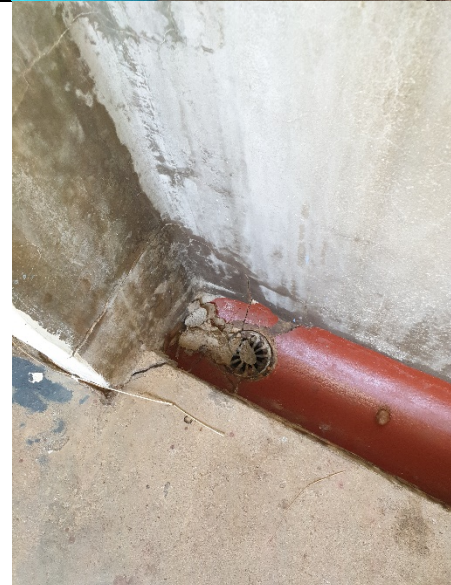
Concrete in urinal deteriorating and cracking causing debris in drain

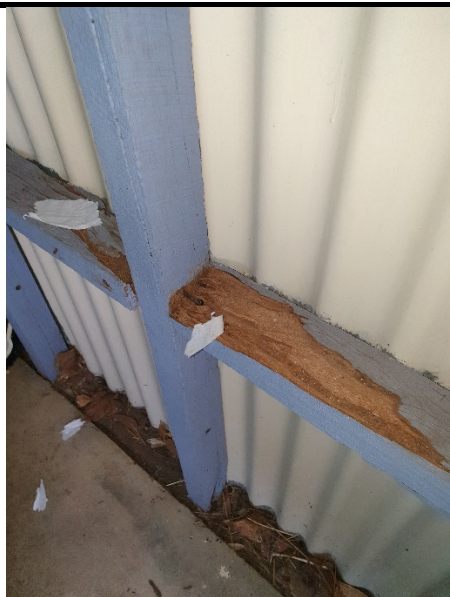
Timbers becoming flaky and powdering possibly due to termites

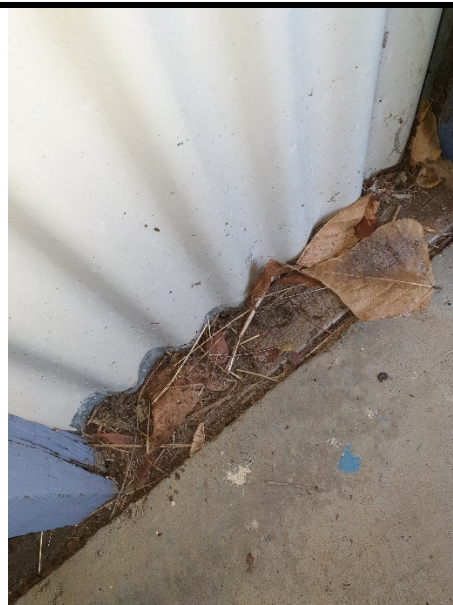
Timbers at base of frame with possible wet rot

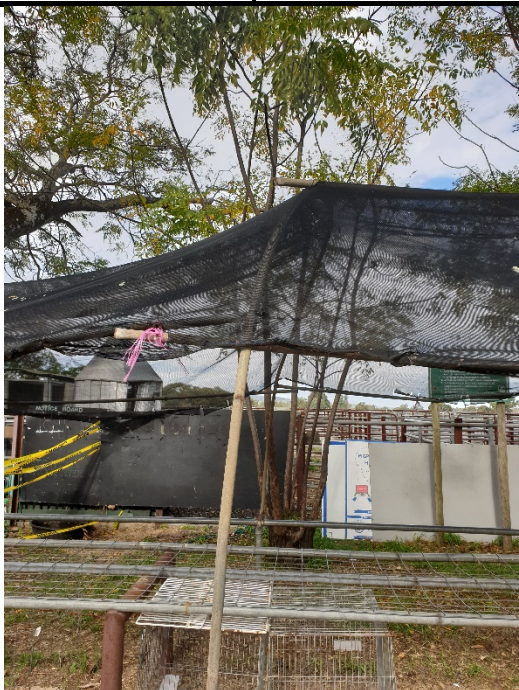
Structure I - Steel frame dome structure for grow tunnels	
Description	Dome shaped tunnels of tubular steel with a loose shade cloth roof
Condition	<p>The tubular step frame is buckled in places and out of shape. A dome shape obtains its structural adequacy through its form and rigid shape, buckles and weak points could cause the structure to fail in a wind event if this structure is ever re-covered with polypropylene as a grow tunnel</p> <p>At present there is a loosely hung piece of shade cloth across the structure.</p>

<p>Shade cloth draped over tubular steel dome structure, structure broke in places</p>

End elevation of steel frame tunnel, out of shape from a wide semi circle dome to a narrow oval	
Build date	unclear
Approval	None on record
Recommendation	have the structure inspected by a structural engineer to recommend remedial work to the tunnel to ensure structural adequacy prior to installing an impermeable material that would then be subject to wind loading

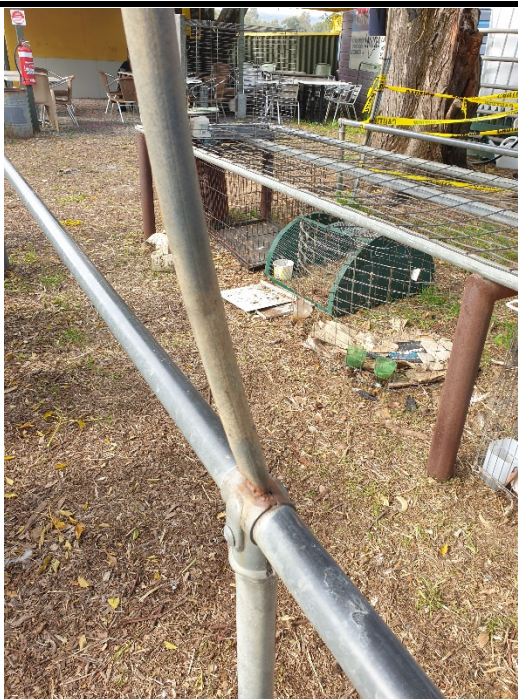
<p>Tubular steel dome frame buckled at a joint</p>
