COMPREHENSIVE PLAYGROUND INSPECTION REPORT

LOCATION: Jarrahdale Hall (Bruno Gianatti Hall), Jarrahdale

CLIENT: Shire of Serpentine Jarrahdale

INSPECTION DATE: 24/09/20

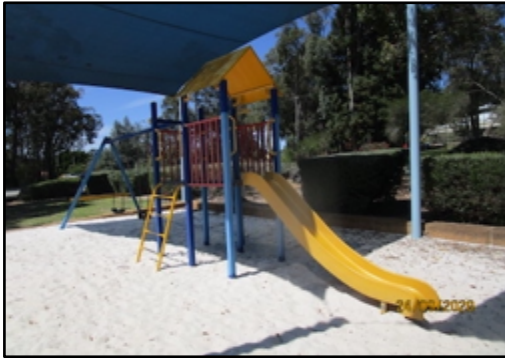
Equipment Type: Play Structure
Manufacturer: Forpark
Installation Date: Circa 2000
Condition: Average

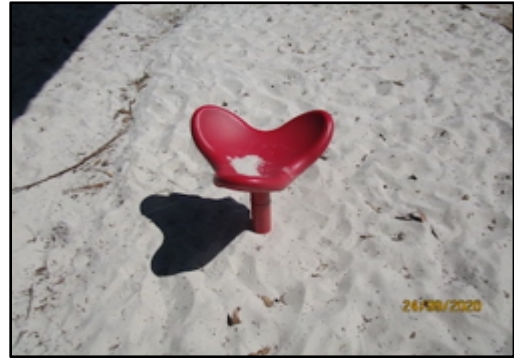
Equipment Type: Spinning Seat
Manufacturer: ?
Installation Date: Circa 2000
Condition: Good

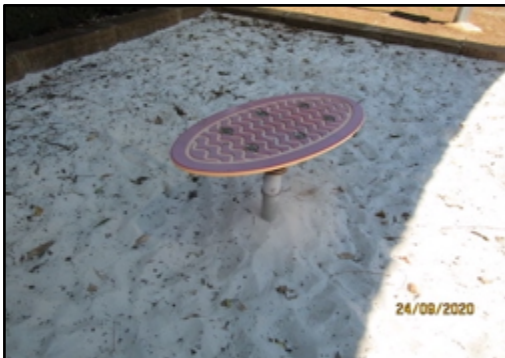
Equipment Type: Surfboard Rocker
Manufacturer: Megatoy
Installation Date: Circa 2000
Condition: Good

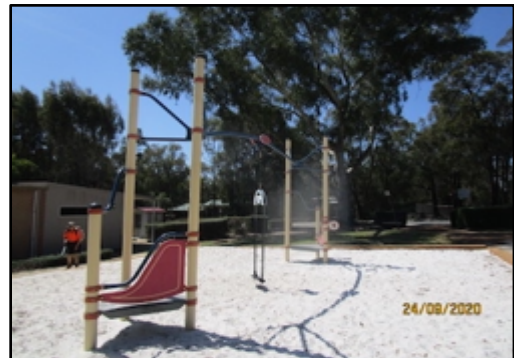
Equipment Type: Sky Surfer
Manufacturer: Megatoy
Installation Date: Circa 2000
Condition: Average

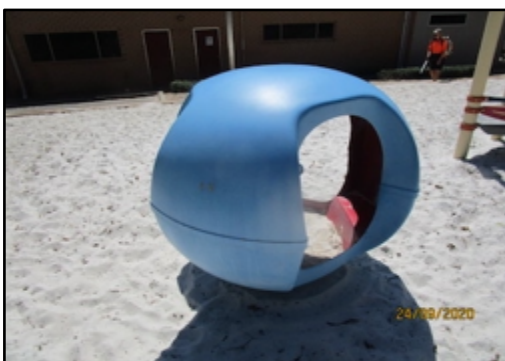
Equipment Type: Spinning Pod
Manufacturer: Miracle
Installation Date: Circa 2000
Condition: Average

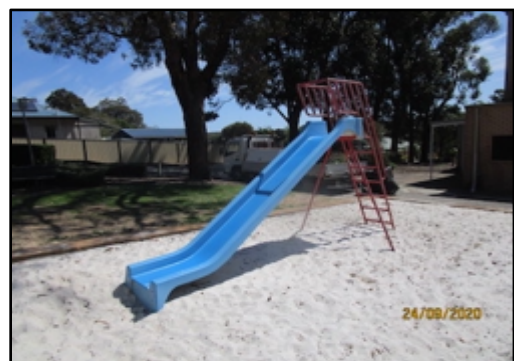
Equipment Type: Slide (free standing)
Manufacturer: Miracle
Installation Date: Circa 2000
Condition: Average

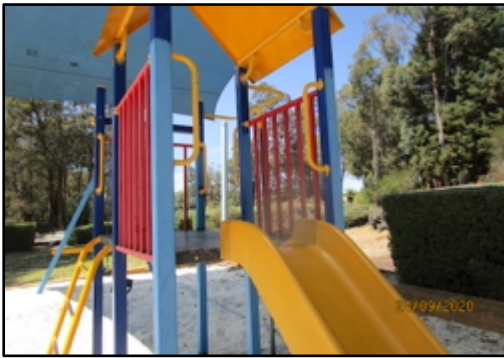
Item:	Slide (Play Structure)		
Finding:	The current Standard requires that slides over 1000mm in height should have a rail above the starting section of the slide. While this was compliant with the Standards at the time of installation a rail could easily be fitted.		
Risk Level:	Low	Priority:	Low
Action:	Council to determine whether to add a rail above the slide. If adding a rail it should be between 600mm and 900mm above the starting section of the slide. Alternatively an entry panel could added, ensuring that the opening to the side of the slide is less than 45mm and greater than 25mm.

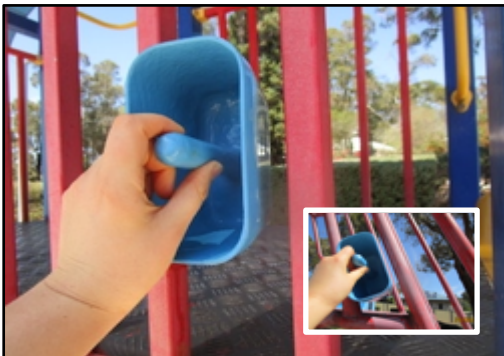
Item:	Safety panels and handgrips (Play Structure and Slide)		
Finding:	The openings in the panels, handgrips and slide entry panel on the free standing slide allow the passage of the small (torso) probe, but not the large (head) probe creating potential head entrapment. The equipment was compliant with Standards in force at the time of installation and the likelihood of incident is very low.		
Risk Level:	Low	Priority:	Very low
Action:	No action required.

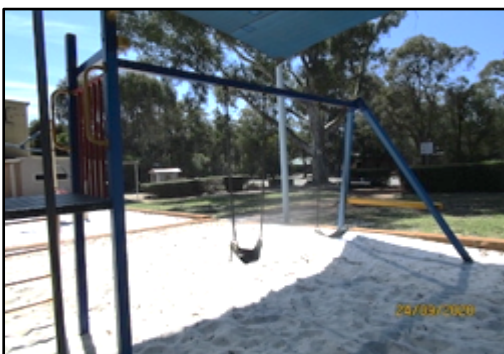
Item:	Swing Frame		
Finding:	Current Standards prohibit swing frames being attached to other equipment unless specific measures are taken to segregate them from other activities, e.g., additional circulation space, barriers or enclosures.		
Risk Level:	Low	Priority:	Low
Action:	As this was compliant with Standards at the time of installation and the risk is low Council will need to determine whether to leave as is or remove the swing.

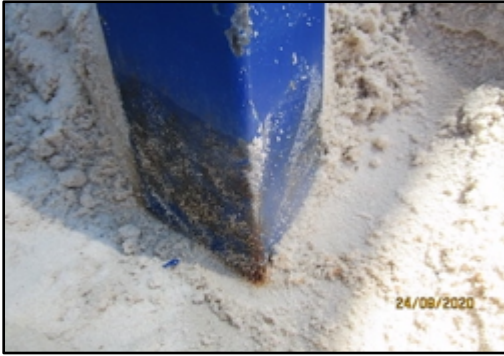
Item:	Various uprights (Play Structure)		
Finding:	There is a moderate amount of corrosion on a number of the uprights at surface level. The uprights still appear to be structurally sound at present.		
Risk Level:	Very low	Priority:	Low-Medium
Action:	Monitor periodically and re-evaluate as the level of corrosion worsens. The affected areas could be rubbed back, re-primed and painted to extend their life. Some uprights may need replacement in the medium term.

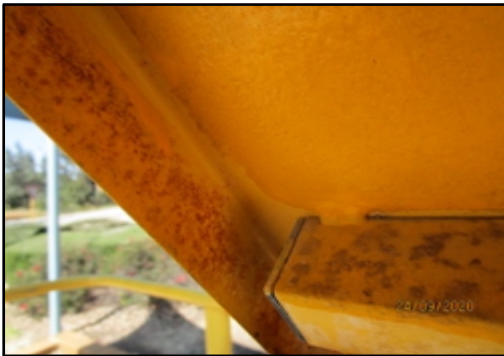
Item:	Various items		
Finding:	A moderate amount of rust is present on several other items. It does not appear to be compromising the structural integrity of the equipment at present.		
Risk Level:	Very low	Priority:	Low-Medium
Action:	Monitor periodically and re-evaluate as the level of corrosion worsens. The affected areas could be rubbed back, re-primed and painted to extend the life of the equipment.

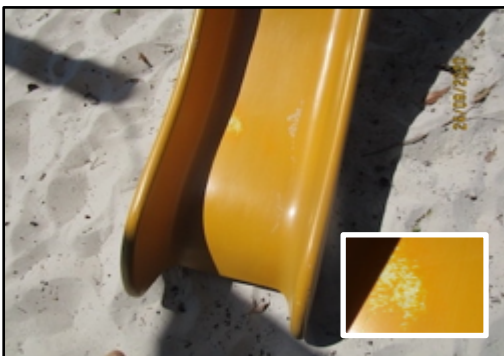
Item:	Fibreglass Slide (Play Structure)		
Finding:	There are several places where the gel-coat has worn away on the slide surface, exposing the fibreglass. The exposed fibreglass does not pose a hazard at present.		
Risk Level:	Very low	Priority:	Low
Action:	In order to limit further wear and prolong the life of the slide, consideration could be given to applying a new gel-coat or coating to the surface of the slide.

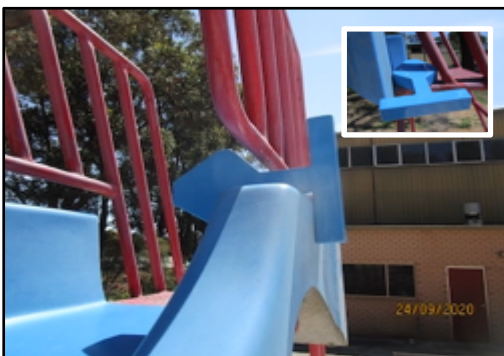
Item:	Free Standing Slide		
Finding:	The opening between the top edge of the slide and the entry panel on the free standing slide allows passage of the neck portion of the probe, creating a potential head/neck entrapment. The likelihood of an incident is low.		
Risk Level:	Moderate	Priority:	Medium
Action:	The openings (at least at the top) should be reduced to less than 45mm. If the opening is reduced all the way down, the remaining opening should be greater than 25mm to prevent clothing entrapment.

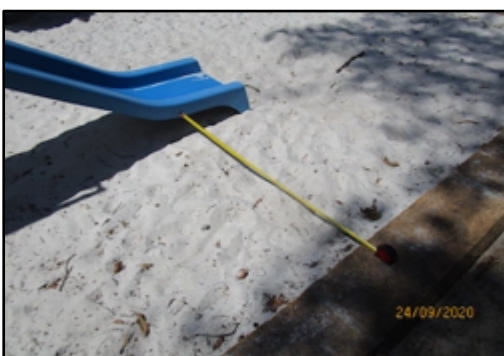
Item:	Free Standing Slide		
Finding:	The impact area to the side of the free standing slide is less than the required 1500mm. The actual distance is around 1400mm.		
Risk Level:	Low	Priority:	Low
Action:	Client to determine whether the low level of risk justifies leaving the sandpit size as is.

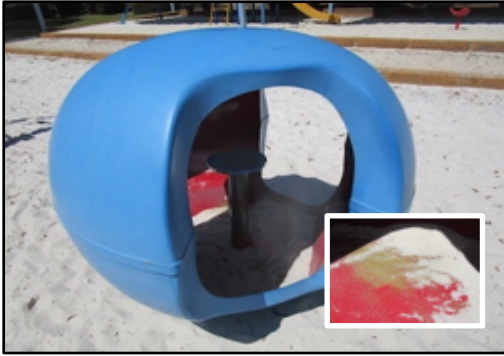
Item:	Spinning Pod		
Finding:	There are several places where the gel-coat has worn away on the inside of the spinning pod, exposing the fibreglass. The exposed fibreglass does not pose a hazard at present.		
Risk Level:	Very low	Priority:	Low
Action:	In order to limit further wear and prolong the life of the spinning pod, consideration could be given to applying a new gel-coat.

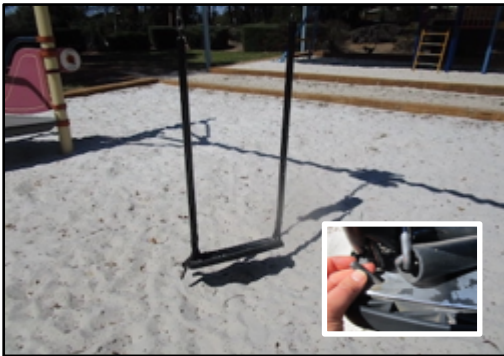
Item:	Sky Surfer		
Finding:	One of the nuts on one of the bolts securing the chain to the standing board on the sky surfer is missing.		
Risk Level:	Low	Priority:	Medium
Action:	Replace the missing nut and re-secure the chain to the board.

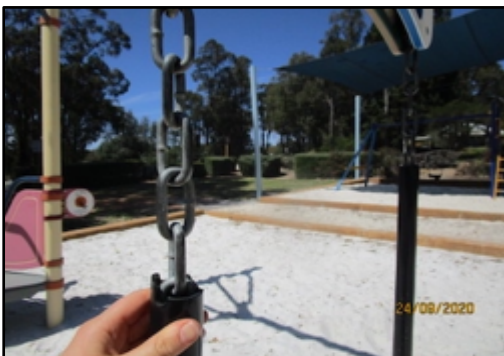
Item:	Sky Surfer		
Finding:	Some of the hose covering the chains has torn, exposing the chain, creating a potential finger entrapment hazard.		
Risk Level:	Low	Priority:	Medium
Action:	Replace or repair the damaged hose. (The split sections could be replaced or taped with an appropriate tape to prevent further splitting.)
