# Mundijong Sales Yard

## Building and incidental structures inspection report

**June 2020**

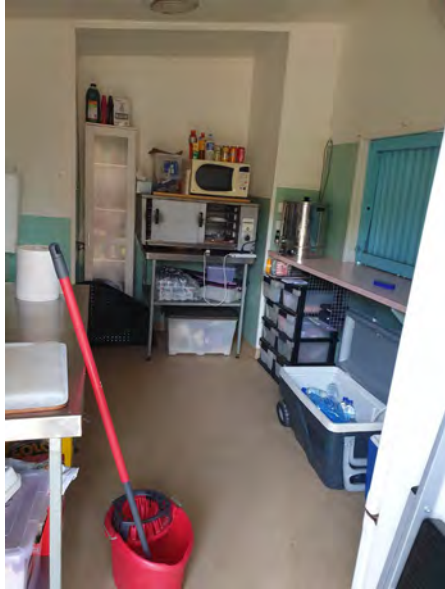
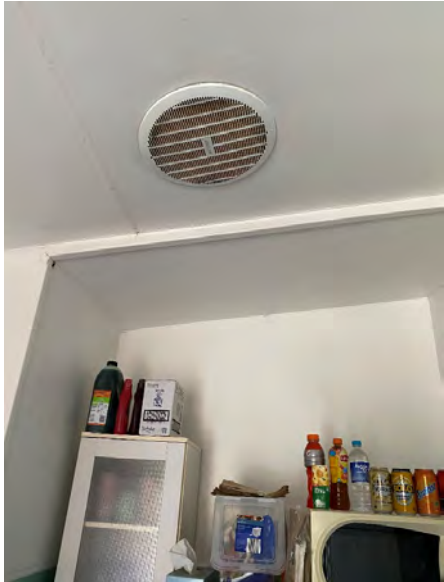
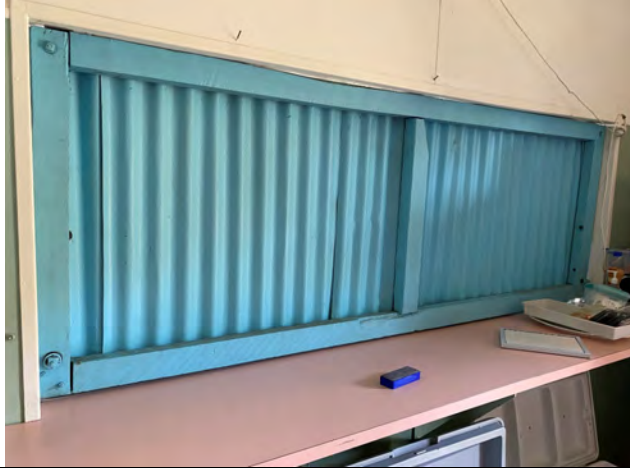
| Condition | The building appears to be in good condition, solid timbers roof frame in good condition, internal wall lining (if original) may be asbestos based on age. Server y hatch door is hinged horizontally from the top and opens outwards with the hatch door held in place with a chain. | |

| Recommendation | <p>Test internal linings for containment of asbestos. Undisturbed asbestos poses a low risk but should be registered.</p> <p>The server hatch door poses a health and safety risk. As it is held up in an open position on a chain, if it fell it could cause an injury to a customer. Replace with a roller door.</p> <p>Remove Shade cloth attached from building to a tree, consider installing a more appropriate structure if required.</p> | |

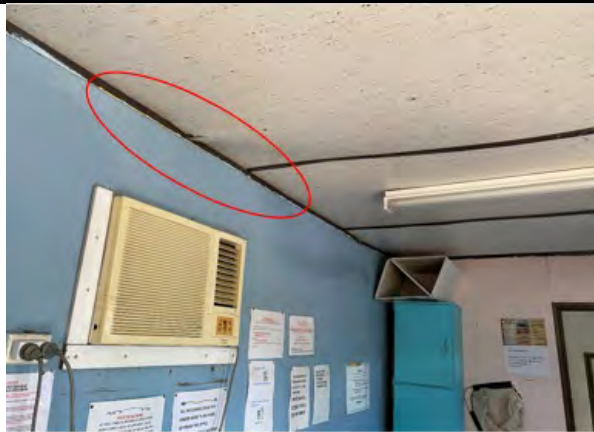
| Condition | Ceiling is sagging and wall lining is deteriorating in places. The building is non-compliant with present day accessibility standards for a class 5 office. (Door Width: 770mm in lieu of 850mm, the entrance height: 190mm step in lieu of a ramp) |

Ceiling sagging

| Recommendation | Deteriorated internal wall and ceiling lining to be replaced, requires retrospective building approval. Will likely require the widening of the doorway to 850mm clear and install a step ramp to comply with accessibility requirements for an office. |

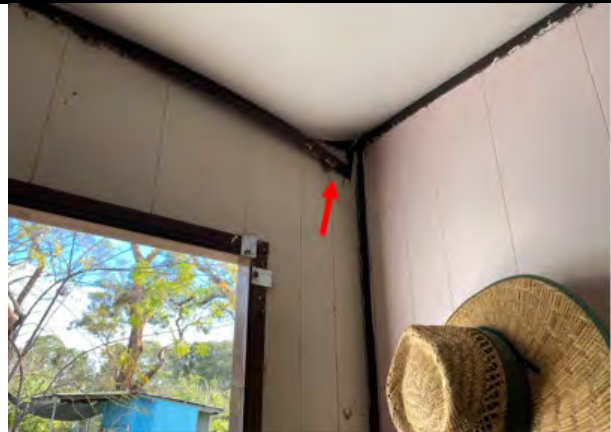
Ceiling sagging and damage

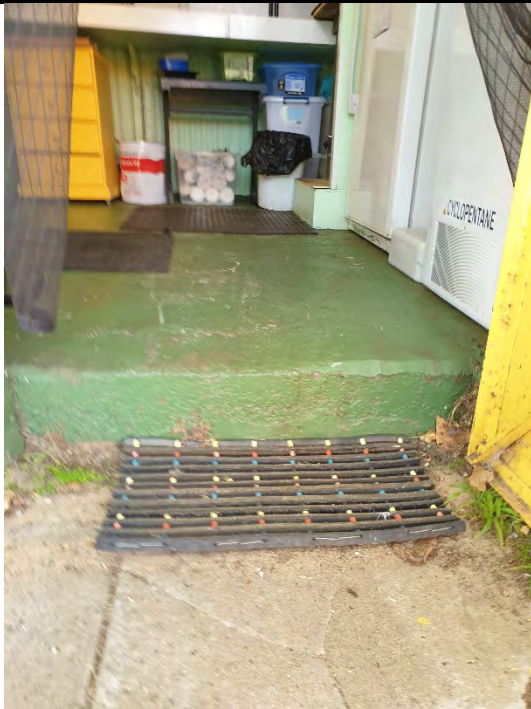
Step into building

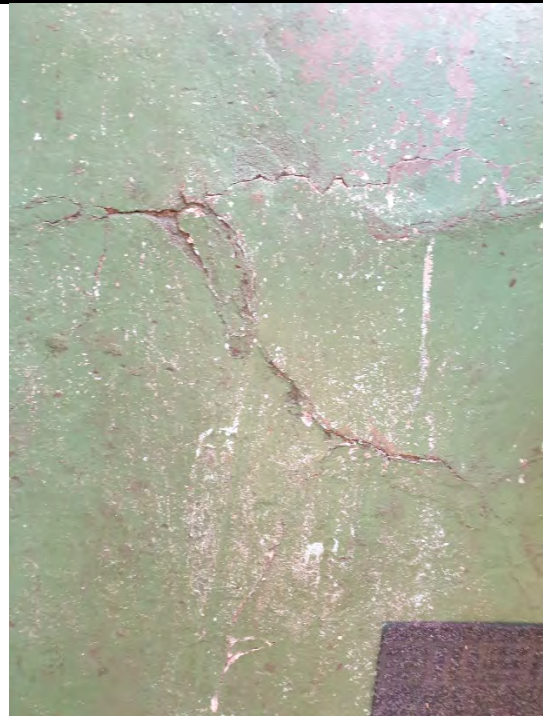
| Condition | <ul style="list-style-type: none"> <li>– Concrete slab on ground in poor condition, has multiple cracks through it and it is uneven. This building appears to be a shed converted into a commercial kitchen. As a shed, it is unlikely to have a damp proof membrane beneath the slab so water may permeate the slab from below and cause cracking of the concrete due to expansion and contraction. The slab appears to be unusually thick, it is likely a poured slab on top of an existing slab, the door extends approx. 140mm down from finished floor level to finished ground level. Impervious and uneven floors can lead to unsanitary conditions in a food preparation area.</li> <li>– The ceiling level is below the 2.4m required for a habitable space such as a kitchen.</li> <li>– There is no roof gutters so water run-off will fall to the base of the wall, further adding to the issues of the floor slab.</li> <li>– The server door hinged from the top is opened upwards and held open with steel nuts threaded onto bolts protruding downward from ceiling of a lean to structure. This poses a health and safety risk to customers if the nuts were not tightened properly or the thread failed.</li> <li>– The step and door do not comply with todays accessibility standards but may not have been required at the time of construction if an approval is in place.</li> </ul> |

Crack in concrete slab

| Recommendation | <p>Remove existing floor to ground level if it is found to not be solid concrete and pour a reinforced concrete floor with a damp proof membrane beneath. Finish with a slip resistant linoleum floor covering or washable water resistant coating.</p> <p>Install roof guttering and downpipes which direct storm water to an appropriate disposal method such as a soak well.</p> <p>It is recommended to replace the horizontal hinged server door with a roller door for safety purposes.</p> <p>If retrospective approval is sought then the building would have to comply as a class 6 kitchen by todays standards. The floor, ceiling height and accessibility will require further attention to bring into compliance as well as the installation of a fire extinguisher and consideration to energy efficiency.</p> |

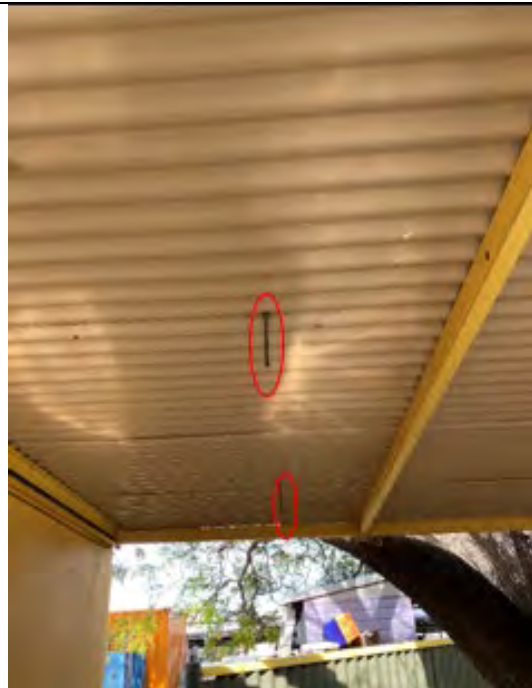
Bolts from roof used to hold up server door

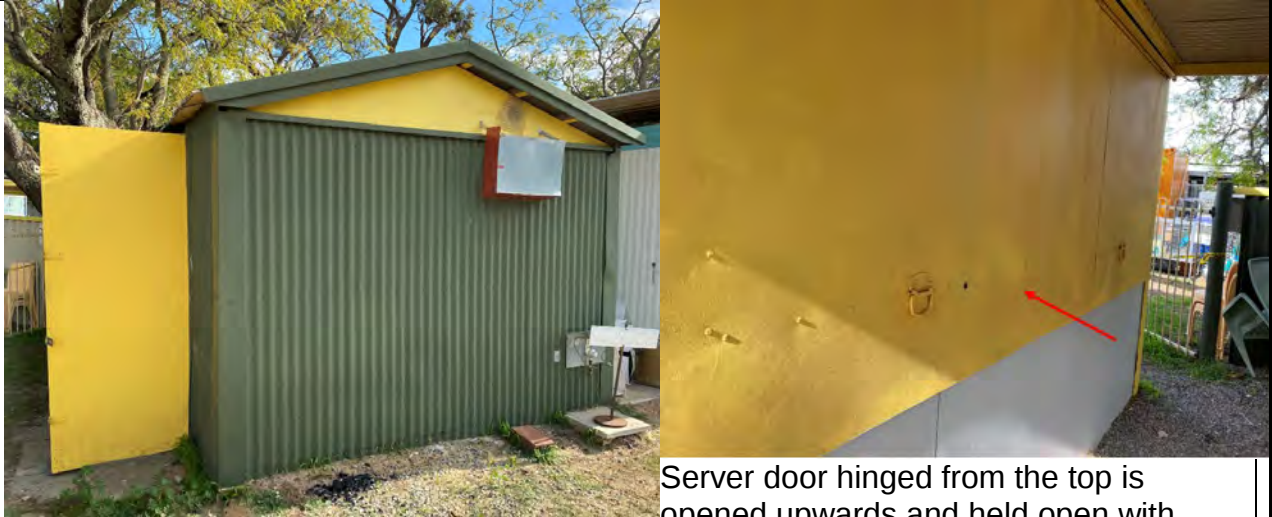
| <p>Server door hinged from the top is opened upwards and held open with steel nuts threaded onto bolts protruding downward from ceiling</p> | |

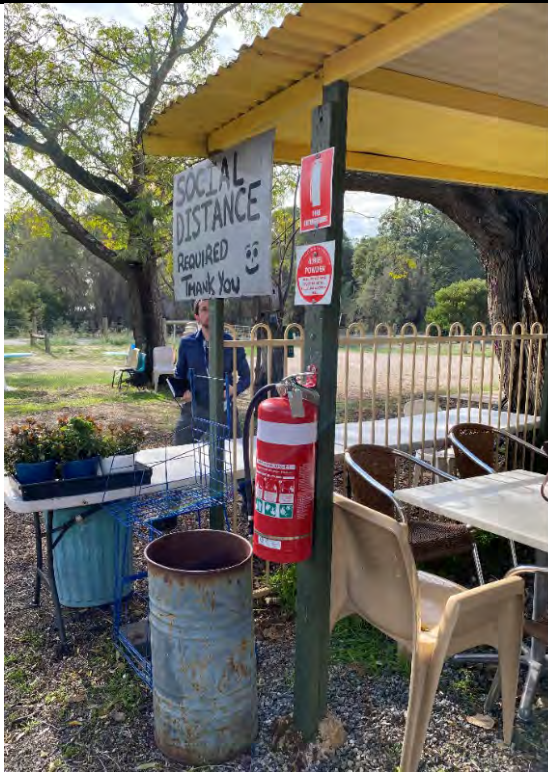
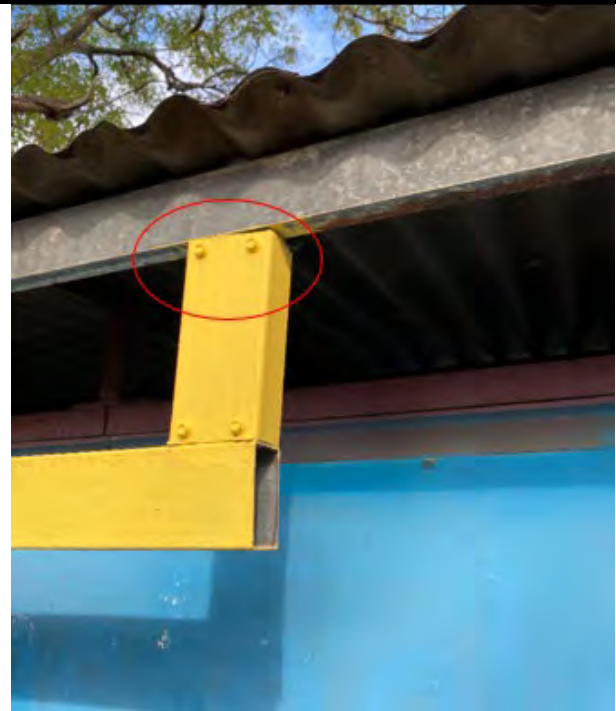
| Condition | The structure appears to be in good condition although the steel tubing used as upright columns is generally used as roof beams or rafters with larger square hollow sections used as posts. Structural beams of structure E where patio is attached by Cantilevered attachment is exposed to weather and continue to deteriorate. |

Cantilevered connection to building E

| Recommendation | Engage a suitably qualified structural engineer to inspect and certify the patio structure. Modifications may be required in order to certify the structural adequacy of the patio structure.<br>Install roof guttering to capture storm water run-off and direct it away from the footings of any structures such as to a soak well. |

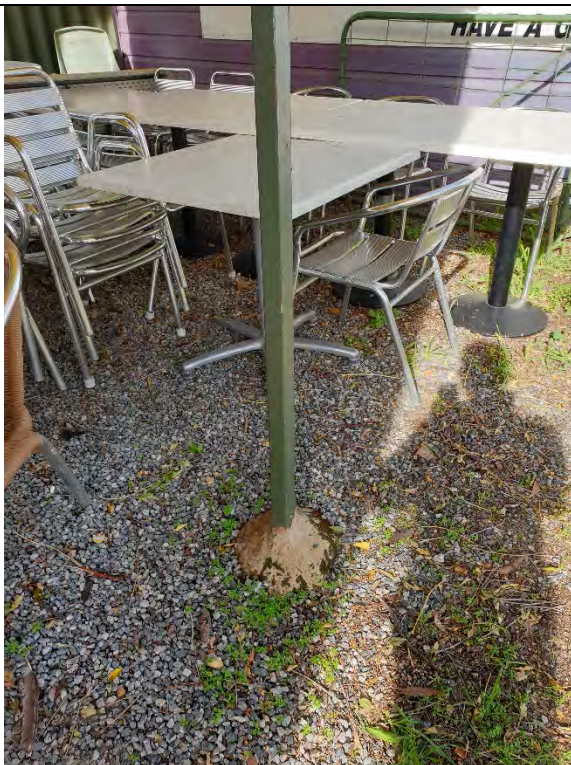
Steel section patio tube posts

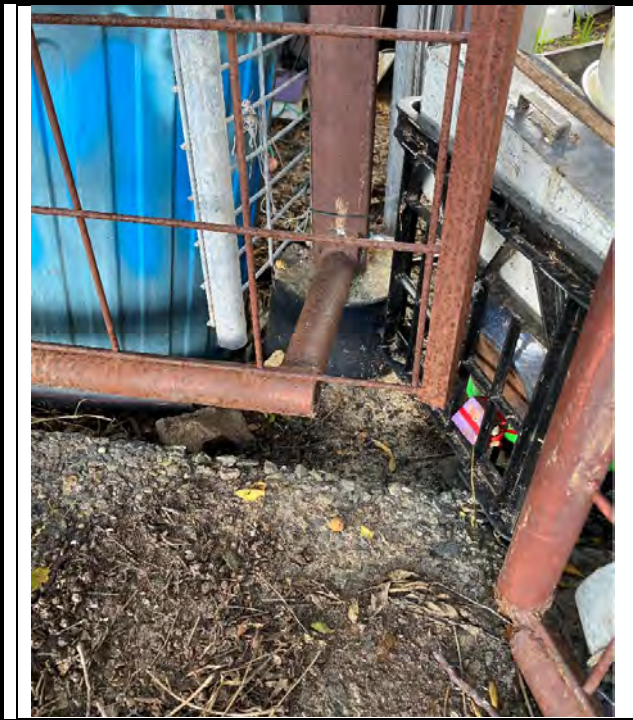
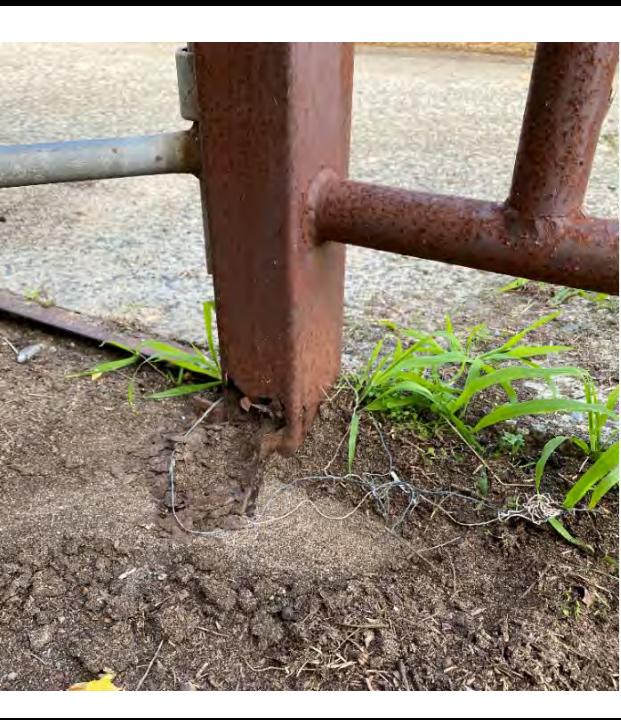
| Structure E - Stockyard Shelter | |
|---|---|
| Condition | The structural frame of hollow square steel columns and C section beams has no rust protection and is severely rusted. Access was not available to view all structural members due to the items being stored |

| | Structural steel post exposed to weather and corroded from inside |

| Recommendation | <ul style="list-style-type: none"> <li>– Have a suitably qualified structural engineer recommend the members to be replaced and correct sizing of replacement members</li> <li>– Coat the new steel frame with a corrosion resistant paint</li> </ul> |

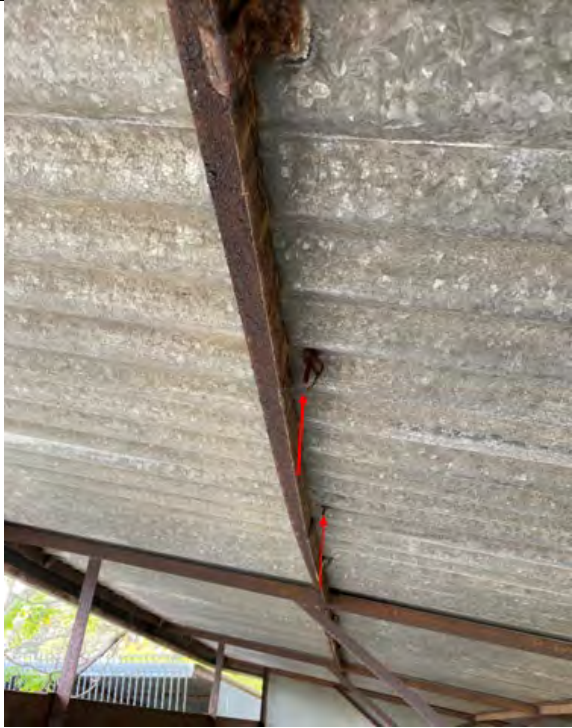
| Condition | The structural frame of hollow square steel columns and C section beams has no rust protection and is severely rusted. The base of the column can be physically busted through by hand, corrosion and flaking of the steel has occurred from within the post. |

| <p>Attachment of roof sheeting corroded</p> | | <p>Front elevation of stockyard shelter for members of the public</p> |

| Recommendation | <ul style="list-style-type: none"> <li>– Do not allow access to members of the public</li> <li>– Have a suitably qualified structural engineer recommend the members to be replaced and correct sizing of replacement members</li> <li>– Coat the new steel frame with a corrosion resistant paint</li> </ul> | |

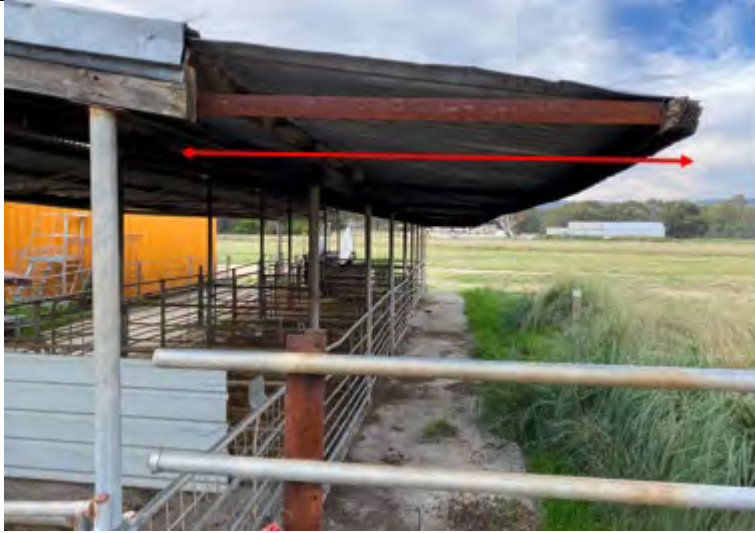
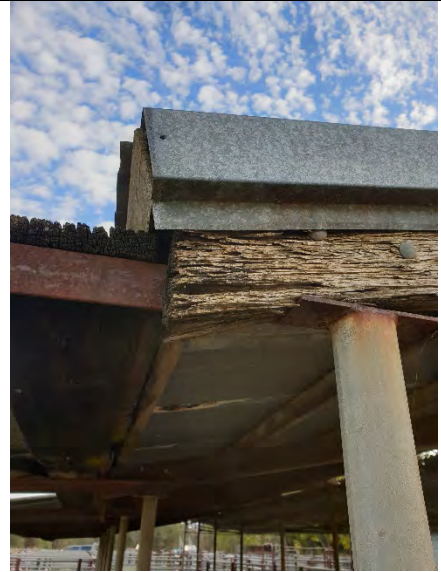
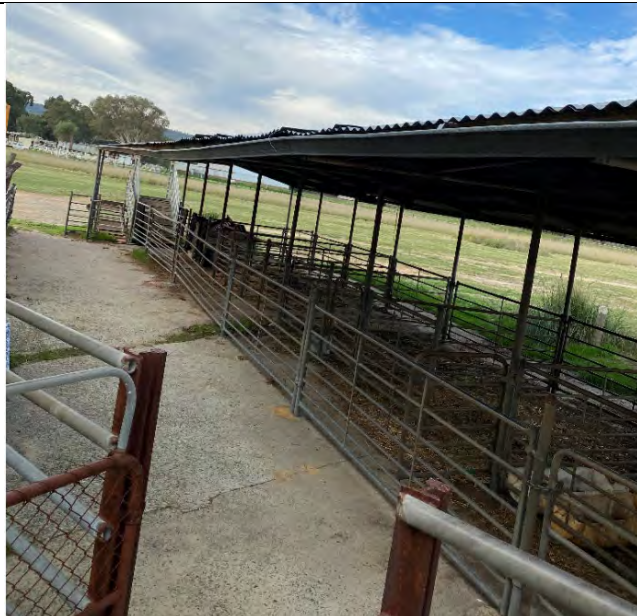
| Condition | <ul style="list-style-type: none"> <li>– The steel frame live-stock pens and gates are in good condition.</li> <li>– The roof is missing sheets in places,</li> <li>– Roof gutters sagging in places</li> <li>– structural timbers are rotten and deteriorated</li> <li>– it appears some posts and roof truss members may have been installed as replacement members</li> <li>– there is a lean-to type roof structure that is cantilevered 1.37m in length from the post</li> <li>– it is unclear where any wash down of the sales yard concrete pad goes to. There would be animal droppings and urine that would be hosed to a suitable drainage containment point as opposed to direct drainage into the soil</li> </ul> |

Parts of the roof buckled

| Recommendation | <ul style="list-style-type: none"> <li>– Remove any deteriorated roof timbers.</li> <li>– Have a suitably qualified structural engineer inspect the existing steel frame for compliance and recommend sizes of any required replacement members</li> <li>– Check fasteners of sheet metal roof and ensure</li> <li>– Further investigation required into where wash down water is drained to or how animal waste is disposed of</li> </ul> |

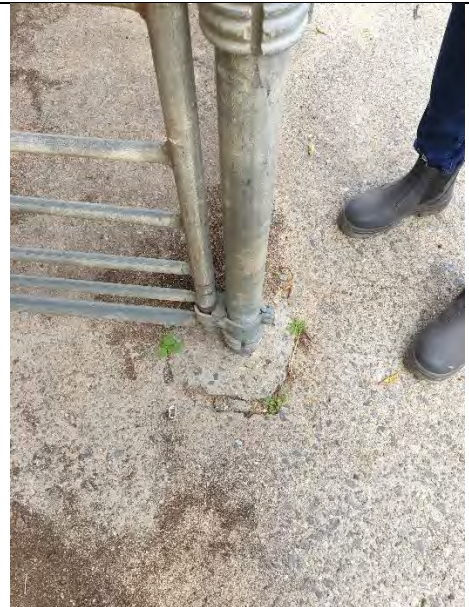
It appears new posts have been installed with new footings

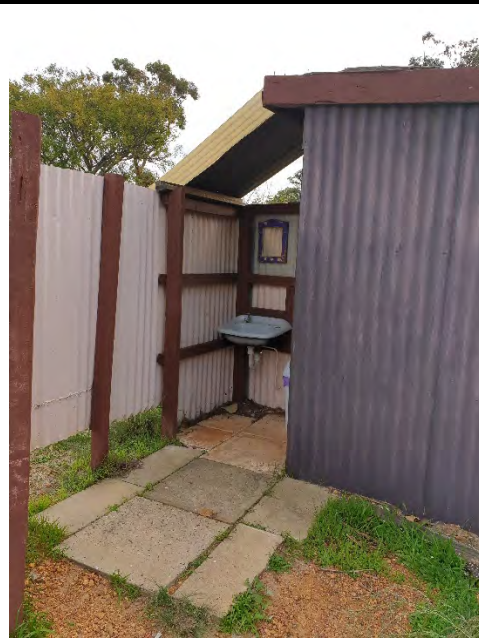
| Condition | <ul style="list-style-type: none"> <li>– The toilets are in poor condition and are an open outhouse style as opposed to a weather proof building.</li> <li>– some timbers are rotting,</li> <li>– there is a mix match of roof sheeting and the concrete slabs entering the facility and around the wash hand basin are uneven.</li> <li>– The sanitary facility does not comply with accessibility requirements and does not have an accessible path of travel to them.</li> <li>– There is no power or light</li> <li>– The effluent disposal system is functional but it is unknown what condition it is in</li> </ul> |

Entrance into female toilets and washbasin, uneven concrete slabs

| Recommendation | <ul style="list-style-type: none"> <li>– Replace toilet facilities with a compliant accessible sanitary facility</li> <li>– Engage a licensed plumber to inspect the effluent disposal system and verify its condition and if the tanks require pumping out.</li> </ul> |

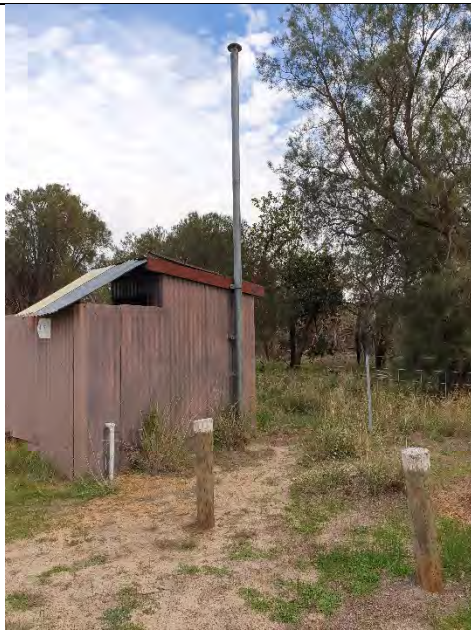
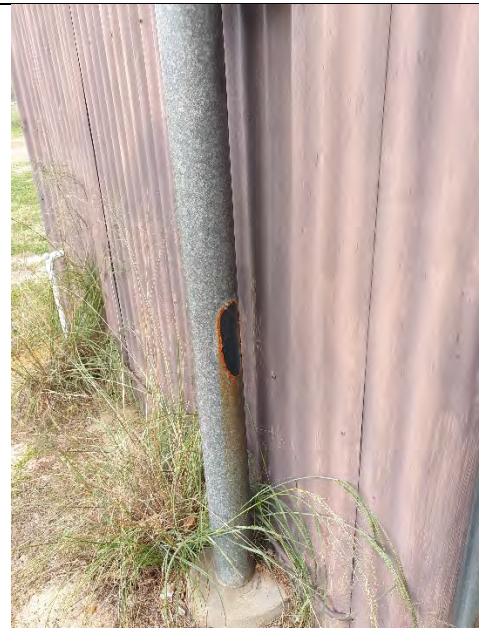
A large hole in what appears to be a ventilation stack

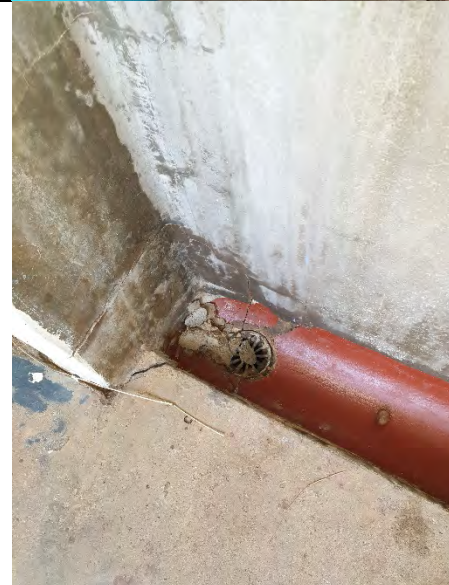
| Condition | <ul style="list-style-type: none"> <li>– The toilets are in poor condition and are an open outhouse style as opposed to a weather proof building.</li> <li>– There are a number of timbers are rotting,</li> <li>– The base of the urinal is cracking and has debris in the drain, there is a garden tap above the urinal with a garden hose connection sitting in the drainage channel in lieu of a flush mechanism,</li> <li>– there is a mix match of roof sheeting</li> <li>– the concrete slabs entering the facility and around the wash hand basin are uneven.</li> <li>– There is no power or light</li> </ul> <p>The sanitary facilities does not comply with accessibility requirements and does not have an accessible path of travel to them.</p> |

Concrete in urinal deteriorating and cracking causing debris in drain

| Recommendation | Replace toilet facilities with a compliant accessible sanitary facility |

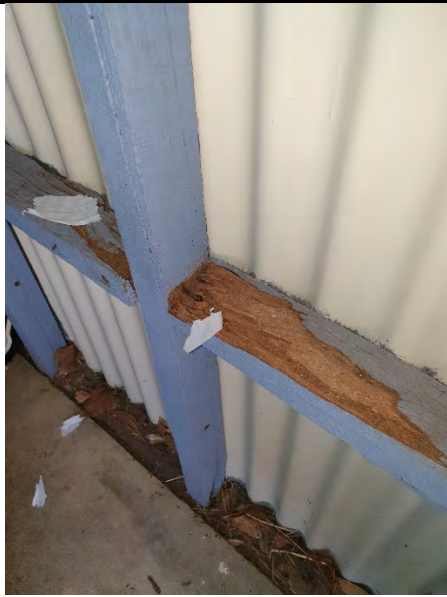
Timbers becoming flaky and powdering possibly due to termites

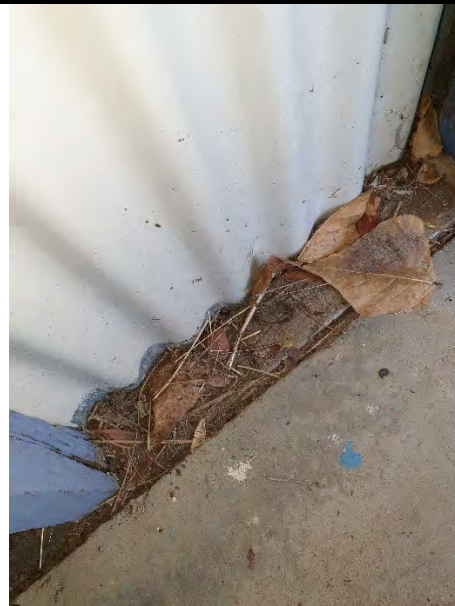
Timbers at base of frame with possible wet rot

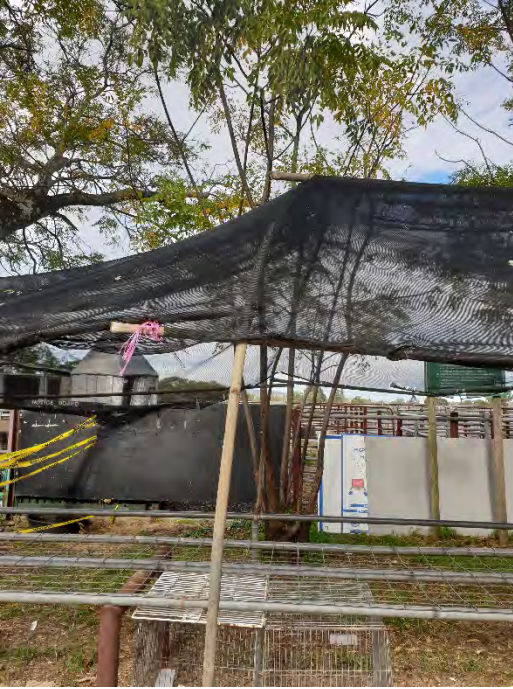
| <b>Structure I - Steel frame dome structure for grow tunnels</b> | |
|---|---|
| <p>Shade cloth draped over tubular steel dome structure, structure broke in places</p> | <p>Tubular steel dome frame buckled at a joint</p> |

| Recommendation | have the structure inspected by a structural engineer to recommend remedial work to the tunnel to ensure structural adequacy prior to installing an impermeable material that would then be subject to wind loading |

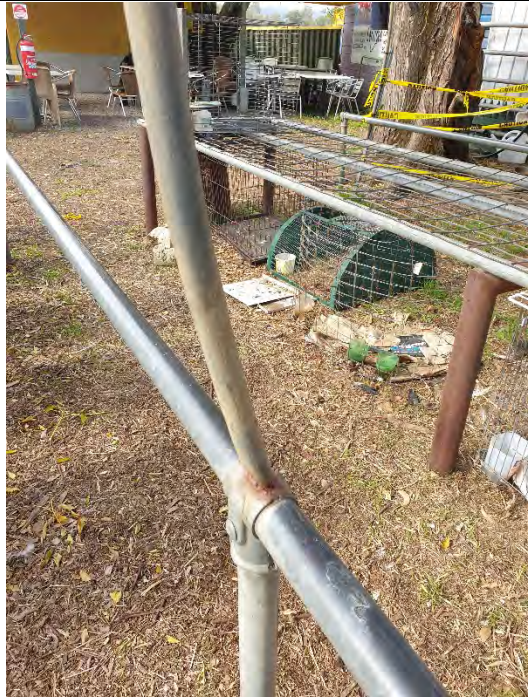
| <b>Structure I - Steel frame dome structure for grow tunnels</b> | |
|---|---|
| Condition | <p>The tubular step frame is buckled in places and out of shape. A dome shape obtains its structural adequacy through its form and rigid shape, buckles and weak points could cause the structure to fail in a wind event if this structure is ever re-covered with polypropylene as a grow tunnel</p> <p>At present there is a loosely hung piece of shade cloth across the structure.</p> |

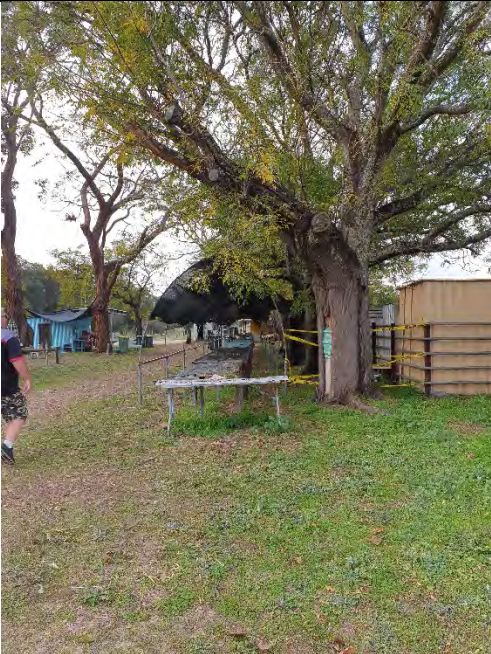
| End elevation of steel frame tunnel, out of shape from a wide semi circle dome to a narrow oval | |
