Shire of Serpentine Jarrahdale
Serpentine Jarrahdale Community Recreation
Centre
Building Condition Audit & Life Cycle Costing

12 February 2021

Serpentine Jarrahdale Community Recreation Centre Building Condition Audit Report_Rev0

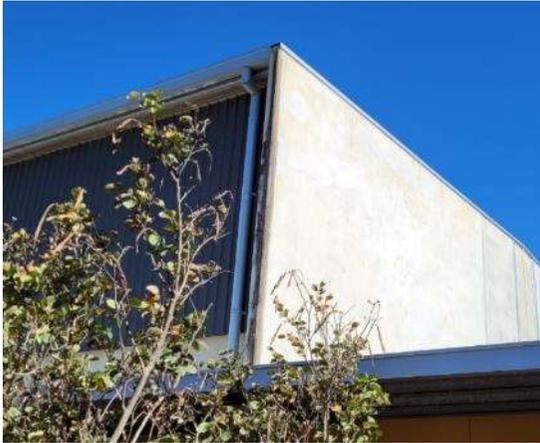
Reference No	Location/Element	Works Type	Description	Photographs	Cost Est.	Year
EW007	Extreme Sports Court – External Walls	Repair	Discolouration to wall slab edge possibly due to leaking gutter. Some imperfections visible on the concrete surface.

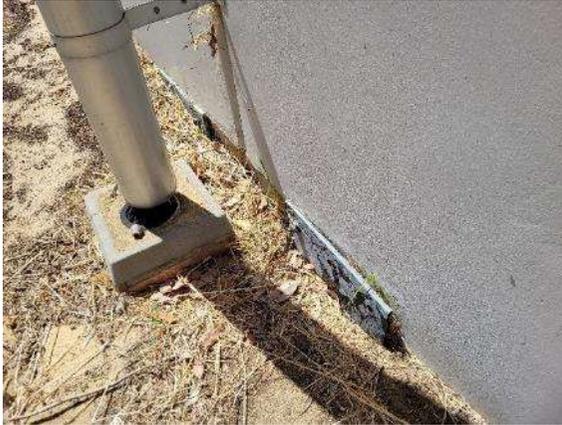
An allowance has been made overall of \$3,500 for structural inspection (See EW005)	2021
EW010	Extreme Sports Court – External Walls		Loose and missing bolts and displacement of tilt panel base plates.

An allowance has been made overall of \$3,500 for structural inspection (See EW005)	2021

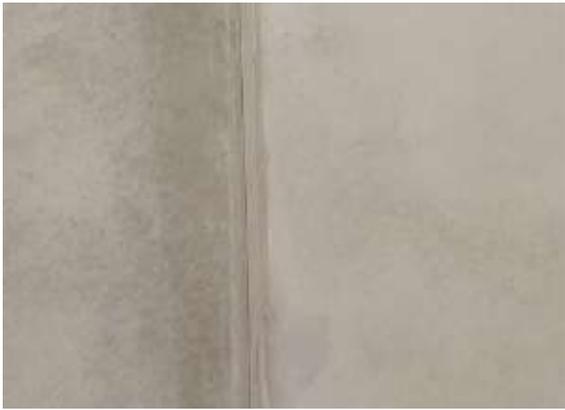
Reference No	Location/Element	Works Type	Description	Photographs	Cost Est.	Year
EW011	Extreme Sports Court – External Walls	Repair	Minor deterioration to slab joints.

An allowance has been made overall of \$3,500 for structural inspection (See EW005)	2021
EW012	Gymnasium Area – External Walls	Renewal	External wall finishes are badly deteriorated. Cost is for preparation and renewal of exterior paintwork.

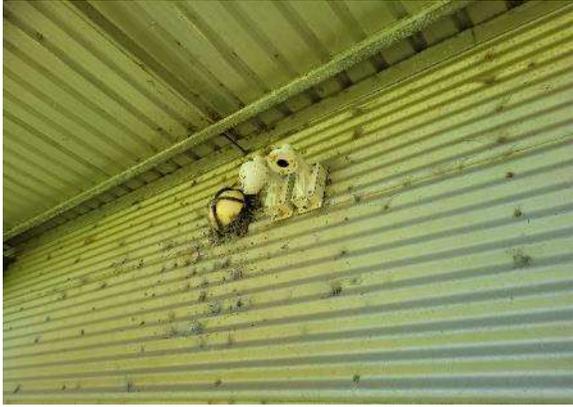
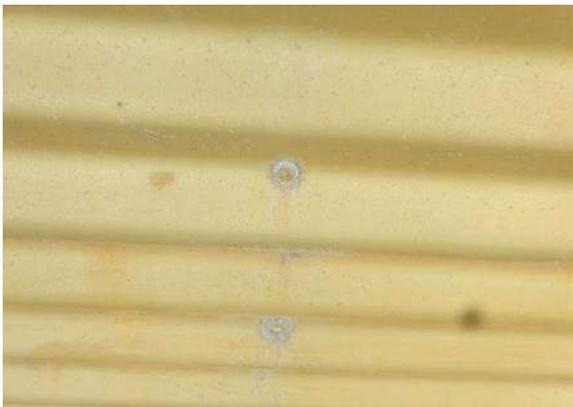
Reference No	Location/Element	Works Type	Description	Photographs	Cost Est.	Year
EW013	Gymnasium Area – External Walls	Renewal	<p>The metal cladding has localised corrosion including corrosion to the tek screws. Additionally, the cladding is very dirty which can escalate overall deterioration.</p> <p>Cost given is for renewal though in the short term it is recommended that the wall coverings are thoroughly cleaned, and any localised corrosion suitably treated which could extend the life of the element.</p>

\$3,422	2028

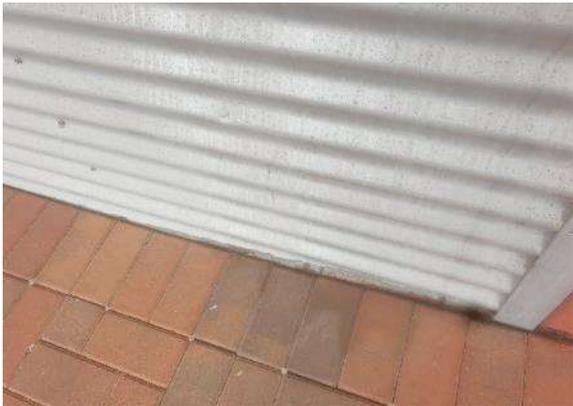
Reference No	Location/Element	Works Type	Description	Photographs	Cost Est.	Year
EW014	Creche Area – External Walls	Repair	Minor corrosion at base of metal wall cladding.

\$200	2021
EW015	Administration/Cafe Area – External Walls Administration/Cafe Area – External Walls	Renewal	Deterioration and minor damage to external painted surfaces. Cost is for preparation and renewal of exterior paintwork.

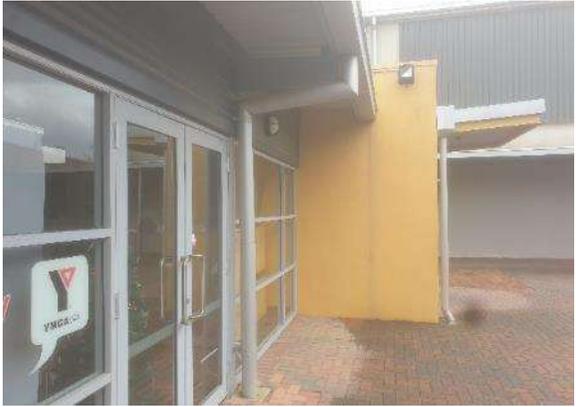
Reference No	Location/Element	Works Type	Description	Photographs	Cost Est.	Year
EW016		Repair	Water staining originating likely from leaking guttering.

\$300	2021
EW017	Administration/Cafe Area – External Walls	Repair	Deteriorated paintwork and deterioration to joint seal at Administration/Café and Extreme Sports interface.

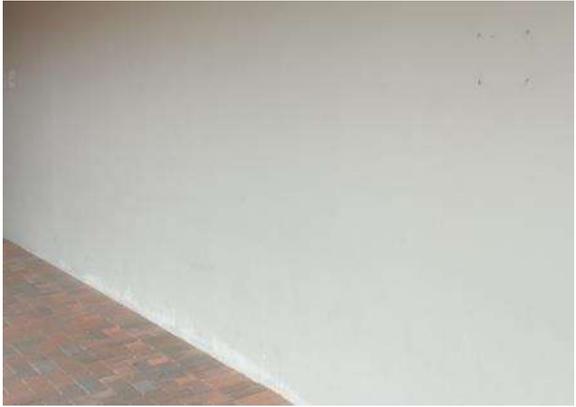
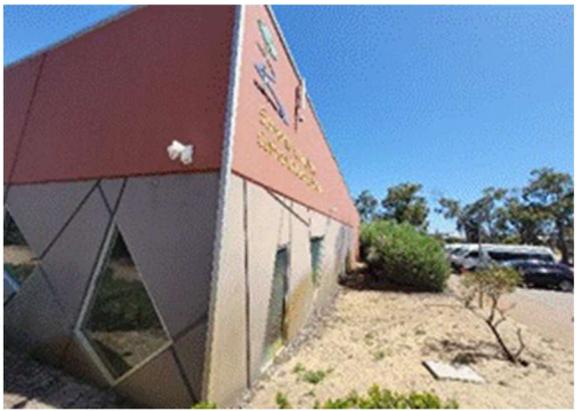
Reference No	Location/Element	Works Type	Description	Photographs	Cost Est.	Year
EW018	Multipurpose Area – External Walls	Renewal	The wall surface treatments are in very poor condition. The painted surfaces are badly deteriorated and retic. stained.

\$14,963	2021

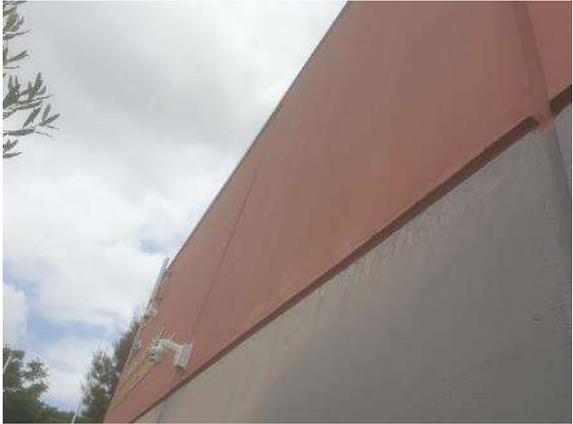
Reference No	Location/Element	Works Type	Description	Photographs	Cost Est.	Year
		Renewal	Further photograph illustrating deterioration highlighted above

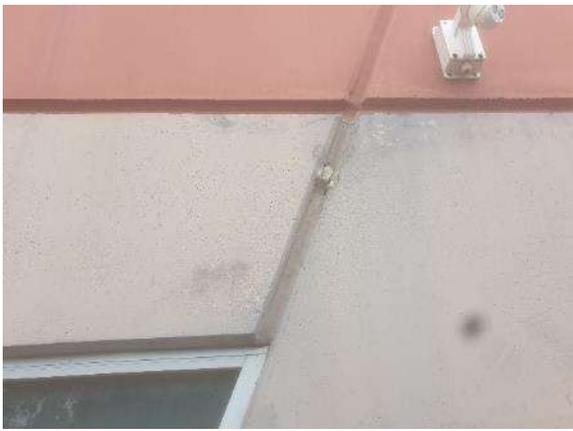
As above	As above
EW019	Multipurpose Area – External Walls	Repair	Minor deterioration to joint seal. Recommend repairs are undertaken as part of the paintwork renewal exercise.

Repair as part of renewals works above	2021

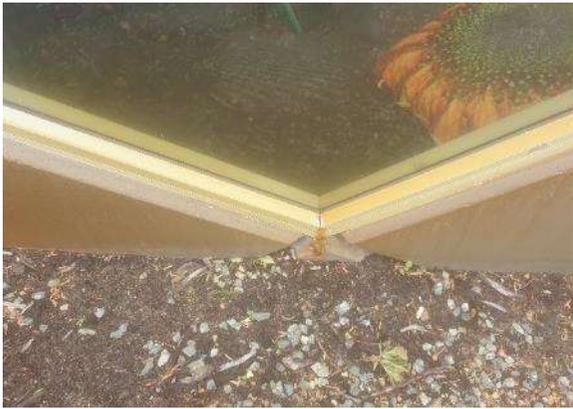
Reference No	Location/Element	Works Type	Description	Photographs	Cost Est.	Year
EW020	Multipurpose Area – Widows	Repair	Minor deterioration and retic staining to windows.

Cleaning as part of operational works	2021

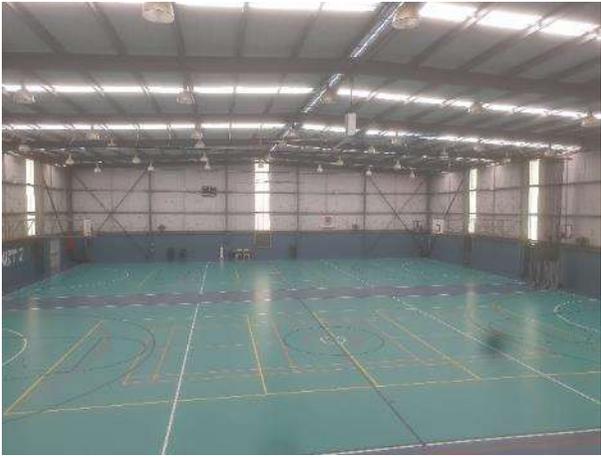
Reference No	Location / Element	Works Type	Description	Photographs	Cost Est.	Year
I001	Sports Court - Walls	Observation	The Sports Court is in average condition overall. There is deterioration and damage evident to the walls evident. The sports surface appears in good condition.

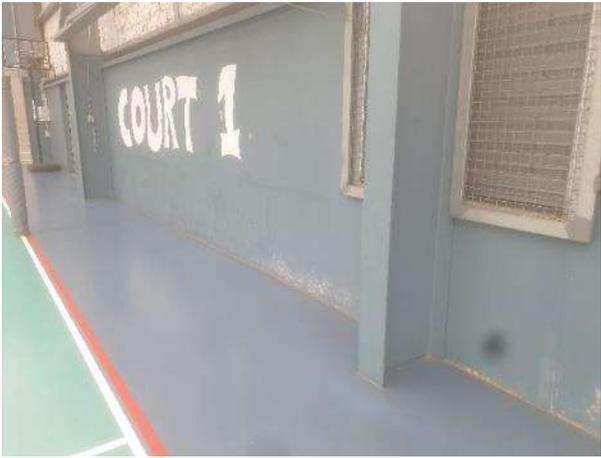
N/A	N/A
I002	Sports Court - Walls	Renewal	Deterioration evident to painted surfaces.

\$4,680	2021

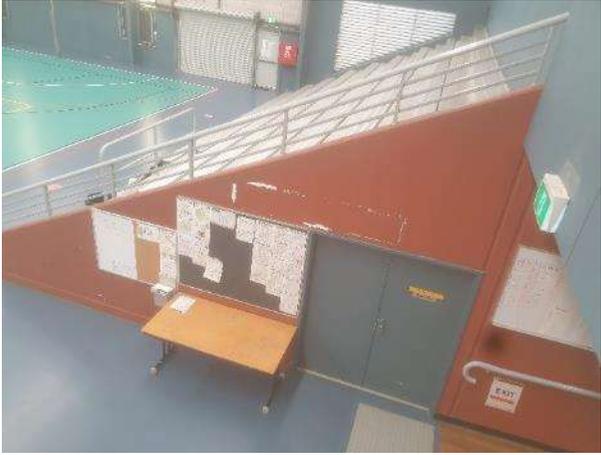
Reference No	Location / Element	Works Type	Description	Photographs	Cost Est.	Year
I003	Sports Court - Walls	Renewal	Damage to paintwork at spectator seating.

Repair as part of Painting Renewal	2021
I004	Sports Court - Walls	Repair	Cracking evident on south wall adjacent to external louver.

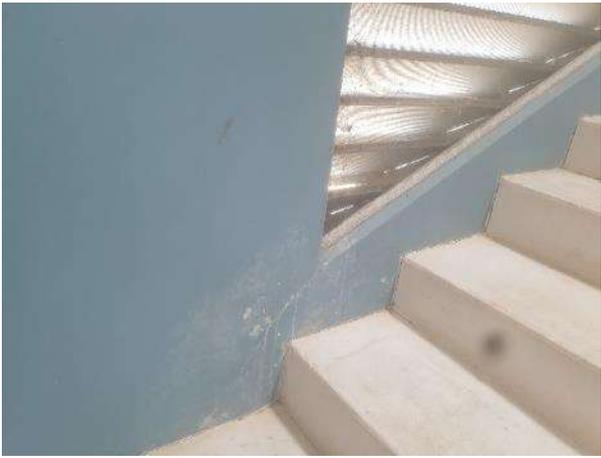
Reference No	Location / Element	Works Type	Description	Photographs	Cost Est.	Year
		Repair	Cracking evident on south wall adjacent to external louver (lower edge).

Repair as part of Painting Renewal	2021
I005	Sports Court - Walls	Repair	Movement visible between concrete panel and spectator seating/stair. Recommend that this is monitored as part of overall Structural Inspection.

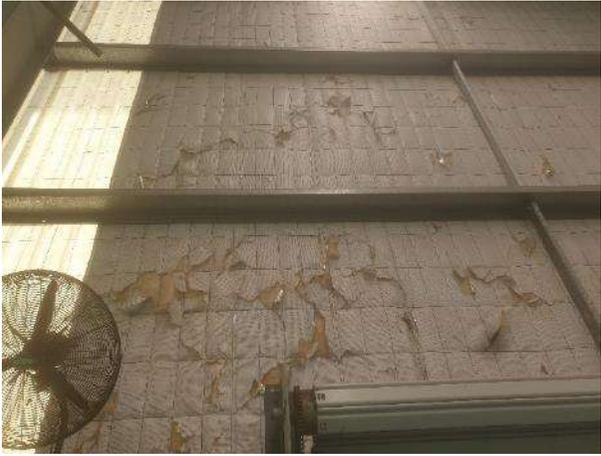
Reference No	Location / Element	Works Type	Description	Photographs	Cost Est.	Year
I006	Sports Court - Walls	Capital	<p>Damage to internal wall insulation due to ball strikes.</p> <p>Note the cost is for installation of wall coverings for both the Sports and Extreme Sports Courts.</p>

\$9,834	2021
I007	Sports Court - Doors	Repair	<p>Door handle to Store Room is loose and requires resecuring. Additional minor damage to door.</p>

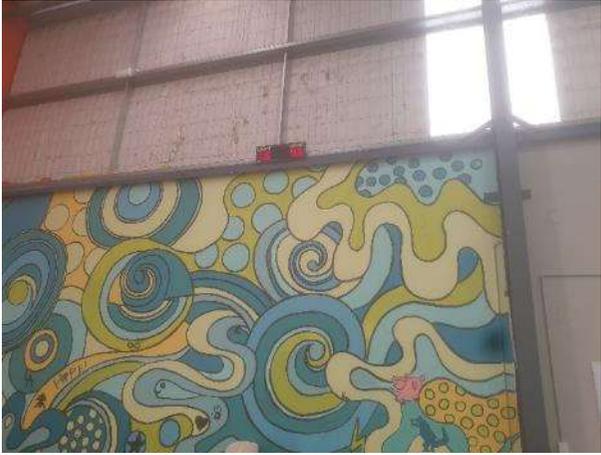
Reference No	Location / Element	Works Type	Description	Photographs	Cost Est.	Year
1008	Extreme Sports Court - Walls	Renewal	<p>Damage to internal wall insulation due to ball strikes.</p> <p>Note cost is estimated based on renewal however it is recommended that the wall has an internal plywood (or similarly robust) material cladding installed.</p>

\$9,800	2021
1009	Extreme Sports Court – Walls	Renewal	<p>Cracking visible internally adjacent to the fire exit door.</p> <p>Cost given is for renewal of paintwork throughout. Recommend repairs carried out as part of renewal works though including crack monitoring in the future.</p>

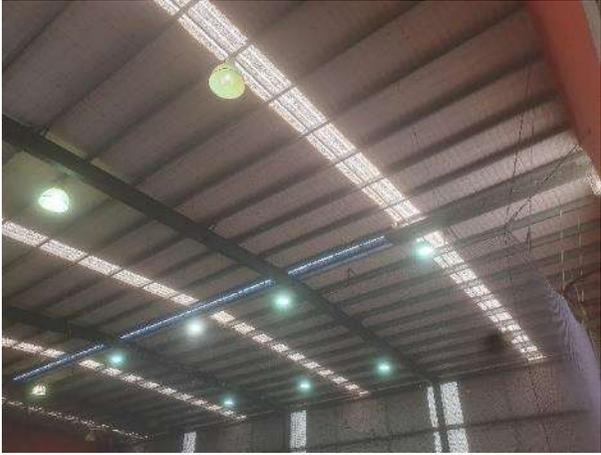
Reference No	Location / Element	Works Type	Description	Photographs	Cost Est.	Year
I010	Extreme Sports Court – Roof (internal)	Observation	Poor appearance due to deterioration and dirt on the fibreglass roof skylights.

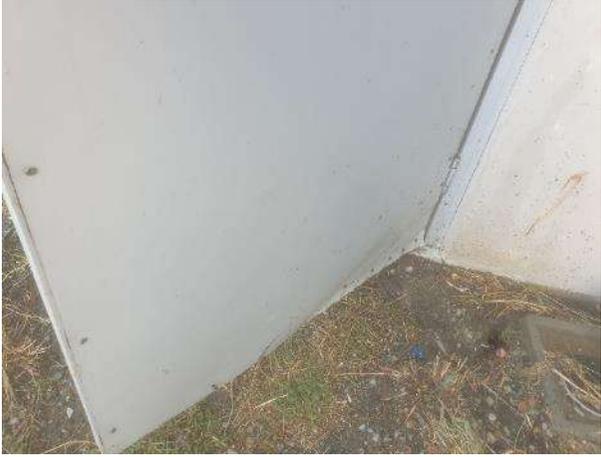
Cost included in roof section of report	N/A
I011	Extreme Sports Court – Doors	Renewal	Fire exit door is damaged. Cost is for renewal of door.

\$800	2021

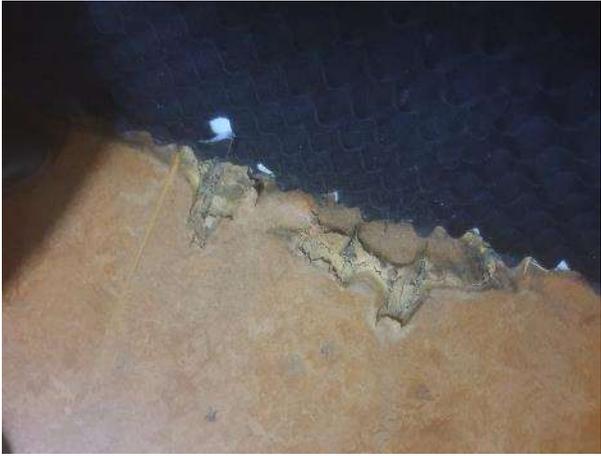
Reference No	Location / Element	Works Type	Description	Photographs	Cost Est.	Year
I012	RPM Room - Flooring	Repair / Renewal	Water damage at rear of RPM Room

\$850 (Repair) \$3,809 (Renewal)	2021 2024
I013	Multipurpose Rooms Store - Flooring	Renewal	Store area Linoleum in poor condition.

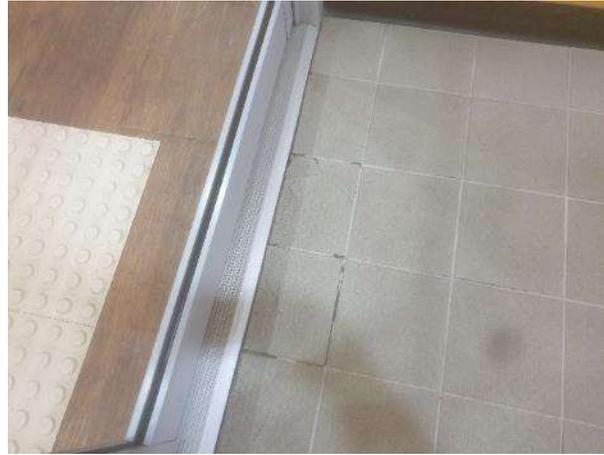
Reference No	Location / Element	Works Type	Description	Photographs	Cost Est.	Year
I014	Toilets Corridor - Flooring	Repair	Small number of cracked floor tiles and deteriorated tile grout at entrance to corridor from the ramp.

\$300	2021
I015	Toilets Corridor - Walls	Renewal	Crack in wall adjacent to electrical cupboard. Cost is for painting of the Corridor area including preparation and repair.

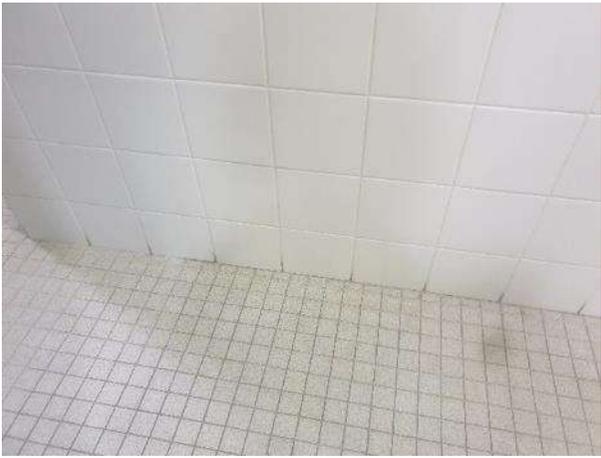
Reference No	Location / Element	Works Type	Description	Photographs	Cost Est.	Year
I016	Toilets (Throughout)	Repair	<p>The wall tiles throughout are in good condition though there are localised areas of grout deterioration. The grout is generally dirty throughout and presents poorly.</p> <p>Costs are given for an industrial steam clean of tiles and re-grout as required for all the toilets, changing rooms (including Multipurpose toilets and creche)</p>

\$14,400	2021
I017	Toilets (Throughout)	Repair	<p>Example where the grout between worktop surface and tiles has deteriorated.</p>

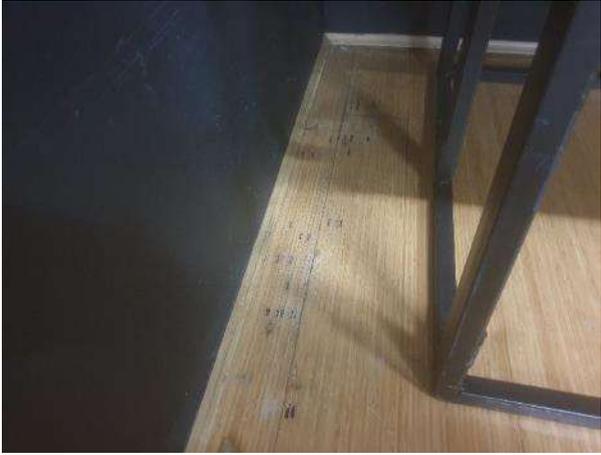
Reference No	Location / Element	Works Type	Description	Photographs	Cost Est.	Year
1018	Multipurpose Rooms Store - Flooring	Renewal	Localised termite damage to Stage Flooring. The flooring has been treated. It is recommended that as part of overall sand and polish that this area is suitably addressed aesthetically. Cost given for sand and polish.

\$4,840	2022
1019	Multipurpose Rooms - Flooring	Renewal	Timber floor is in good overall condition though the surface treatment has deteriorated. Recommended that sanding and polishing is undertaken to improve finish and longevity of floor. Cost given for sand and polish as part of renewals.

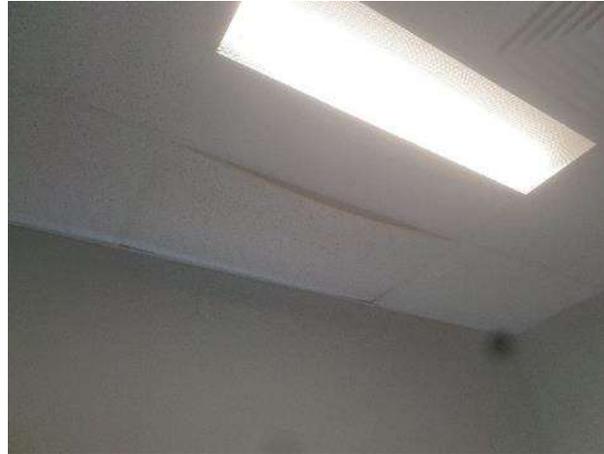
I020	Multipurpose Rooms Green Room - Ceiling	Repair	Bowed ceiling tile

\$120	2021

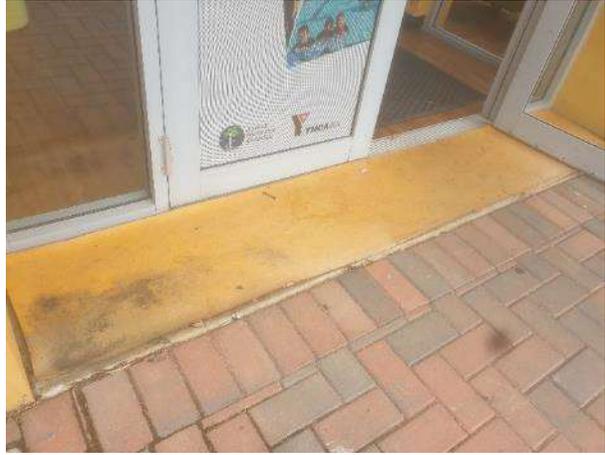
Reference No	Location / Element	Works Type	Description	Photographs	Cost Est.	Year
I021	Entrance - Flooring	Repair	The linoleum at the entrance is lifting and presents very poorly.

\$500	2021
I022	Entrance - Autodoor	Renewal	Internal auto door actuator is leaking and noisy in operation.

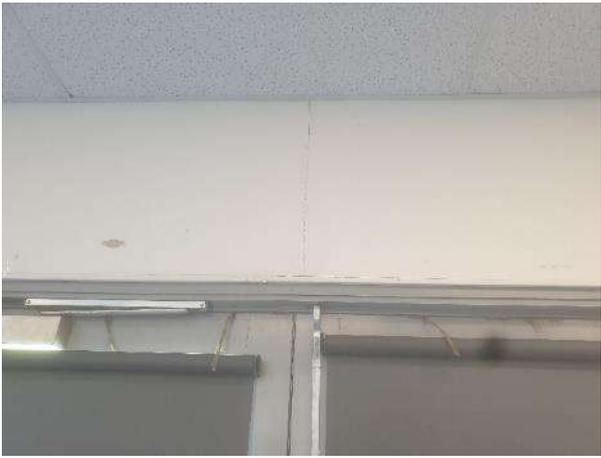
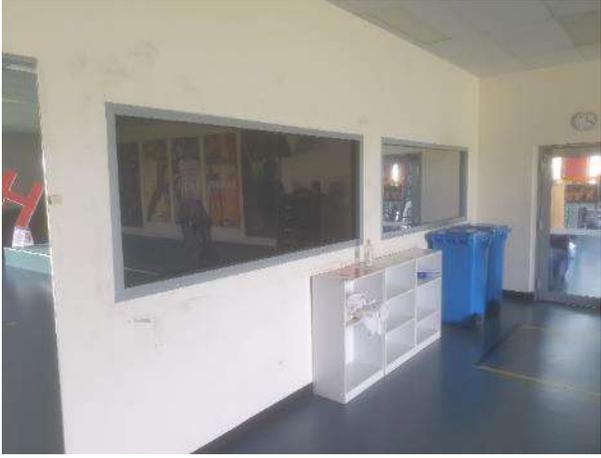
Reference No	Location / Element	Works Type	Description	Photographs	Cost Est.	Year
I023	Fitness Room - Walls	Renewal	Minor hairline cracking and deterioration to painted surfaces.

\$1,937	2022
See above	See above	See above	See above

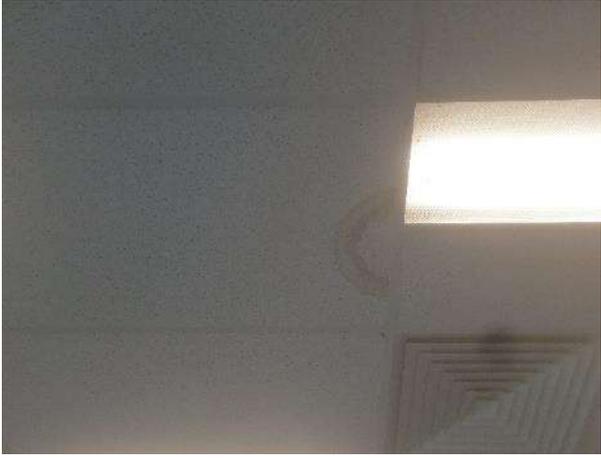
I024	Fitness Room - Ceiling	Repair	Minor water staining to ceiling tiles.

\$200	2021

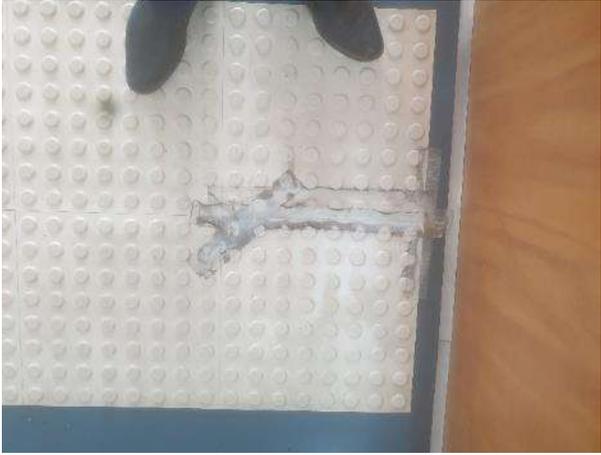
Reference No	Location / Element	Works Type	Description	Photographs	Cost Est.	Year
I025	Gymnasium - Flooring	Repair	Tactile flooring has been crudely secured by tape.

\$120	2021
I026	Gymnasium - Ceiling	Renewal	There are a number of ceiling tiles that are water stained.

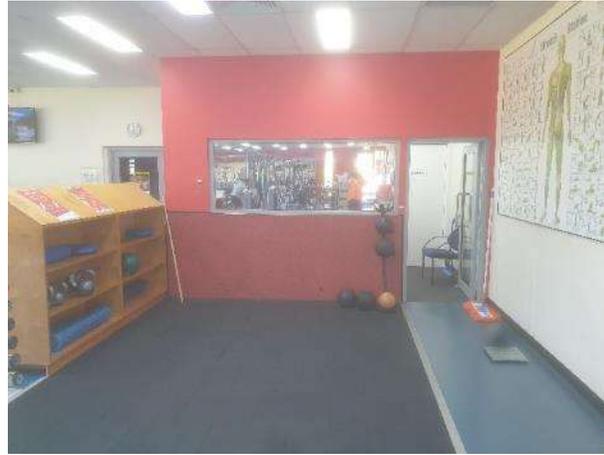
Reference No	Location / Element	Works Type	Description	Photographs	Cost Est.	Year
I027	Gymnasium - Walls	Renewal	Walls are in average condition though with some deterioration evident to painted surfaces.

\$3,095	2024
I028	Creche - Ceiling	Repair	Minor water staining to ceiling tiles.

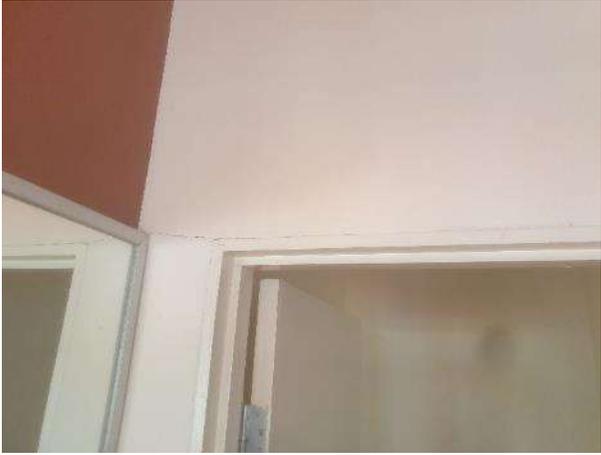
Reference No	Location / Element	Works Type	Description	Photographs	Cost Est.	Year
1029	Creche - Walls	Renewal	Minor cracking and deterioration to painted surfaces. Costs are for renewal of paint throughout.

\$1,114	2024
1030	Creche - Walls	Repair	Discolouration to tiling grout.

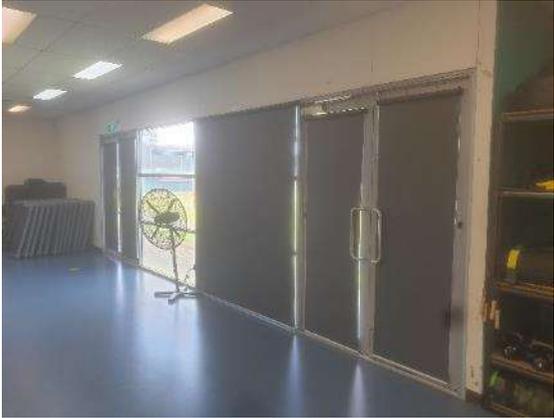
Reference No	Location / Element	Works Type	Description	Photographs	Cost Est.	Year
I031	Fitness Room	Renewal	The window roller blinds are in average condition. An allowance has been made in renewals for replacement in 2025

\$2,588	2025
I032	Creche - Flooring	Renewal	The Creche linoleum floor covering is in average condition though exhibits wear and tear and presents poorly.

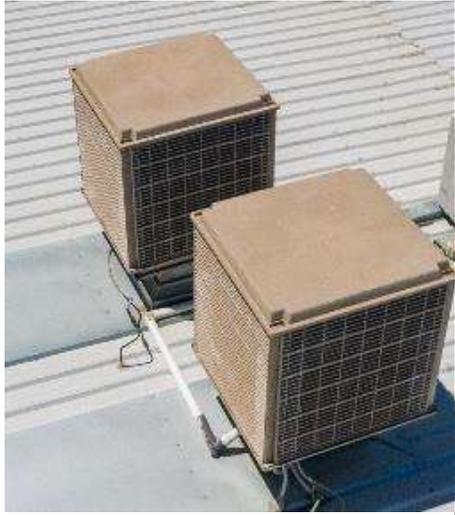
Reference No	Location / Element	Works Type	Description	Photographs	Cost Est.	Year
M002	Evaporative Coolers	Renewals	There are two evaporative coolers installed. The units are in average condition though are old in appearance with deteriorated housings.

\$9,704	2025
M003	Toilet Exhaust	Repair	Flexible duct has become detached discharging toilet exhaust into common roof space.

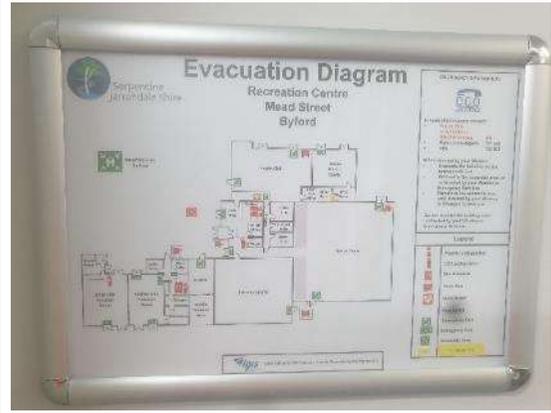
Reference No	Location/Element	Works Type	Description	Photographs	Cost Est.	Year
F001	Throughout – Fire Evacuation Plans	Renewal	Evacuation plans are due for renewal in 2021.

\$2,500 \$2,747	2021 2026

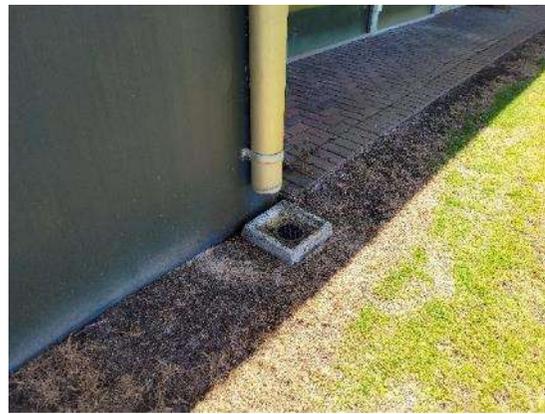
\$4,000	2021
H007	Gymnasium - Stormwater	Repair	Stormwater down pipe is missing a small diversion piece. Water not fully to drain. Washing out between wall and drain.

\$120	2021

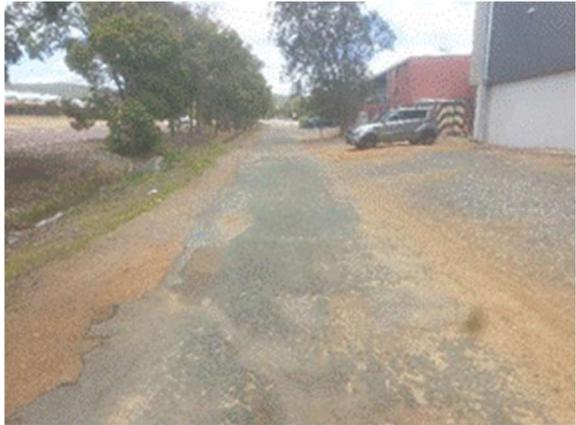
\$2,600 (Repair) \$81,737 (Renewal)	2021 2030
EX003	Roads – North Service Road	Renewal	Road surface is in poor condition with deterioration and potholes evident. Cost included in renewals for skim and resurface.

\$6,624	2022

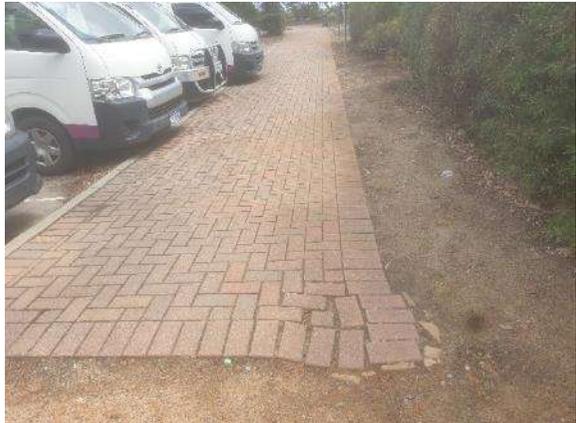
\$1,600	2021
EX005	Paving	Repair	The brick paving adjacent to the carpark is breaking away at its northern edge.

\$1,200	2021
