7<sup>th</sup> September 2021

Letter No. 1.21.22198.1 Project No. 1.21.22198

## RE: Structural Assessment of the Collapsed Steel Helical Culverts Corner of Wellard Street and Karnup Road Serpentine

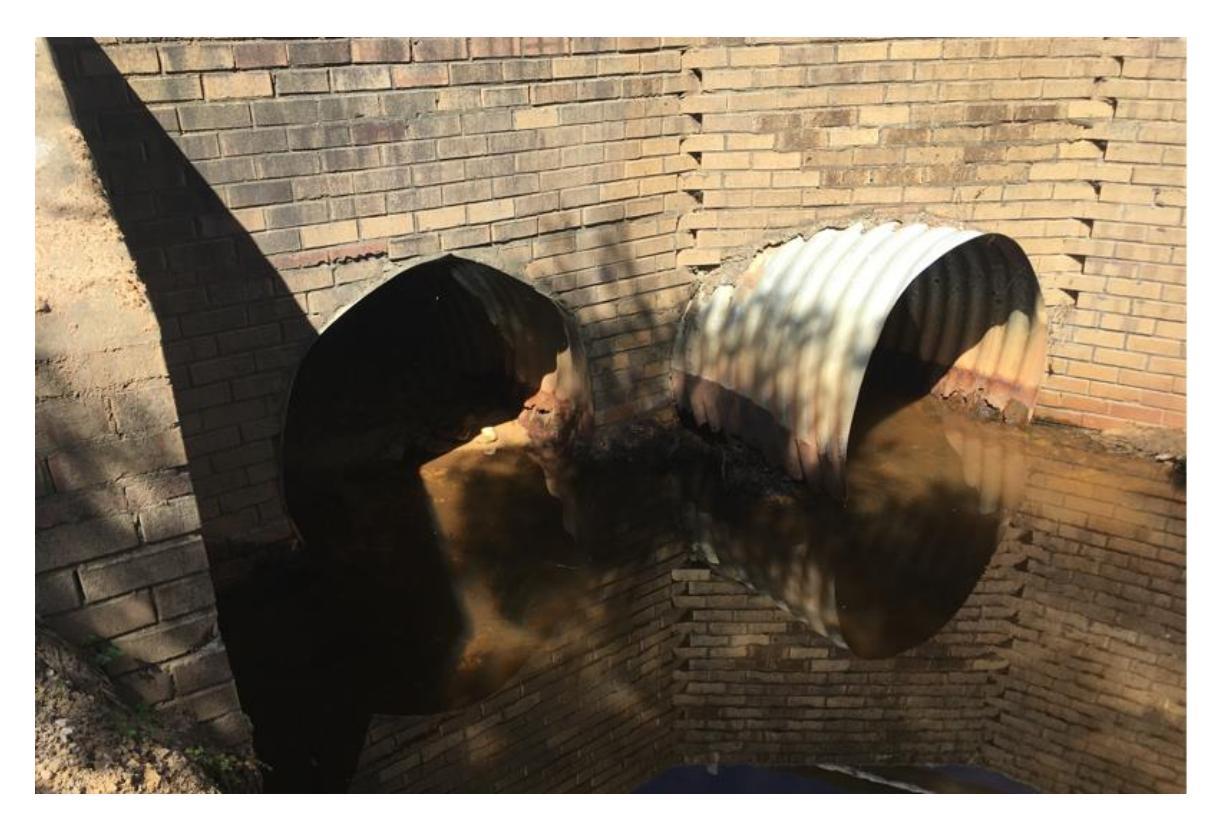
- o the culverts have collapsed and are at risk of imminent failure,
  - o the culvert section shapes are deformed by dipping at the top,
  - o at the culvert entries the inverts have completely corroded through,

Photograph 1: General arrangement of the culverts from the northern end

As soon as practicable and within six months, replace the culverts.

Due to the permanence of standing water in the culvert, it is recommended that the culverts be replaced with concrete structures.

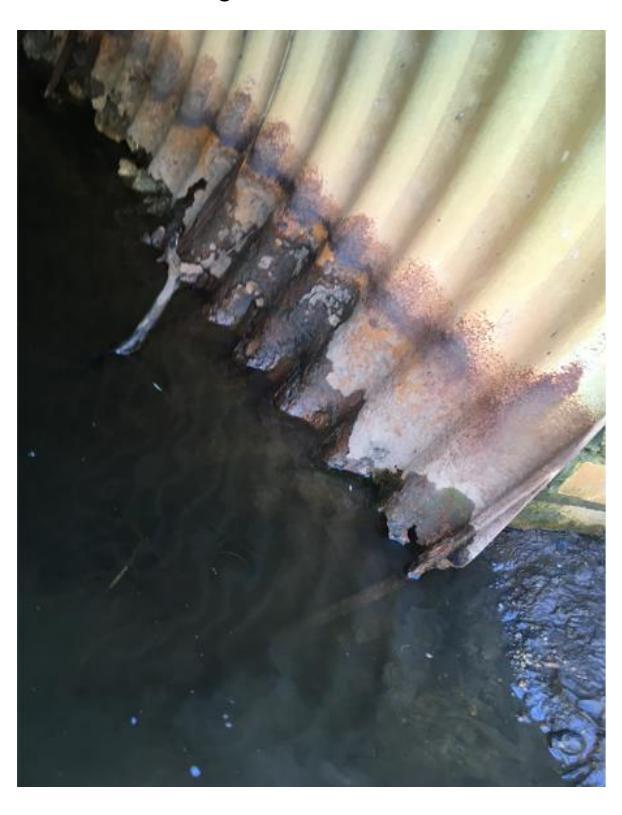
- o the culvert sections have retained their shape,
  - o at the culvert outlets the inverts have completely corroded through,
  - o along the length the inverts have almost completely corroded through,

Photograph 2: Corrosion loss of section at the invert from the southern end

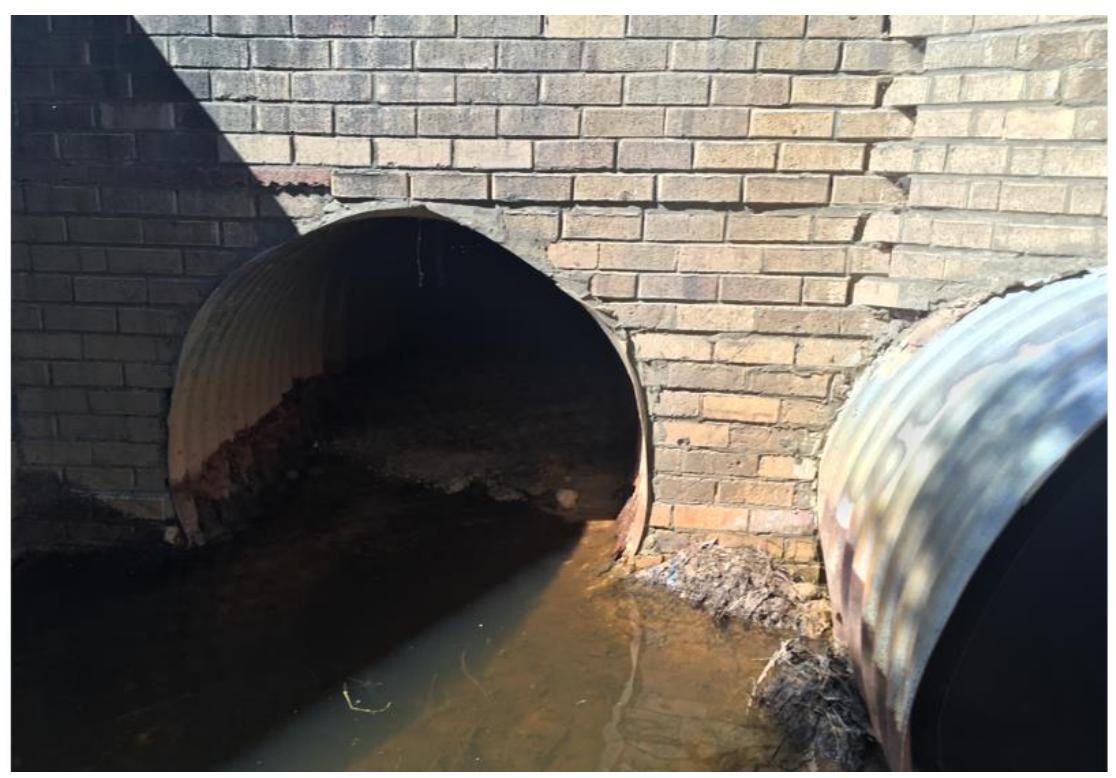
- along much of the length the inverts have almost completely corroded through,
  - o perforations in the culverts have allowed fill to fall into the culverts,

Photograph 3: Debris inside culvert northern end

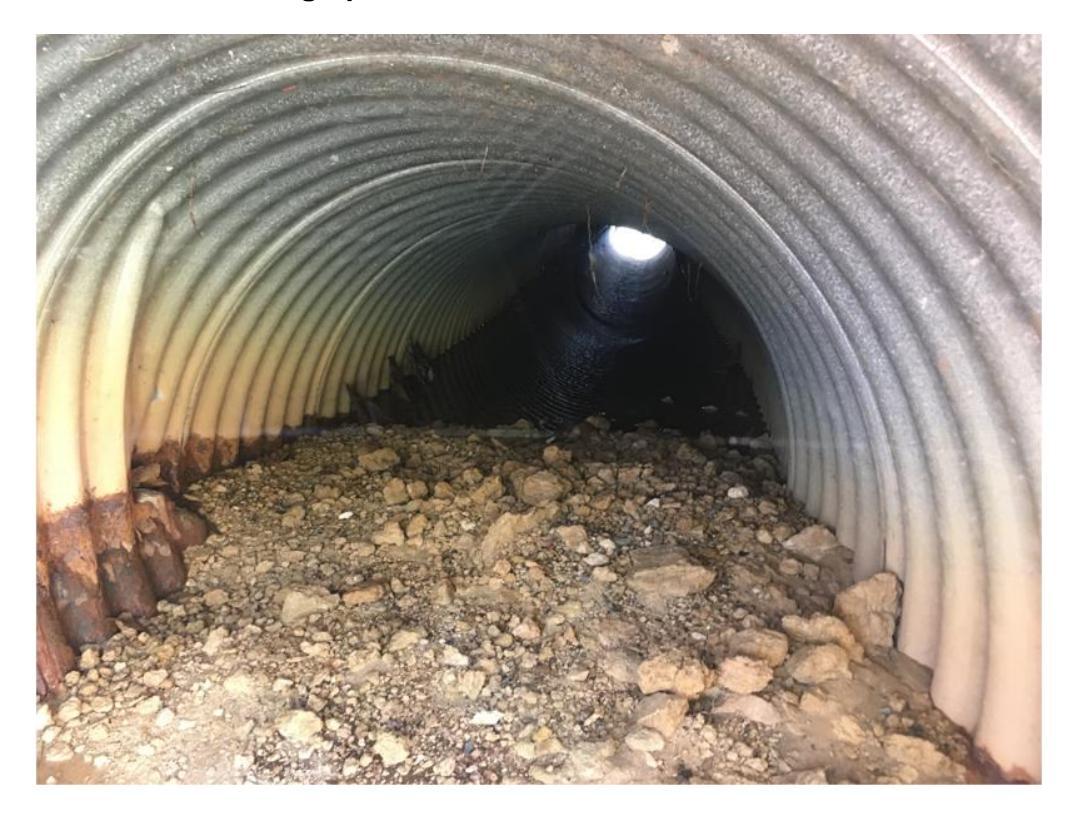
Photograph 4: Inside culvert from the northern end showing the collapsed section

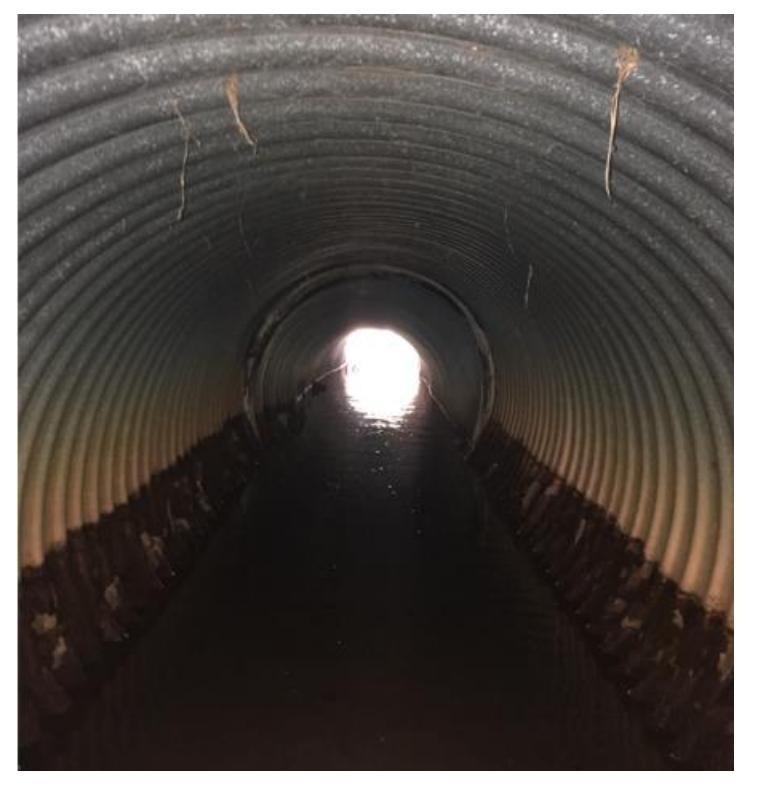
- o joints between helical segments have become misaligned,
  - the road surface has subsided.
- At the southern end:
  - the culverts have not yet collapsed,

Propping is only possible under the southern lane, up to the location of misalignment of joints (shown in Appendix B, photograph 5). Under the northern lane the culvert has collapsed.

Photograph 5: Separation and failure of the joint from the southern end

Propping should be installed in a south to north direction, so that the structure is progressively propped as you enter deeper into the culvert.

Due to the extent of corrosion at the base, propping is to be installed at 45 degrees.

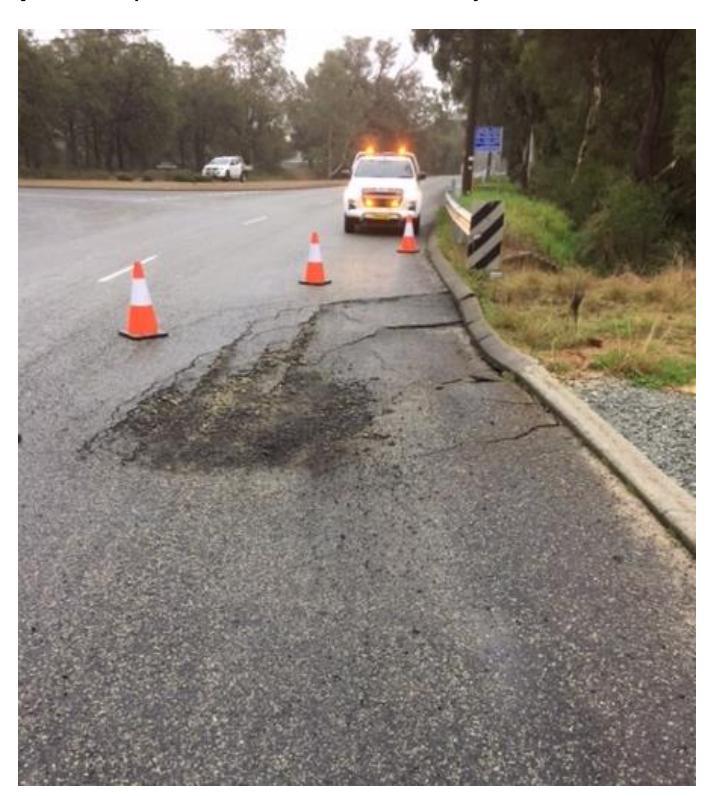
Photograph 6: Historical photo (provided by the Shire) showing subsidence of the northern end road surface

- The northern lane is to be closed to all traffic until such time as the culvert is replaced.
- All heavy traffic is to be diverted away until such time as the culvert is replaced.
