**Application for Temporary Works Approval  
Lot 102 (No. 766) King Road, Oldbury**

## **Transport Impact of Waste Material Removal from Lot 102, King Road, Oldbury**

## Lot 102 King Road Oldbury Remediation Management Plan

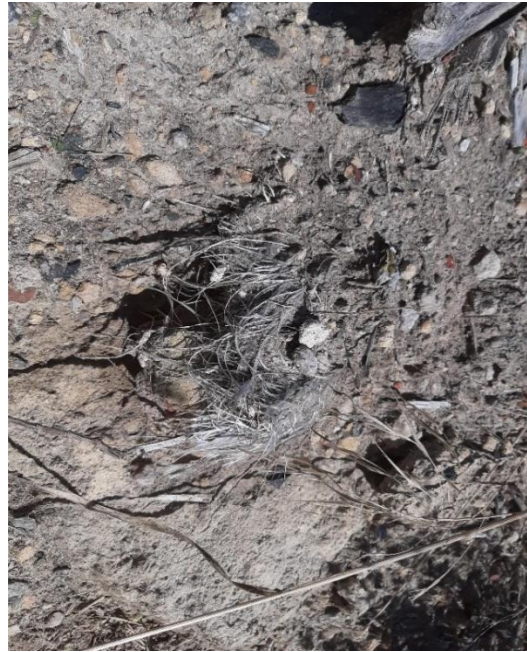
<p>Photo 13</p>

Site Photographs			Description	
  <p>Photo 7</p>	  <p>Photo 8</p>	  <p>Photo 9</p>	<ul style="list-style-type: none"> <li>• Stockpiles of mulch ranging from 2 – 4 metres in height are present at the site placed directly to the south and east and of the two large stockpiles</li> <li>• Debris is present on the surface of some of the stockpiles including timber, plasterboard, concrete fragments</li> <li>• Several of the mulch stockpiles potentially have debris entrained throughout.</li> </ul>	
  <p>Photo 10</p>	  <p>Photo 11</p>	  <p>Photo 12</p>		<ul style="list-style-type: none"> <li>• Further west of the uncontrolled fill stockpiles there are a number of other smaller stockpiles which appear to comprise of building rubble.</li> </ul> <p>During the site inspection a number of hazardous materials were identified including:</p> <ul style="list-style-type: none"> <li>• numerous electrical fittings including old Fluorescent lights (potential polychlorinated biphenyls (PCBs))</li> <li>• ACM (primarily non-friable asbestos fibre cement, however friable asbestos items may be present and cannot be ruled out).</li> </ul>

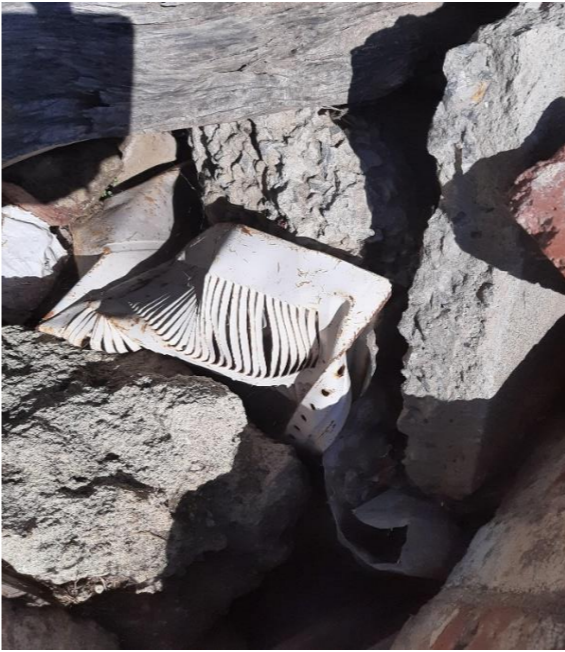
<p>Photo 15</p>	<p>Other additional hazardous materials were identified including:</p> <ul style="list-style-type: none"> <li>• Suspected lead based paints</li> <li>• Old air conditioning units (potential chorofluorocarbons (CFCs)</li> <li>• Synthetic Mineral Fibre</li> <li>• Treated pine (potential copper-chrome-arsenate or cresols).</li> </ul>

5	Temporary stockpiling of impacted soils prior to offsite disposal	<ul style="list-style-type: none"> <li>Stockpiles will be segregated into recyclable materials, potentially hazardous non-recyclable materials and putrescible materials.</li> <li>All identified potential ACM should be managed in accordance with the abbreviated AMP</li> <li>If direct disposal to landfill of material &lt;65 mm is not undertaken soils may require stockpiling onsite.</li> <li>If stockpiles remain onsite, they will be covered with an impermeable plastic and adequately bunded to minimise runoff.</li> </ul>	Nominated Excavator Contractor 360 Environmental
<b>Constraints and Contingency Measures</b>			
6	Residual impacts from stockpiles are present in soil beneath removed stockpiles	In the event visual impacts (i.e. staining) in surface soils are observed these soils will be excavated further and stockpiled for sampling, analysis and waste classification and disposal to landfill. Following removal of stockpiles, validation sampling of surface soils will be undertaken progressively to assess the suitability of the site for ongoing use as a commercial/industrial premises.	360 Environmental
