## Attachment 4

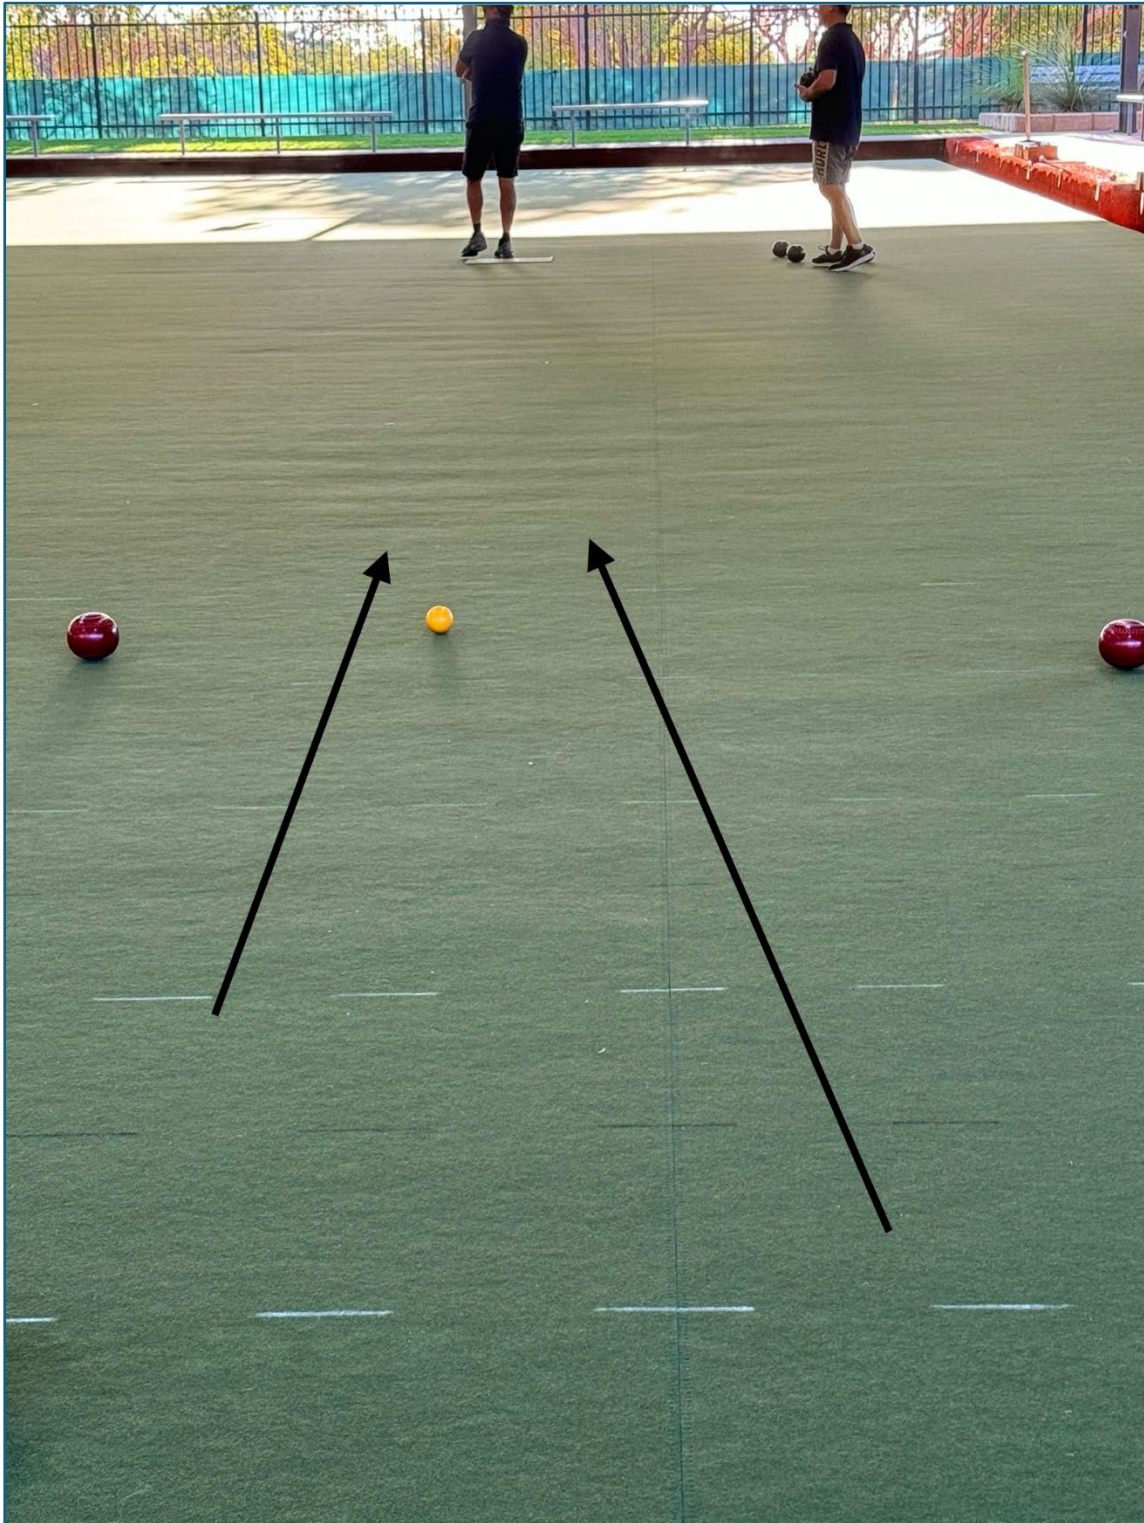
**Image 1:** Base issues beneath the playing surface, causing inaccuracies and tracking problems during bowls games.

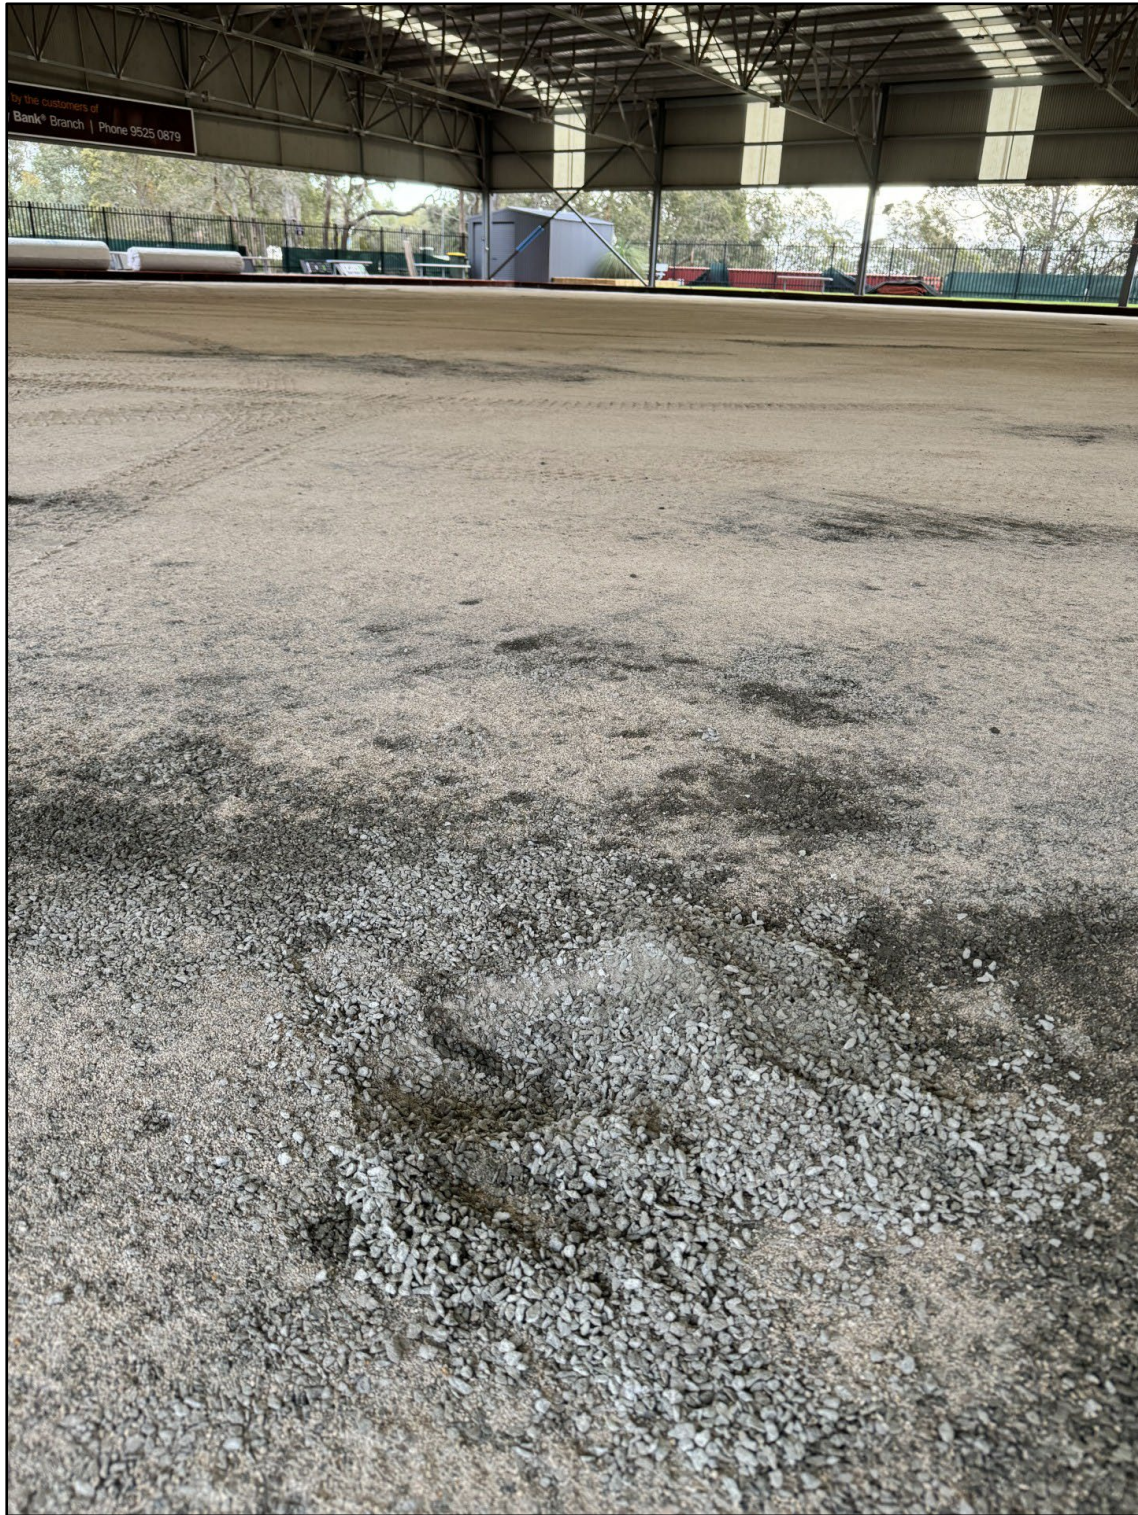
**Image 2:** This shows the crumbling base, which should consist of a bonded mixture of blue metal and concrete to create a solid, level playing surface.

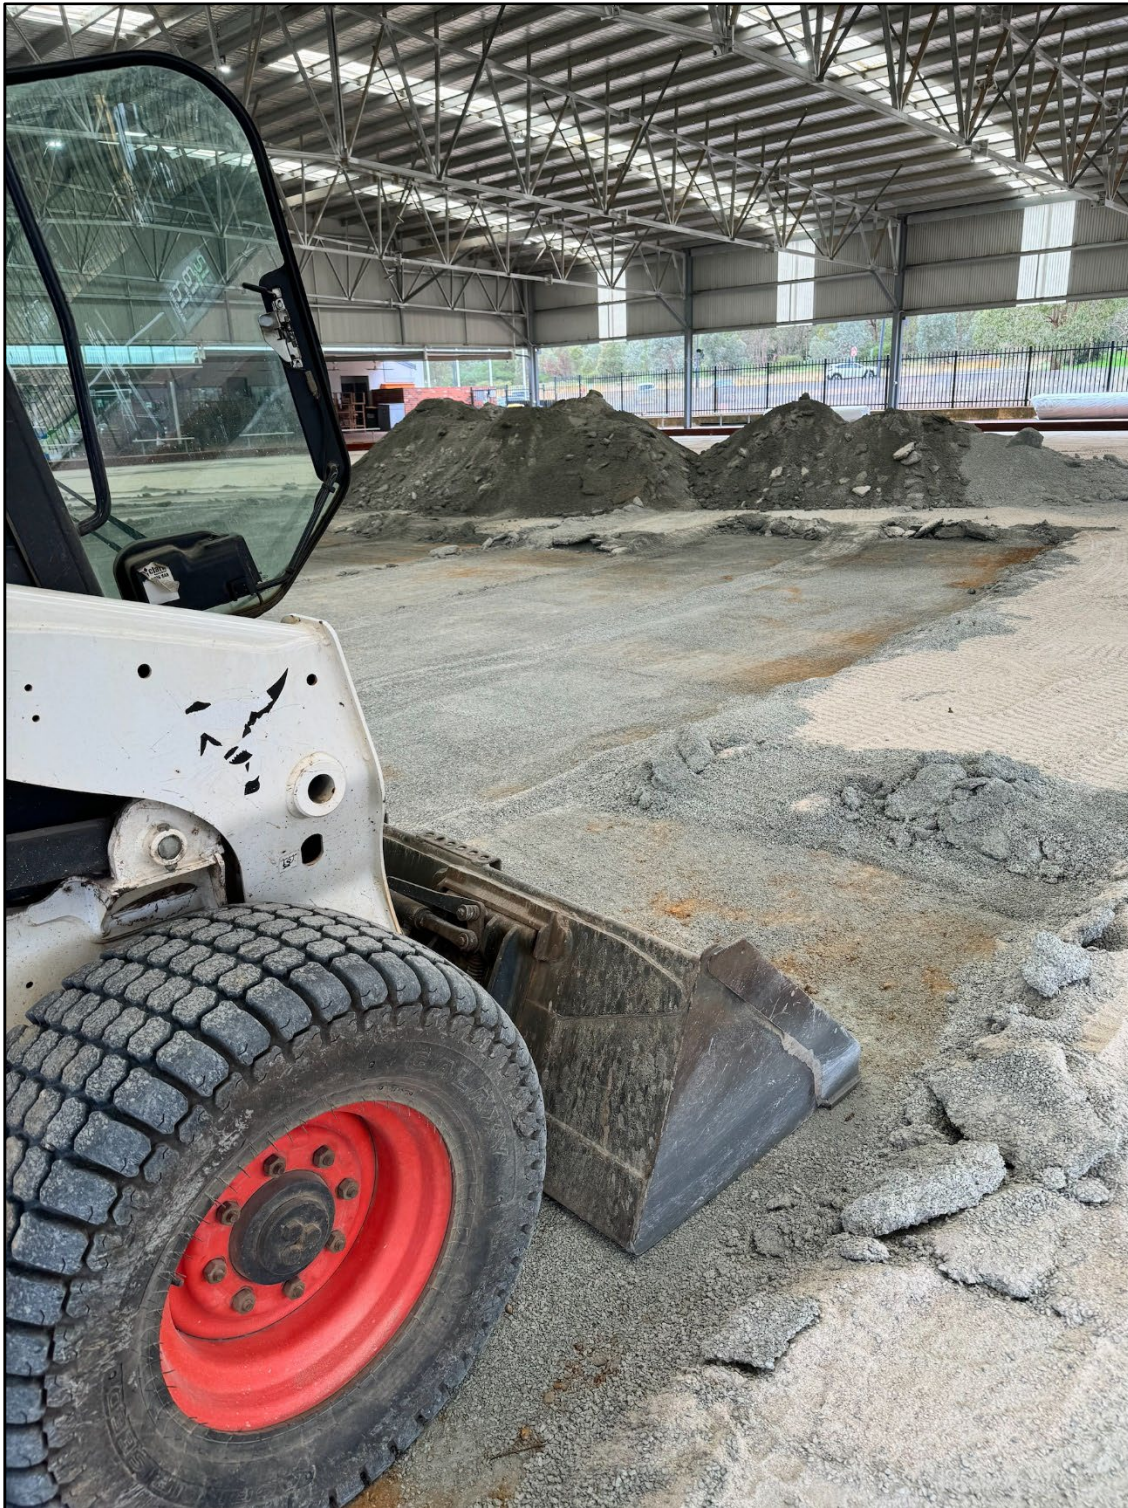
**Image 3:** This depicts the removal of the crumbling base. It should have been a bonded mixture of blue metal and concrete to provide a solid, level playing surface.

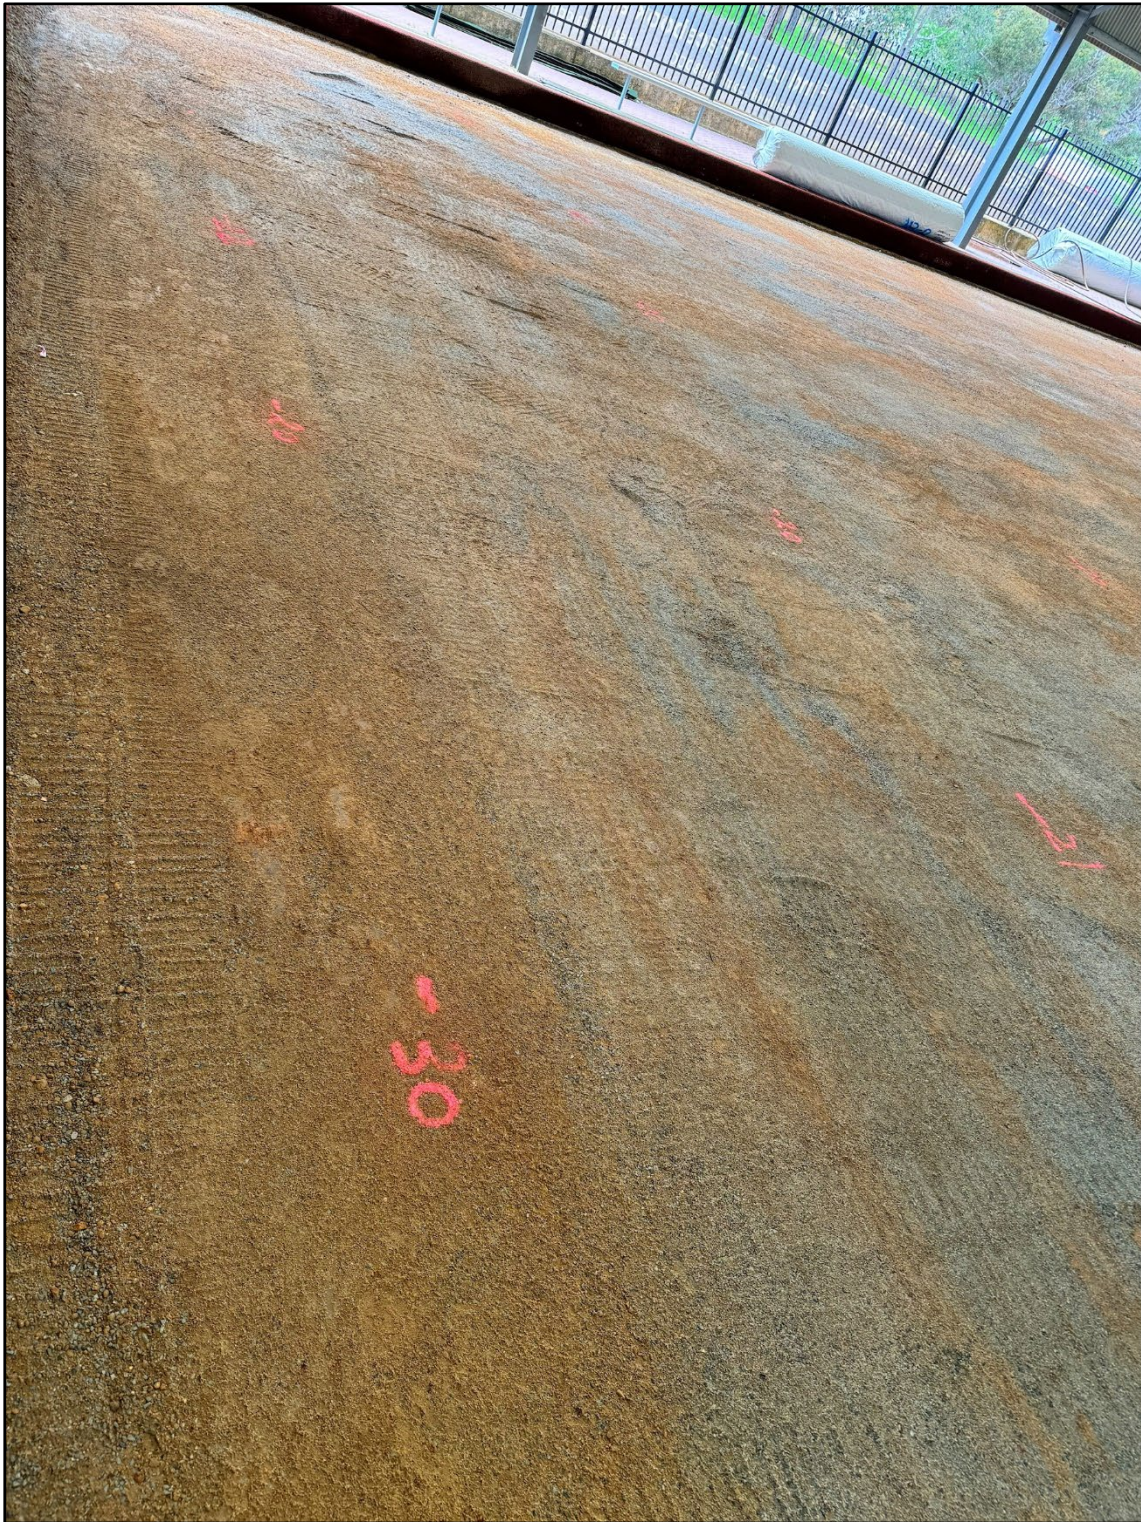
**Image 4:** This image highlights sub-base variations of up to 30mm in certain areas, far exceeding the accepted tolerance of  $\pm 4\text{mm}$ . These discrepancies were a major factor in the failure of the base system.

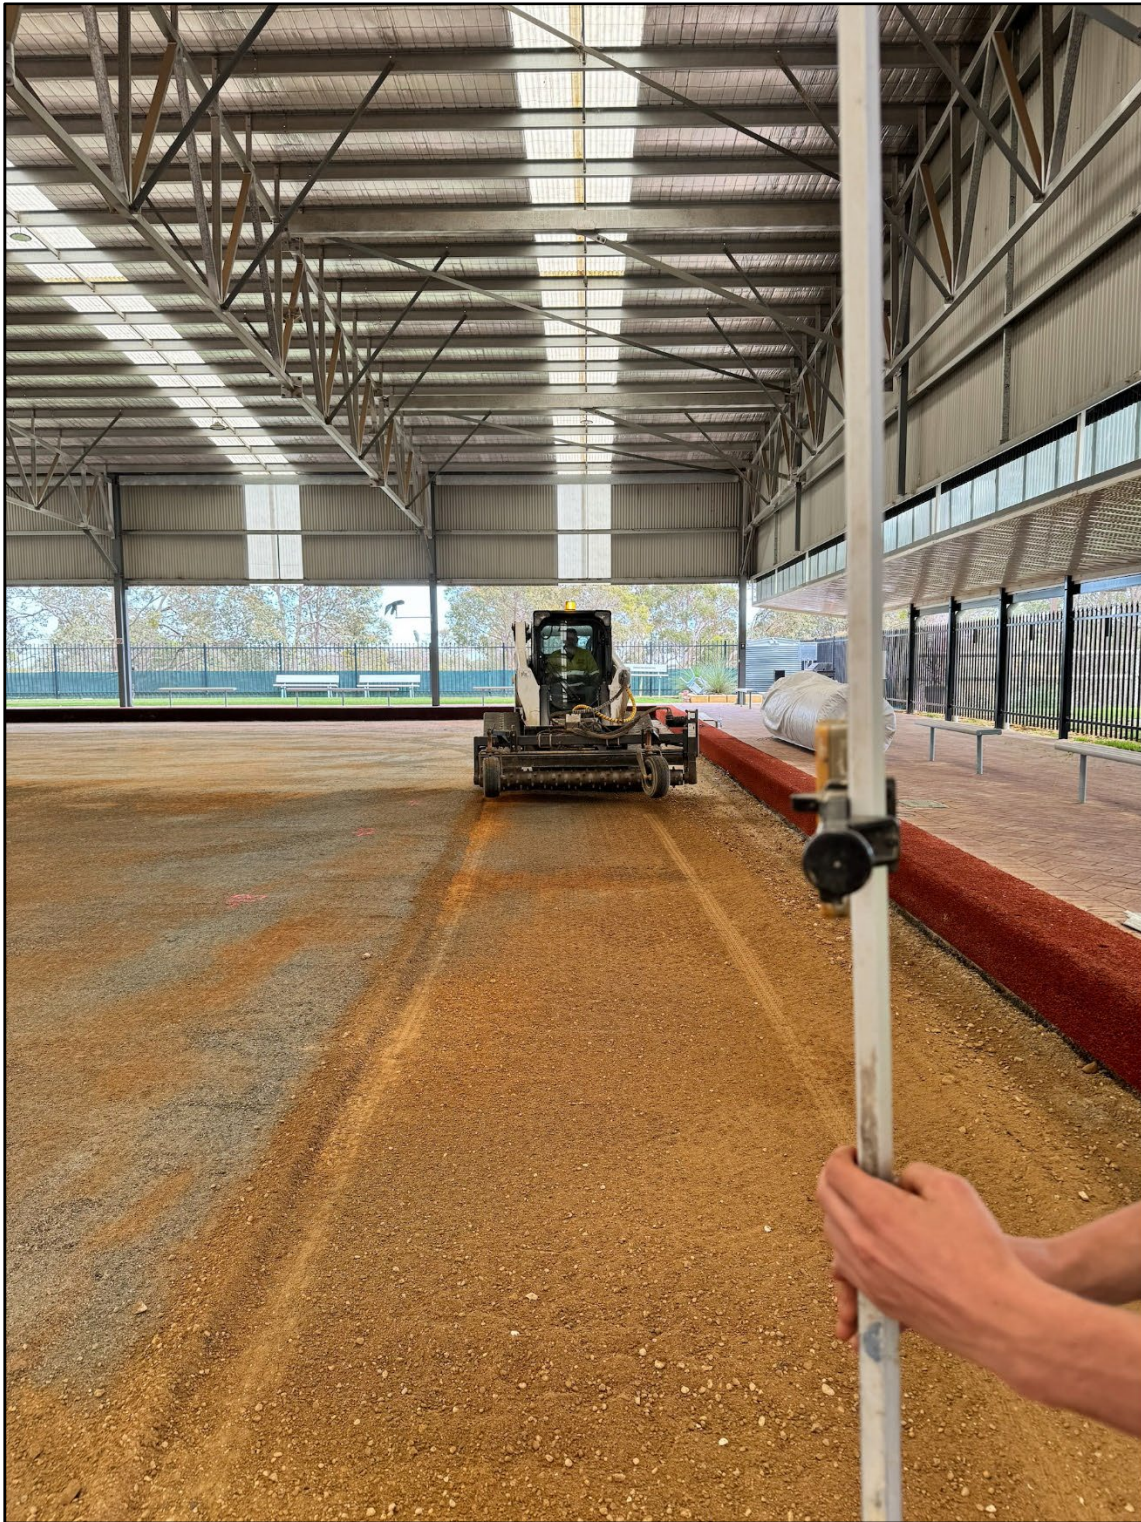
**Image 5:** This image shows the amelioration works being carried out to level the sub-base, preparing it for the installation of the new base system.
