PROPOSED ANCILLARY LOT 13, No. 119, PETERS WAY, OAKFORD

## **Bushfire Attack Level (BAL) Report and Certificate**

Proposed Ancillary Dwelling at: Lot 13 (#119) Peters Way, Oakford, WA, 6121

**Report Number: 23-15075**

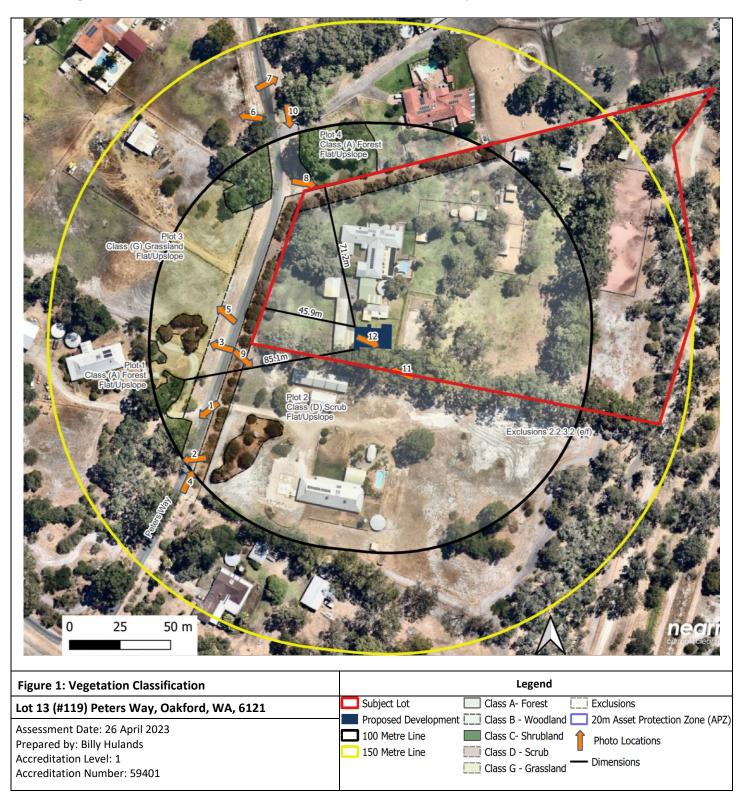
The assessment of this site was undertaken on 26 April 2023 by a BPAD Accredited Practitioner for the purpose of determining the Bushfire Attack Level in accordance with AS 3959–2018 Simplified Procedure (Method 1).

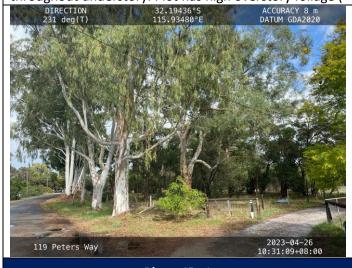
Photo ID: 1

Plot: 1 Vegetation Classification or Exclusion Clause Class A Forest - Open forest A-03

Forest with mature trees spaced along street verge with young trees, scrub, shrubs, and unmanaged grasses throughout understory. Plot has high overstory foliage (>40%)

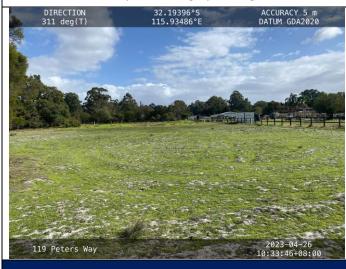
Photo ID: 5

Plot: **Vegetation Classification or Exclusion Clause** Class G Grassland - Open tussock G-23

Grassland on nearby lots is largely managed with low overstory foliage (<10%)

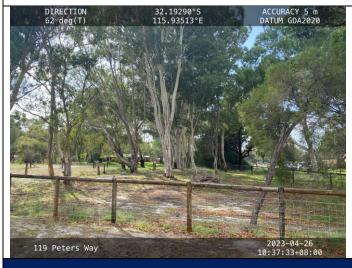
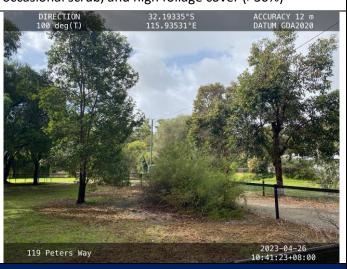
Photo ID: 7

Plot: **Vegetation Classification or Exclusion Clause** Class A Forest - Low open forest A-04

Forest on nearby lot has largely managed understory with occasional scrub, and high foliage cover (>30%)

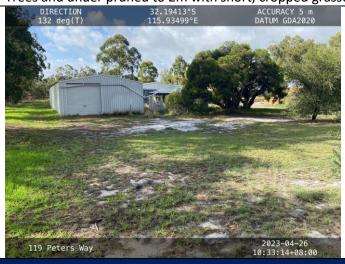
Photo ID: 9

Plot: 5 Vegetation Classification or Exclusion Clause

Excludable - 2.2.3.2(f) Low Threat Vegetation

Neighbouring lots and street verges have short, cropped grasses <100mm with small clumps of scrub with managed understory. Subject lot and neighbouring lots have single files to trees extending along lot boundaries. Trees and under pruned to 2m with short, cropped grasses throughout understory.

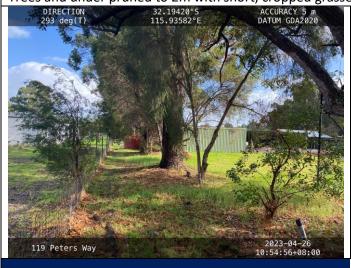
Photo ID: 11

Plot: 5 Vegetation Classification or Exclusion Clause

Excludable - 2.2.3.2(f) Low Threat Vegetation

Neighbouring lots and street verges have short, cropped grasses <100mm with small clumps of scrub with managed understory. Subject lot and neighbouring lots have single files of trees extending along lot boundaries. Trees and under pruned to 2m with short, cropped grasses throughout understory.
