Asbestos testing CERTIFICATE OF ANALYSIS FIBRE IDENTIFICATION (Soils / Aggregate)

Client Reference: Postans – Road Base Production

PARTICLE SIZE DISTRIBUTION & CONSISTENCY LIMITS

Lot 10 Gossage Rd, Oldbury: Review of Surface Water Management for Upgraded Firebreak

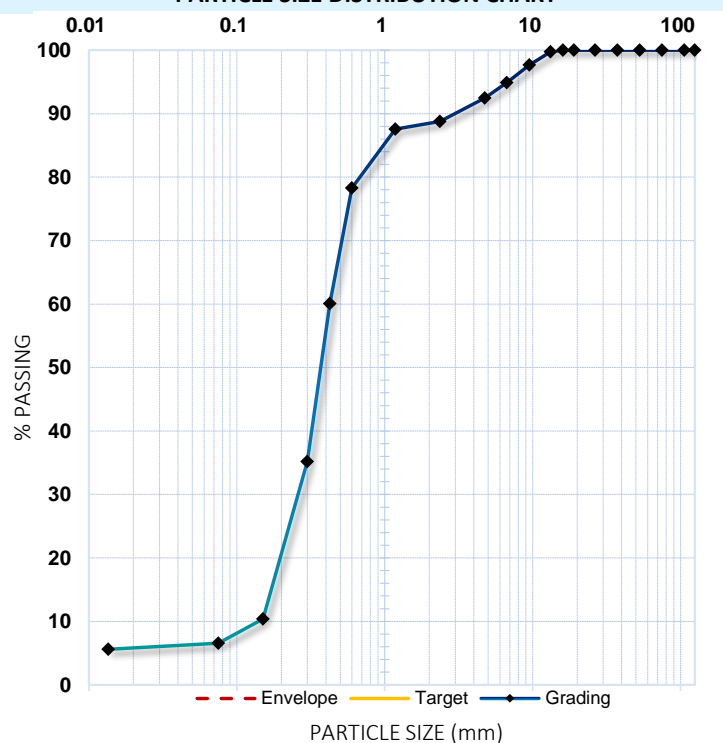
PARTICLE SIZE DISTRIBUTION CHART

Sieve Size (mm)	Passing (%)	Minimum (%)	Maximum (%)
125.00	100	-	-
106.00	100	-	-
75.00	100	-	-
53.00	100	-	-
37.50	100	-	-
26.50	100	-	-
19.00	100	-	-
16.00	100	-	-
13.20	100	-	-
9.50	98	-	-
6.70	95	-	-
4.75	92	-	-
2.36	89	-	-
1.180	88	-	-
0.600	78	-	-
0.425	60	-	-
0.300	35	-	-
0.150	10	-	-
0.075	7	-	-
0.0135	6	-	-

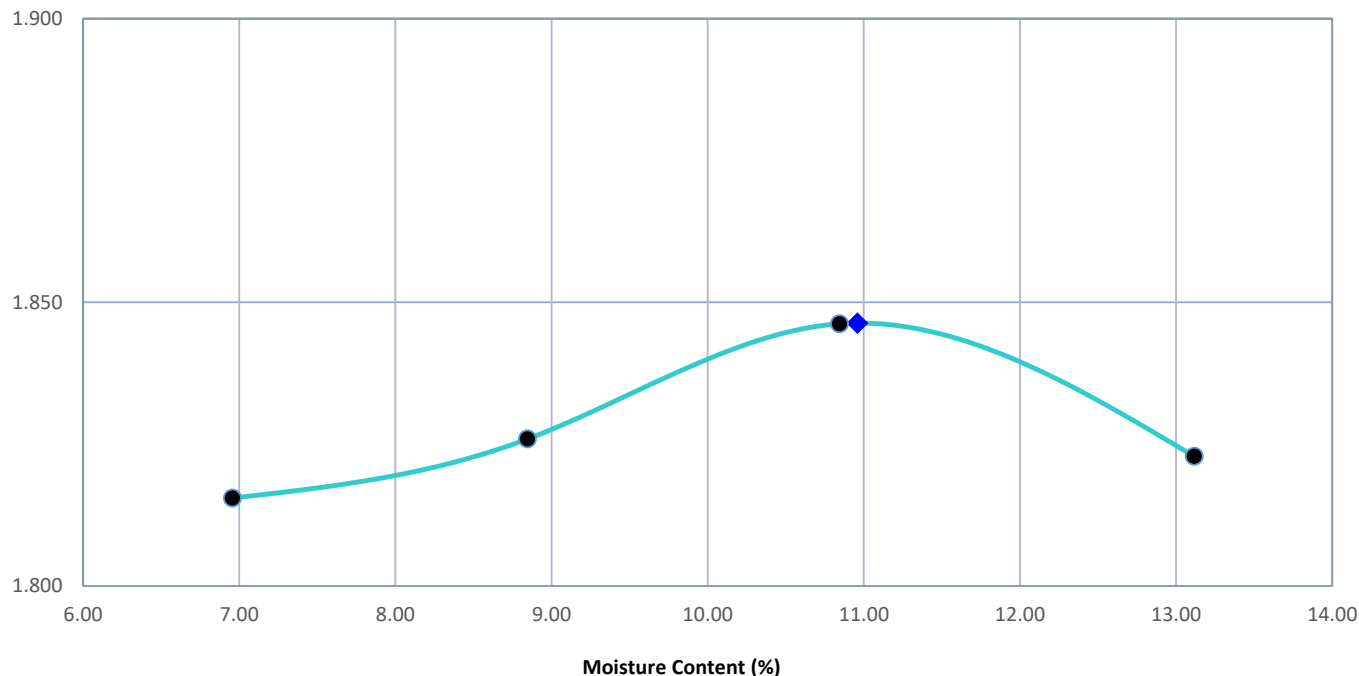
Plot: Dry Density vs. Moisture Content

Modified Maximum Dry Density (t/m³)

1.846

Modified Optimum Moisture Content (%)

11.0

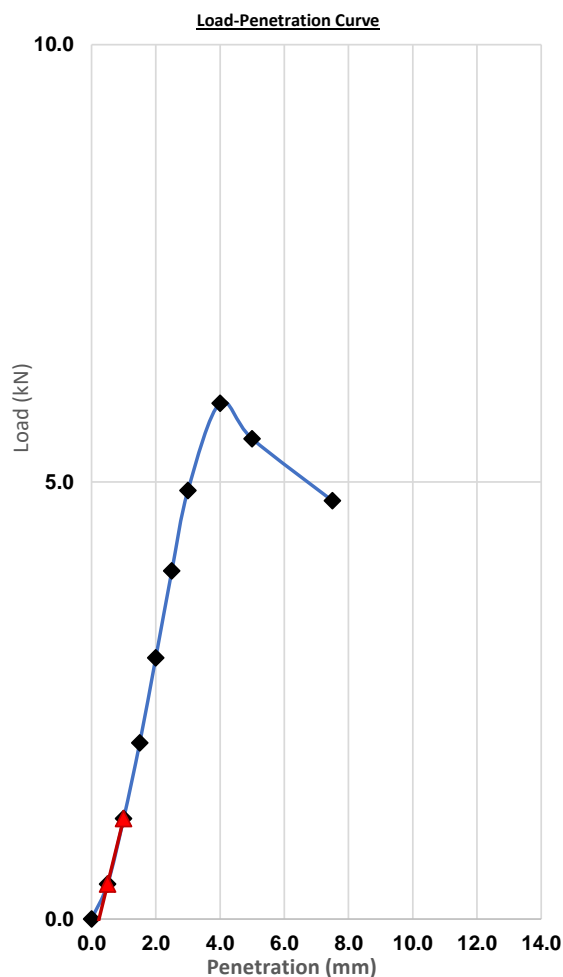
California Bearing Ratio (CBR)	35%
Determined at a Penetration of	2.5mm
Correction applied to Penetration	0.2mm

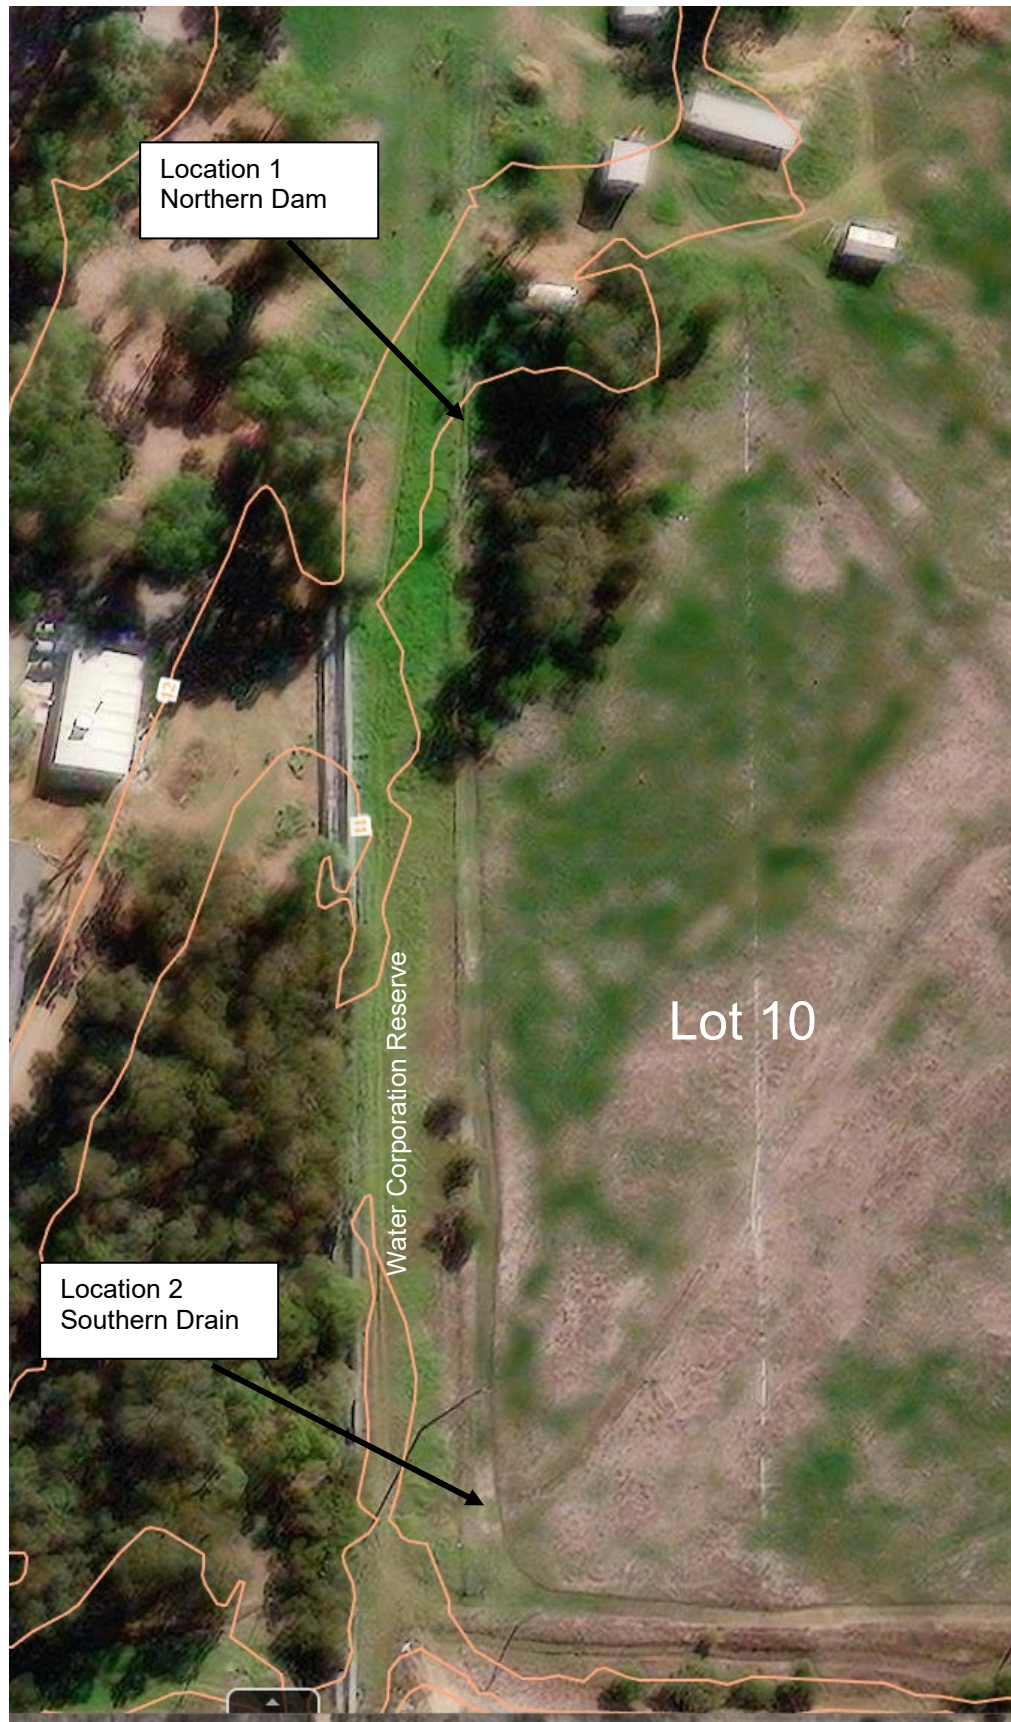
FIGURE 1. INSPECTION LOCATIONS

A site inspection of the property was completed on Friday 30 September 2022, focused on the surface water flow regime along the western boundary of Lot 10, in particular the two locations marked on Figure 1 attached, namely:

1. The northern dam
2. The southern drain crossing.

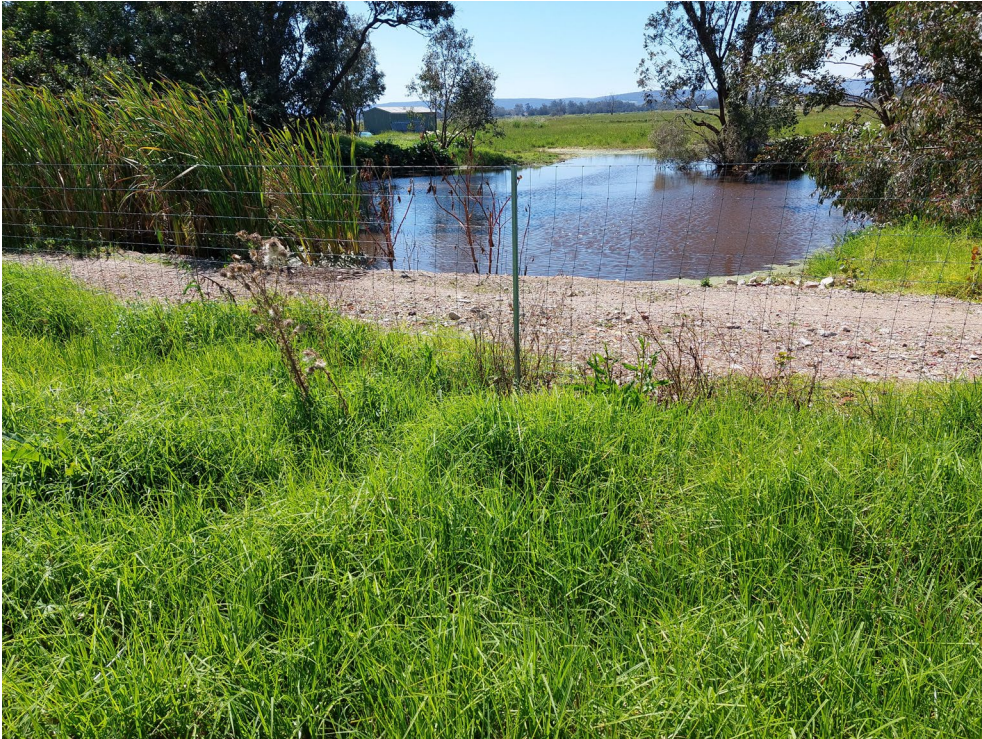
Plate 1. Looking east towards northern dam from Water Corporation reserve.

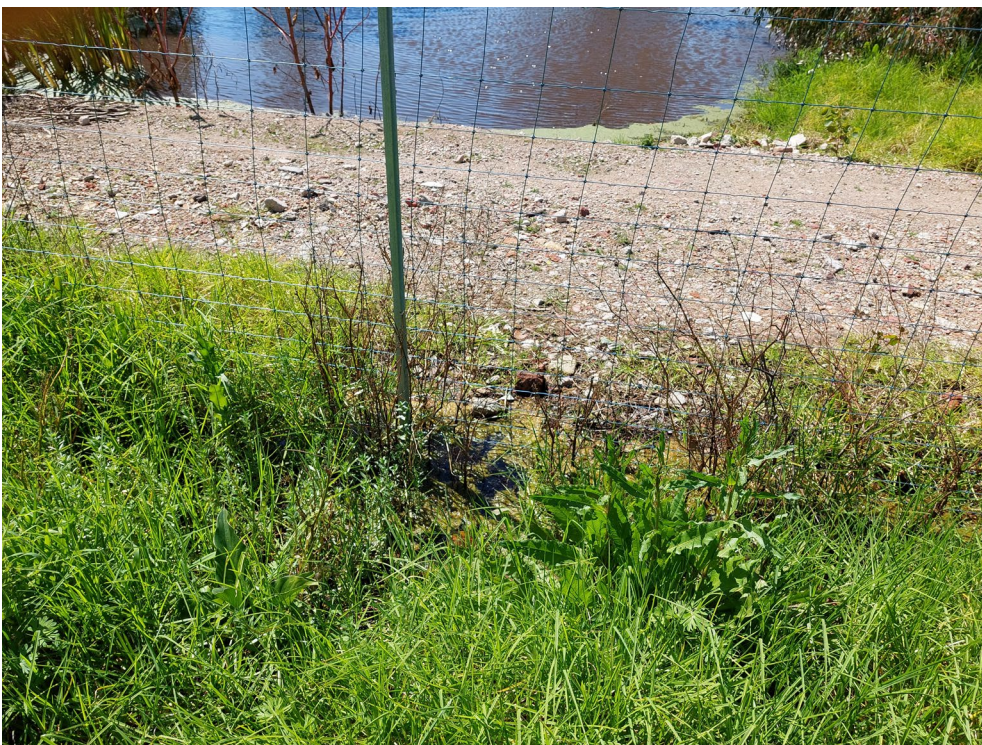
- The finished level of the firebreak adjacent to the northern dam ties in with the ground level of the existing boundary fence, with only a minor lip of approximately 100 mm (see Plate 2 attached).
- The ground slopes up from the western boundary through the Water Corporation reserve and is at least 1m higher on the other side of the reserve (see Plate 3 attached).
- The Water Corporation reserve is dry, with only a very minor area of standing water on the fence line.
- Any water flowing from west to east will flow over the firebreak. The fire break is lower than the land to the west and the firebreak will not cause any more than 100 mm of ponding at the fence line before water will flow over the firebreak.
- The dam fills from a drain connection to the east. The firebreak at its current level helps to contain the water and prevent it from overtopping into the Water Corporation reserve.

Plate 2. Firebreak finish level relative to existing fence line.

Based on my observations I recommend that no further work is required to the firebreak for surface water management. The basis of this recommendation is that:

- The southern drain provides more of a storage function than a water conveyance function. Once the drain fills up flow is relatively low, and the culvert crossing at the firebreak acts as a balance pipe. The two 375 mm diameter pipes installed have sufficient capacity for this function.
- The northern dam is contained by the firebreak and there is no risk of the land west of the firebreak flooding due to the elevation of the land. Any flow emanating from the western property can flow over the firebreak.

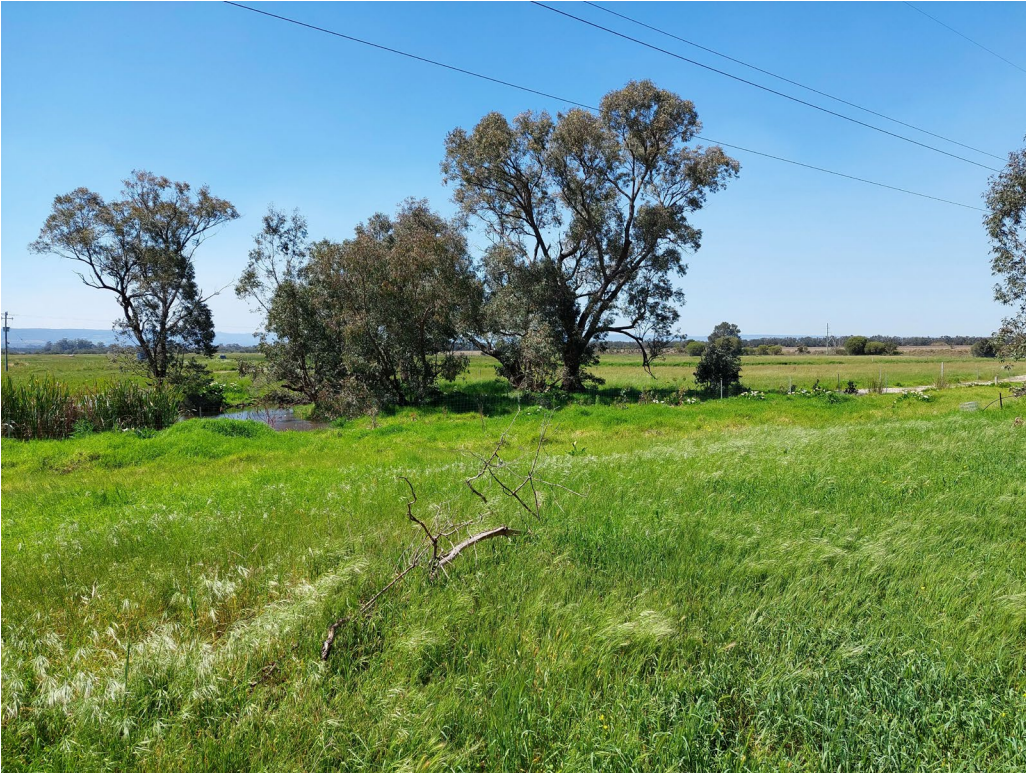
Plate 3. Looking south-east across Water Corporation reserve towards northern dam. Ground is falling towards dam.
