**Proposed Three Irrigation Dams
Lot 2, 206 Firns Road, Serpentine**

Planning and Development Act 2005
Shire of Serpentine Jarrahdale
**Notice of Determination on Application for
Development Approval**

Description of Proposed Development: Three Irrigation Dams

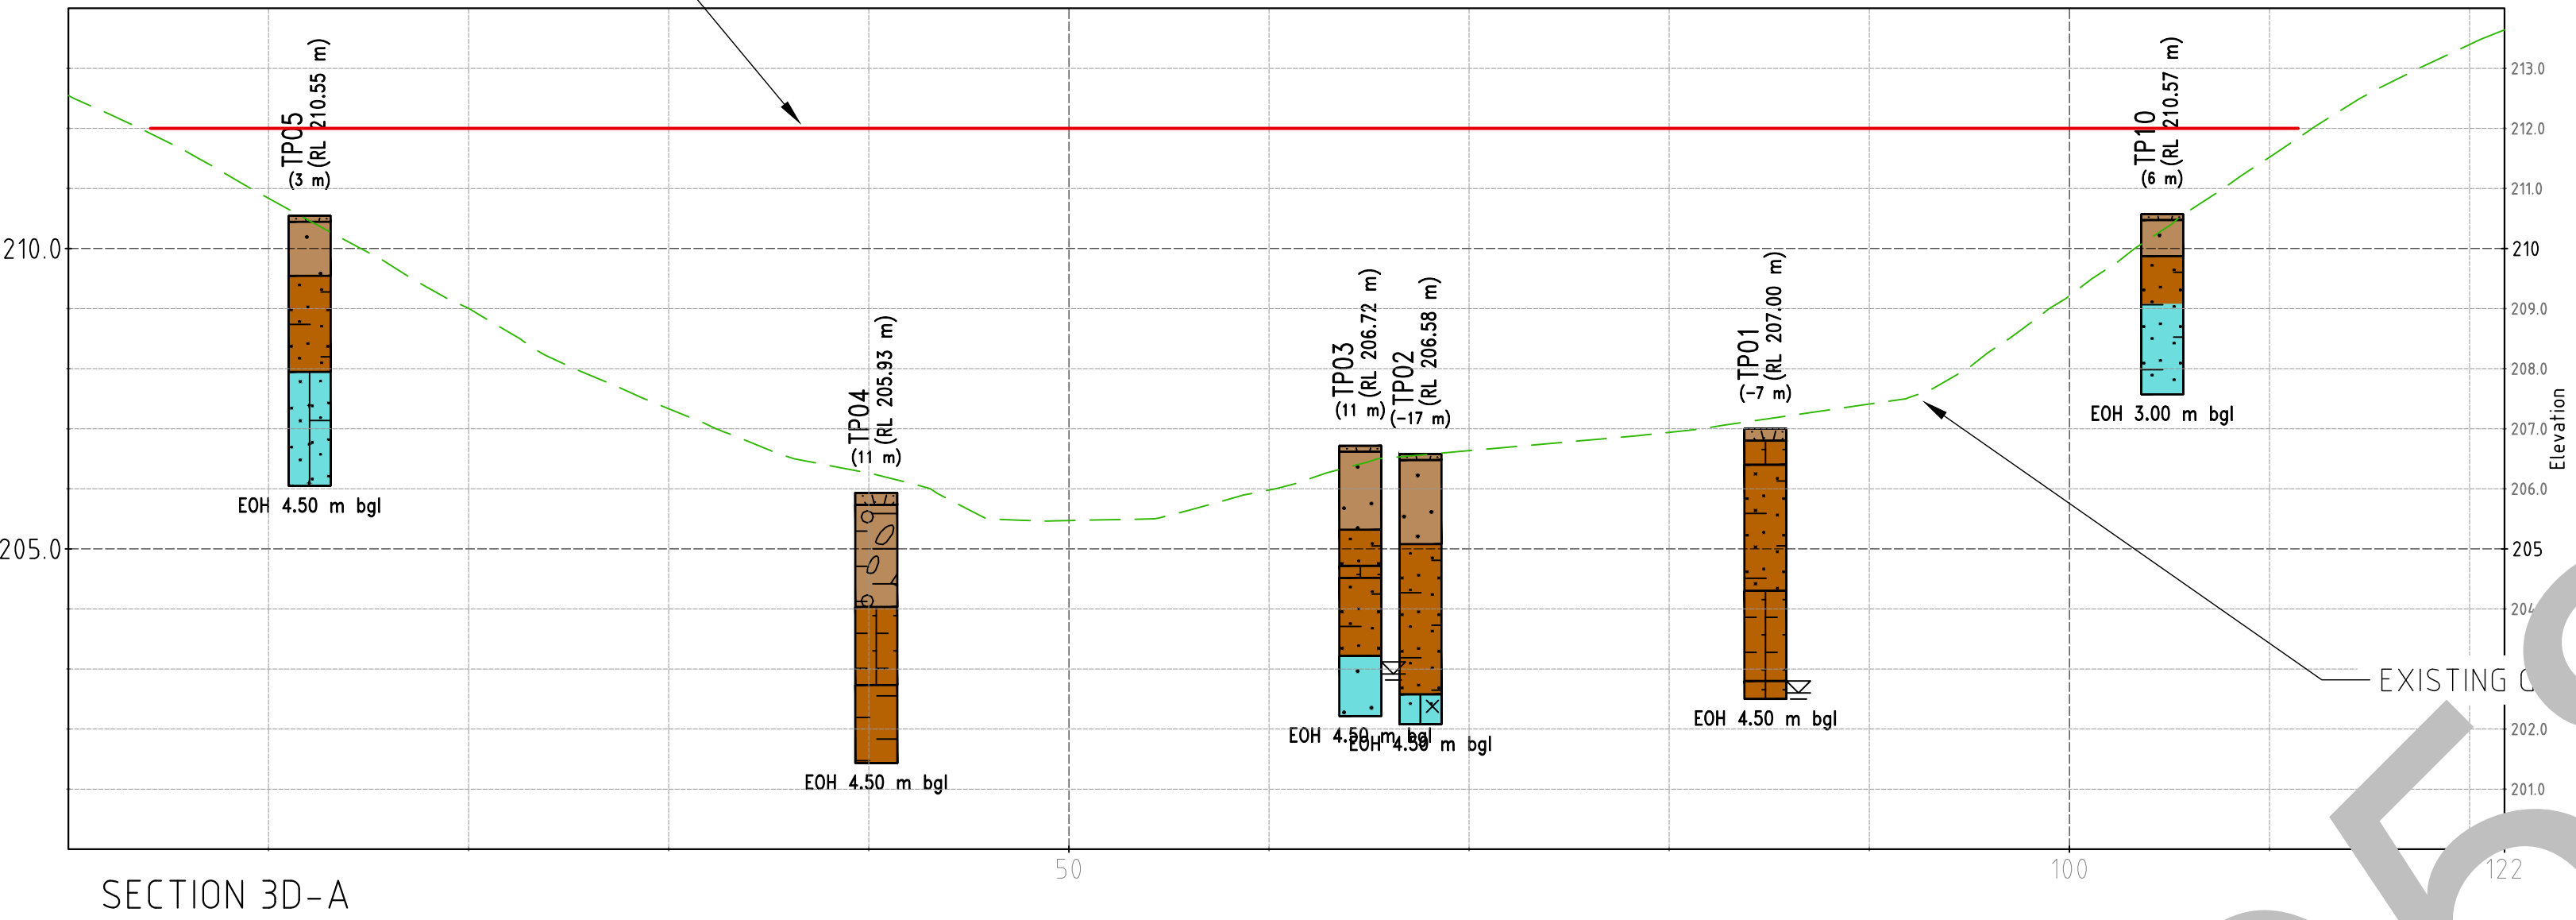
SECTION 3D-A

APPROXIMATE CREST OF DAM 3D EARTH EMBANKMENT FOOTPRINT

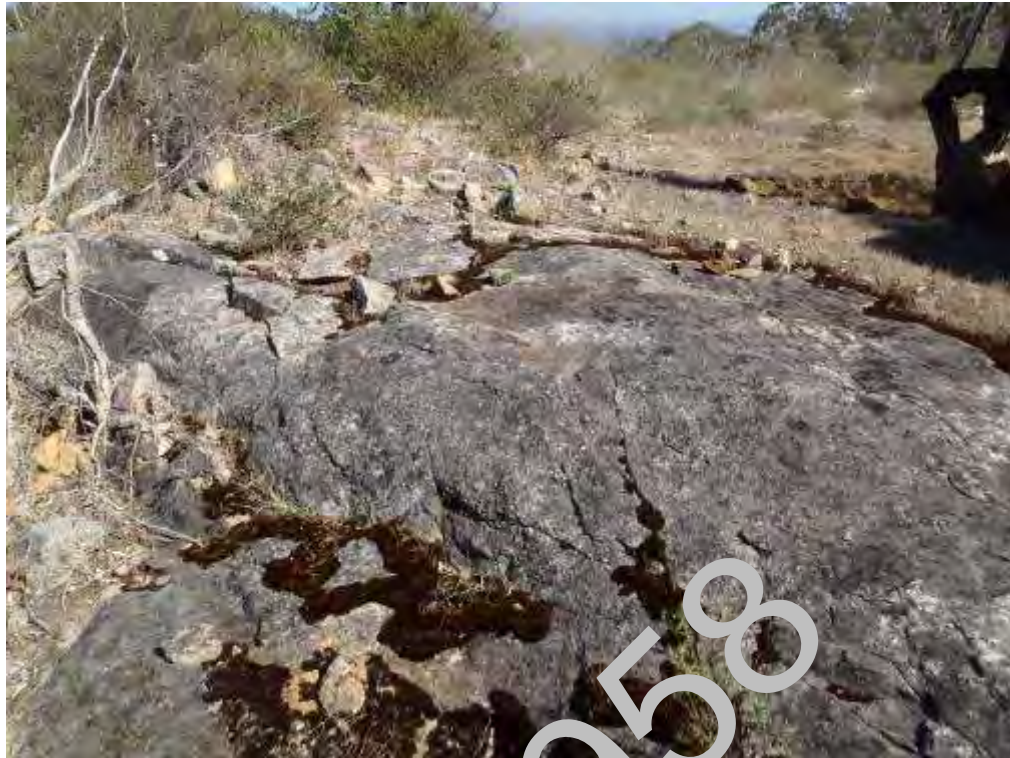
Photograph 1: Dam 2 – View of rock exposed at surface on northern abutment

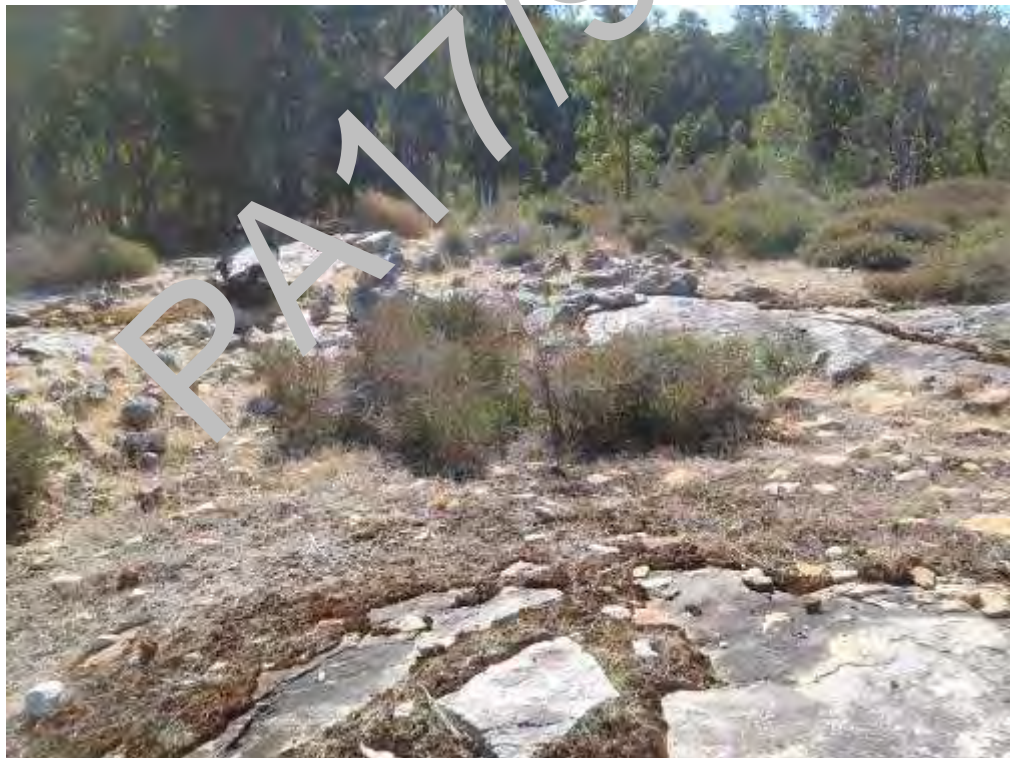
Photograph 2: Dam 2 – View of rock exposed at surface on northern abutment

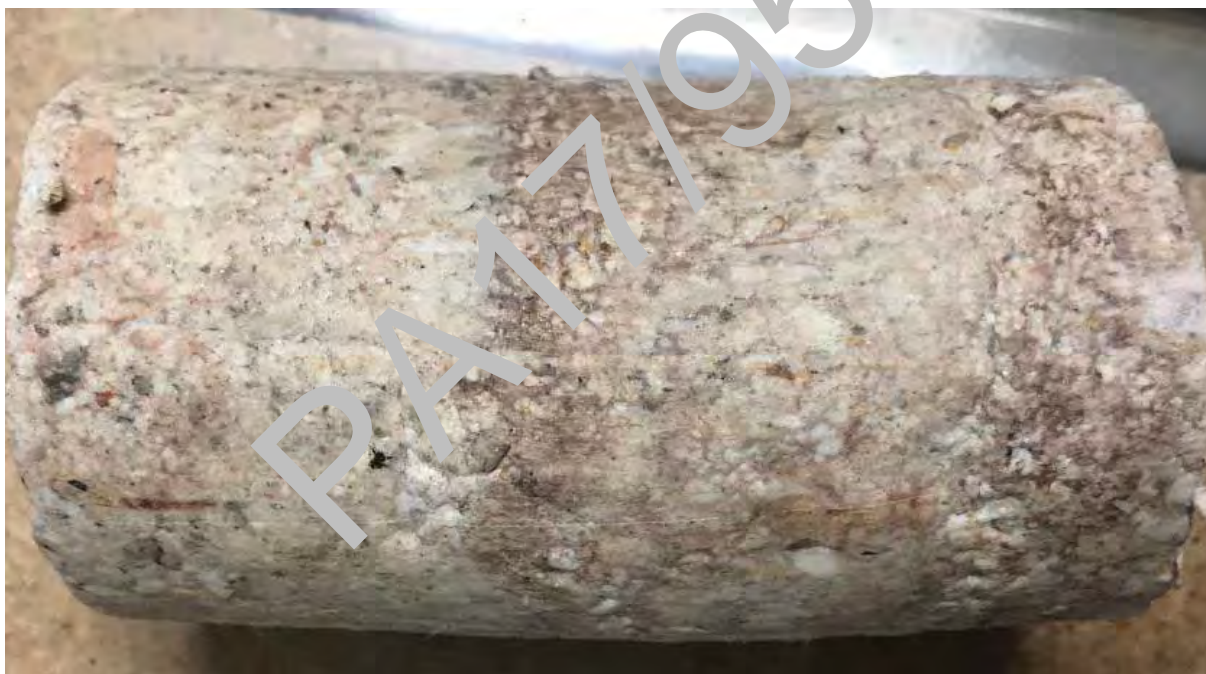
Photo After Test

Sample ID: LLS17/725 TP32 (1.40-1.80)	Depth (m): 1.40 - 1.80
Lab ID: LLS17_725_CU3	Date Tested: 4/05/2017

Failure Mode: Bulging Failure
