LOCAL STRUCTURE PLAN

Lot 2 Thomas Road & Lot 4 Kargotich Road, Oakford

This structure plan is prepared under the provisions of the Shire of Serpentine-Jarrahdale Town Planning Scheme No. 2.

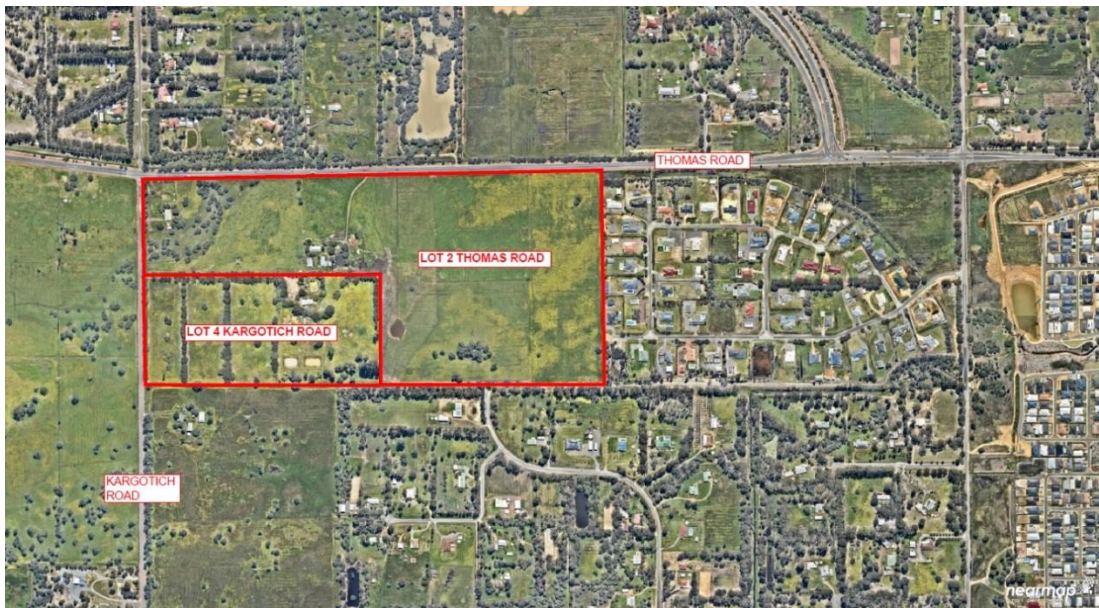
Figure 1 – Subject Land

The subject land (see **Figure 1**) is located in Oakford and is situated approximately 30km southeast of the Perth CBD, and 5km east of the Byford Town Centre. It is located on the south eastern corner of Thomas Road and Kargotich Road. Nearby development includes similar rural living estates to the east and south with lot sizes ranging between 4,000m² and 2 hectares within those estates. Other estates to the north also comprise rural residential development, but land to the west is used for rural purposes.

Lot 2 Thomas Road is 35.1746ha in area and has frontage to Thomas Road, Kargotich Road, Byford Meadows Drive and Jersey Road. Lot 4 Kargotich Road is 13.4984ha in area and has frontage to Kargotich Road. The total area subject to the proposed Local Structure Plan, is therefore, 48.6748ha.

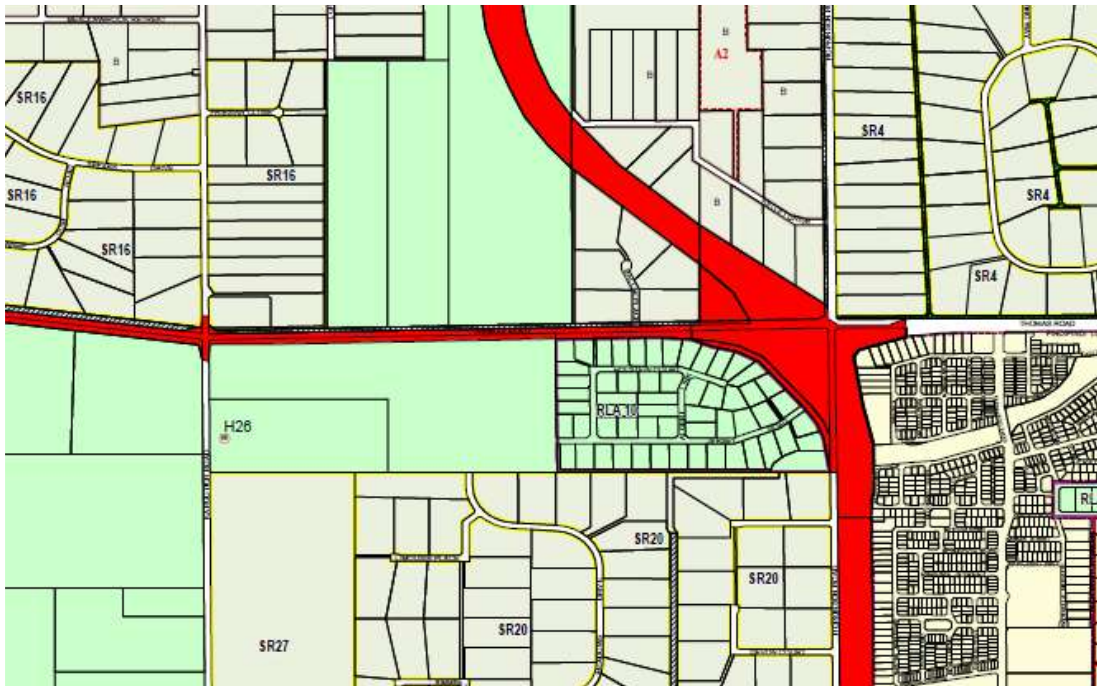
Figure 2: Town Planning Scheme No. 2 – Zoning Extract

The subject land is identified as "Rural" in the Shire of Serpentine-Jarrahdale's Town Planning Scheme No. 2 (TPS 2), as outlined in **Figure 2**. The MRS Primary Regional Road reservation outlined in above is also reflected. Heritage Item 26 is identified on the Scheme Map and is discussed further in this report.

Land to the south of Lot 2 is zoned Special Rural (SR 20) and land to the east of Lot 2 is zoned Rural Living A (RLA 10). Land to the south of Lot 4 is zoned Special Rural (SR27). Other land surrounding the site is a mixture of Special Rural and Rural.

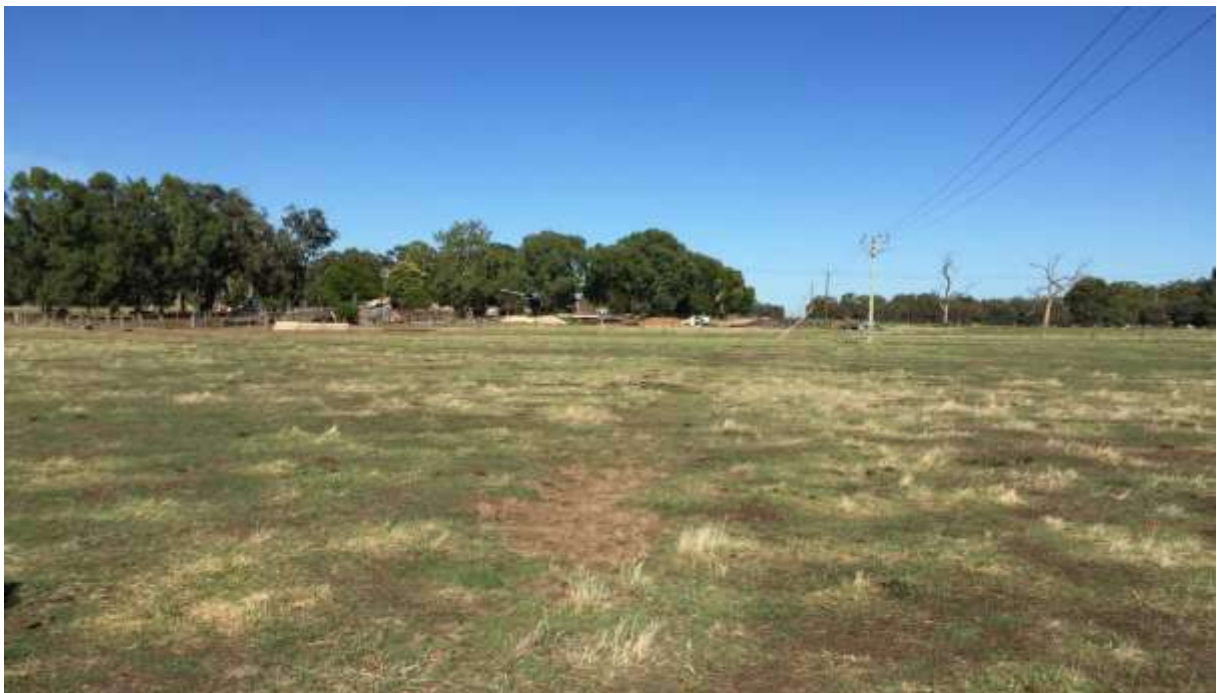
Figure 1: Lot 2 Thomas Road, looking west from TP03

At the time of the investigation, the site was generally open and accessible (refer to Figure 1). Residential dwellings and sheds were observed towards the centre of the site, and within the north western corner of the site. Dilapidated vehicles and equipment were observed adjacent to the dwelling in the centre of the site. Stockpiles, observed to be mostly sand, were also observed within this area as well as one stockpile of mulch.

Vegetation was observed to generally comprise pasture grass. Multiple rows of mature trees were observed within the western half of the site, with an isolated group of trees adjacent to the southern boundary in the eastern half of the site. Overhead power lines were observed transecting the site in an easterly direction from Kargotich Road, and in a southerly direction from Thomas Road. Fences divided the site into multiple sections.

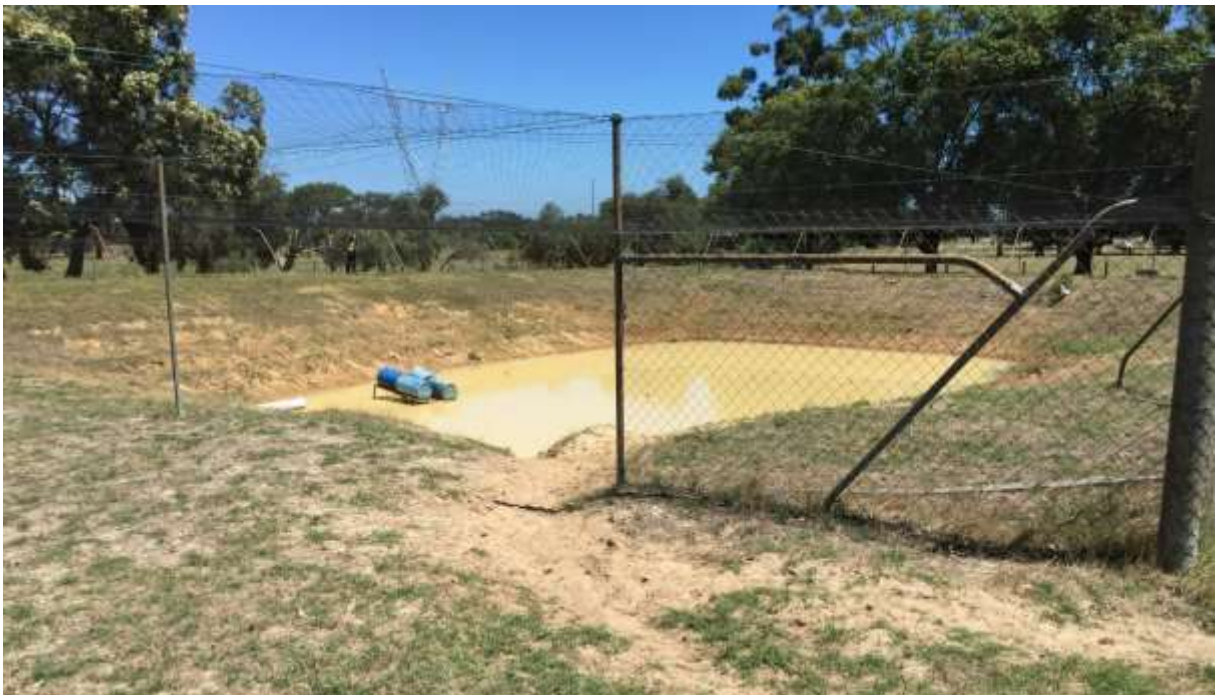
Figure 3: Observed Dam, Lot 4 Kargotich Road

An open drain was observed along the western and southern boundary of the site. Three fenced dams were observed towards the southern boundary of the site, and an unfenced dam was observed towards the centre of the site. Gravel hardstands were observed between the roads to the dwellings.

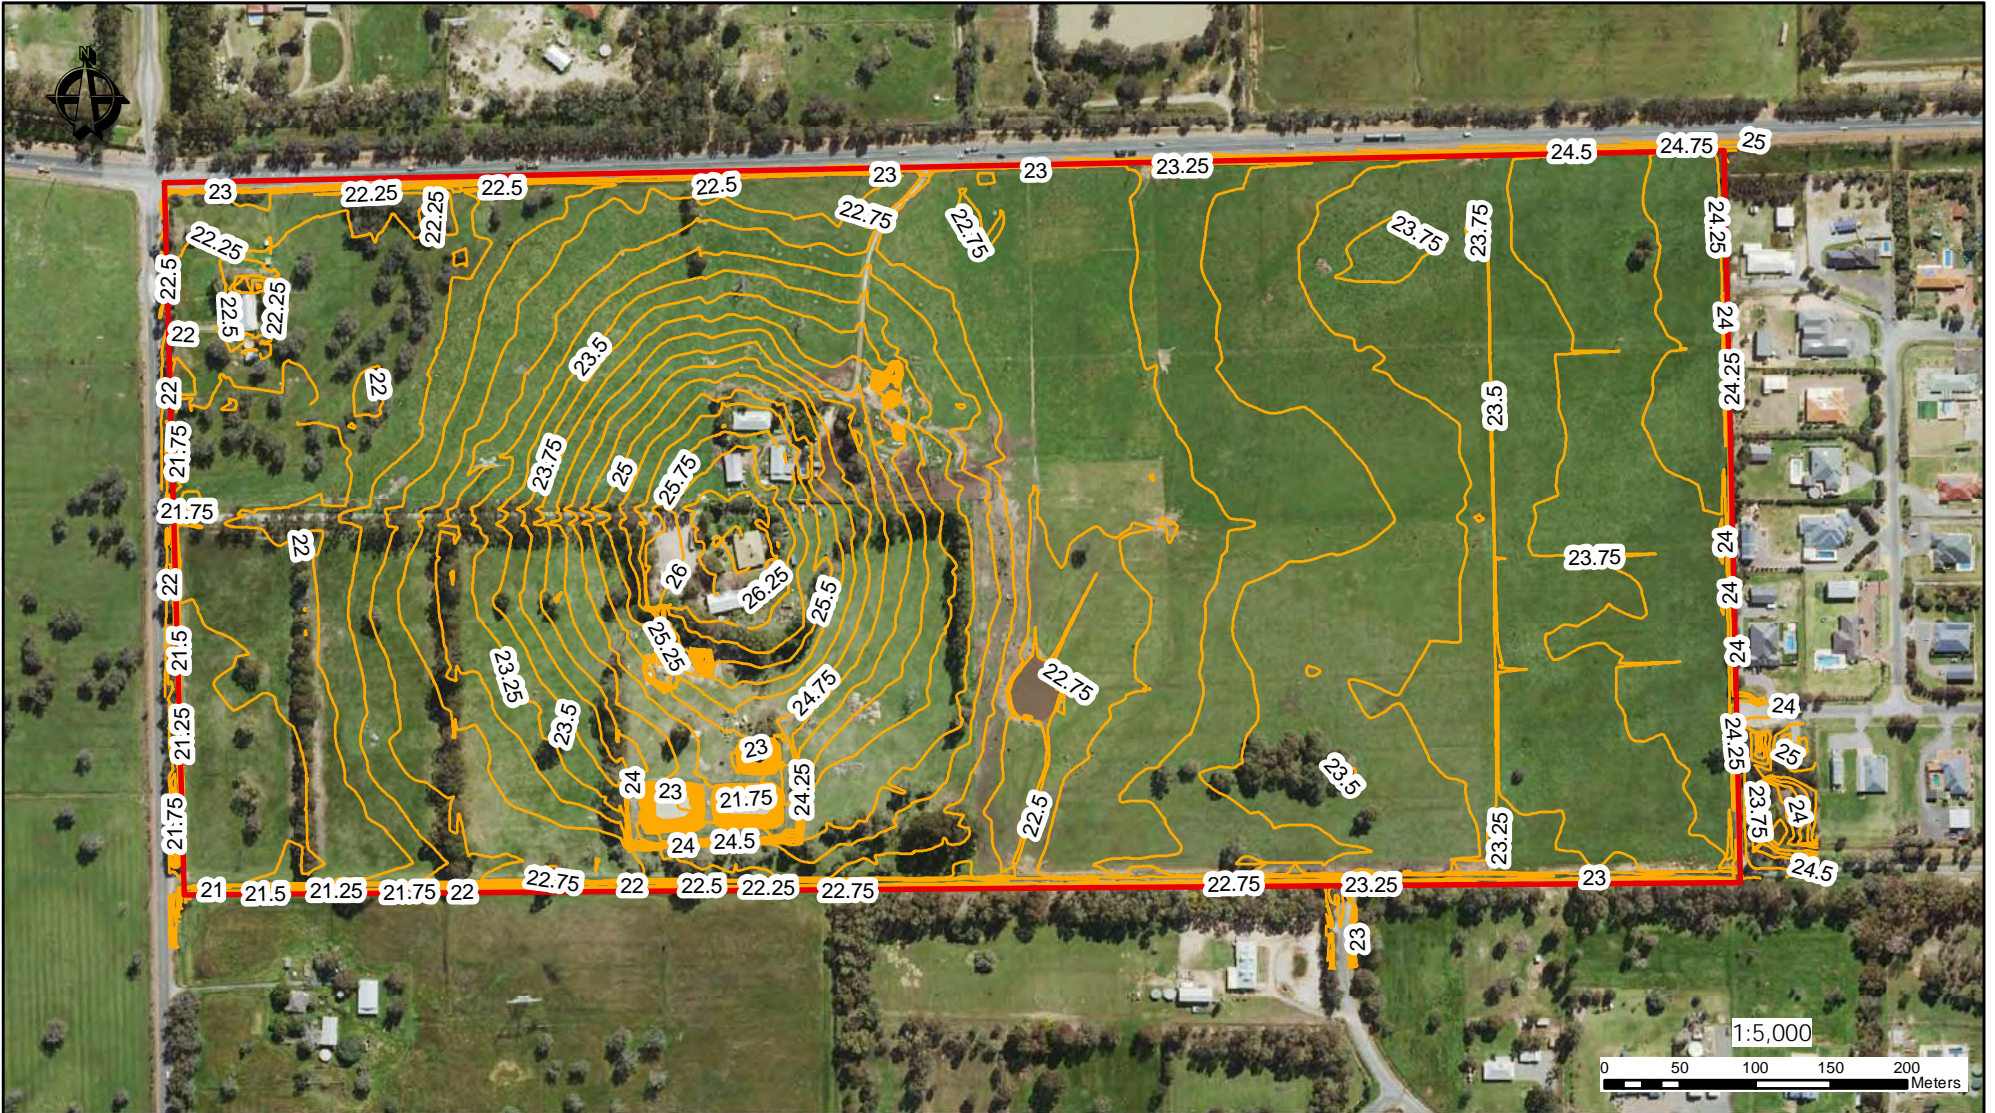
hyd2o
Lot 2 Thomas Rd & Lot 4 Kargotich Rd, Oakford
Site Conditions
Figure 3

- Site
- Topography (mAHD) MNG, 2017

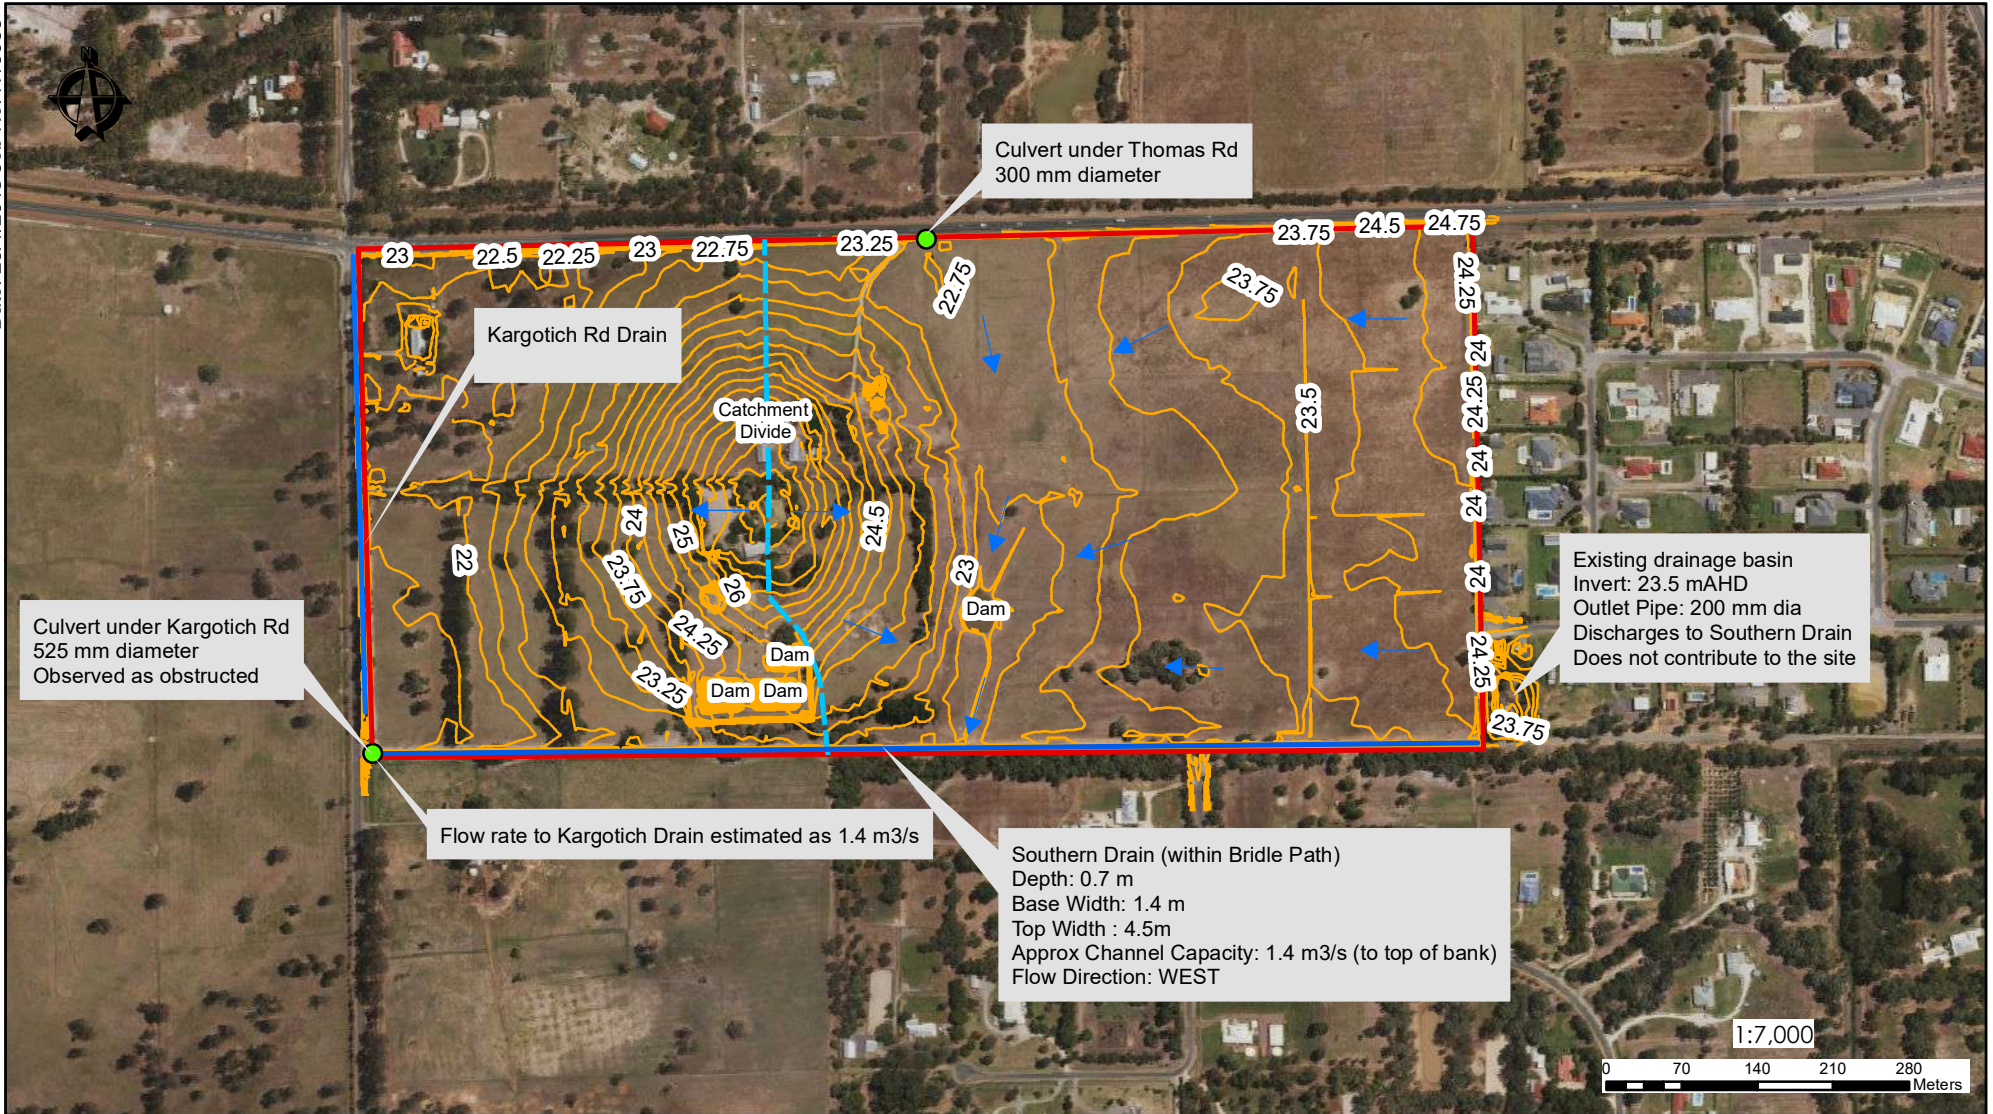
The topography splits the site into two surface water catchments which drain via diffuse overland flow towards the western and southern boundaries of the site (Figure 5).

- Site
- Topography (mAHd) MNG, 2017
- ▶ Flow Direction
- Catchment Divide
- Drain

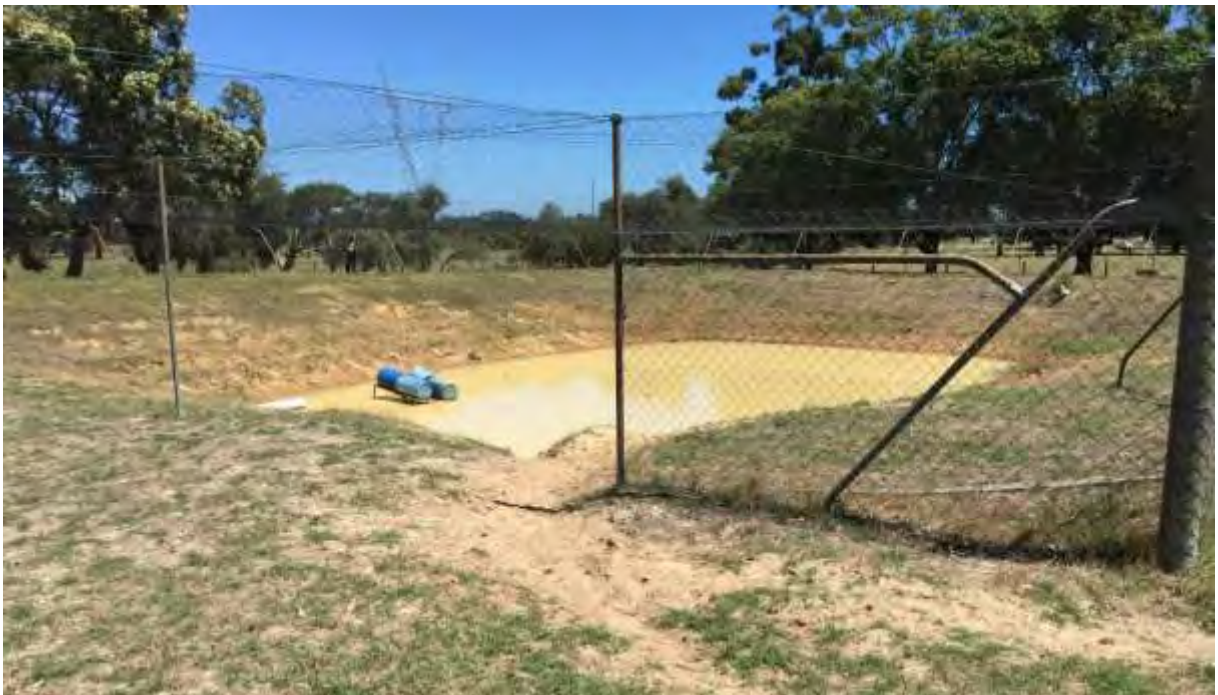
Figure 3: Observed Dam, Lot 4 Kargotich Road

The ground surface level falls from a high point of RL 26 m AHD to approximately RL 24 m AHD on the eastern boundary and RL 22 m AHD on the western boundary.

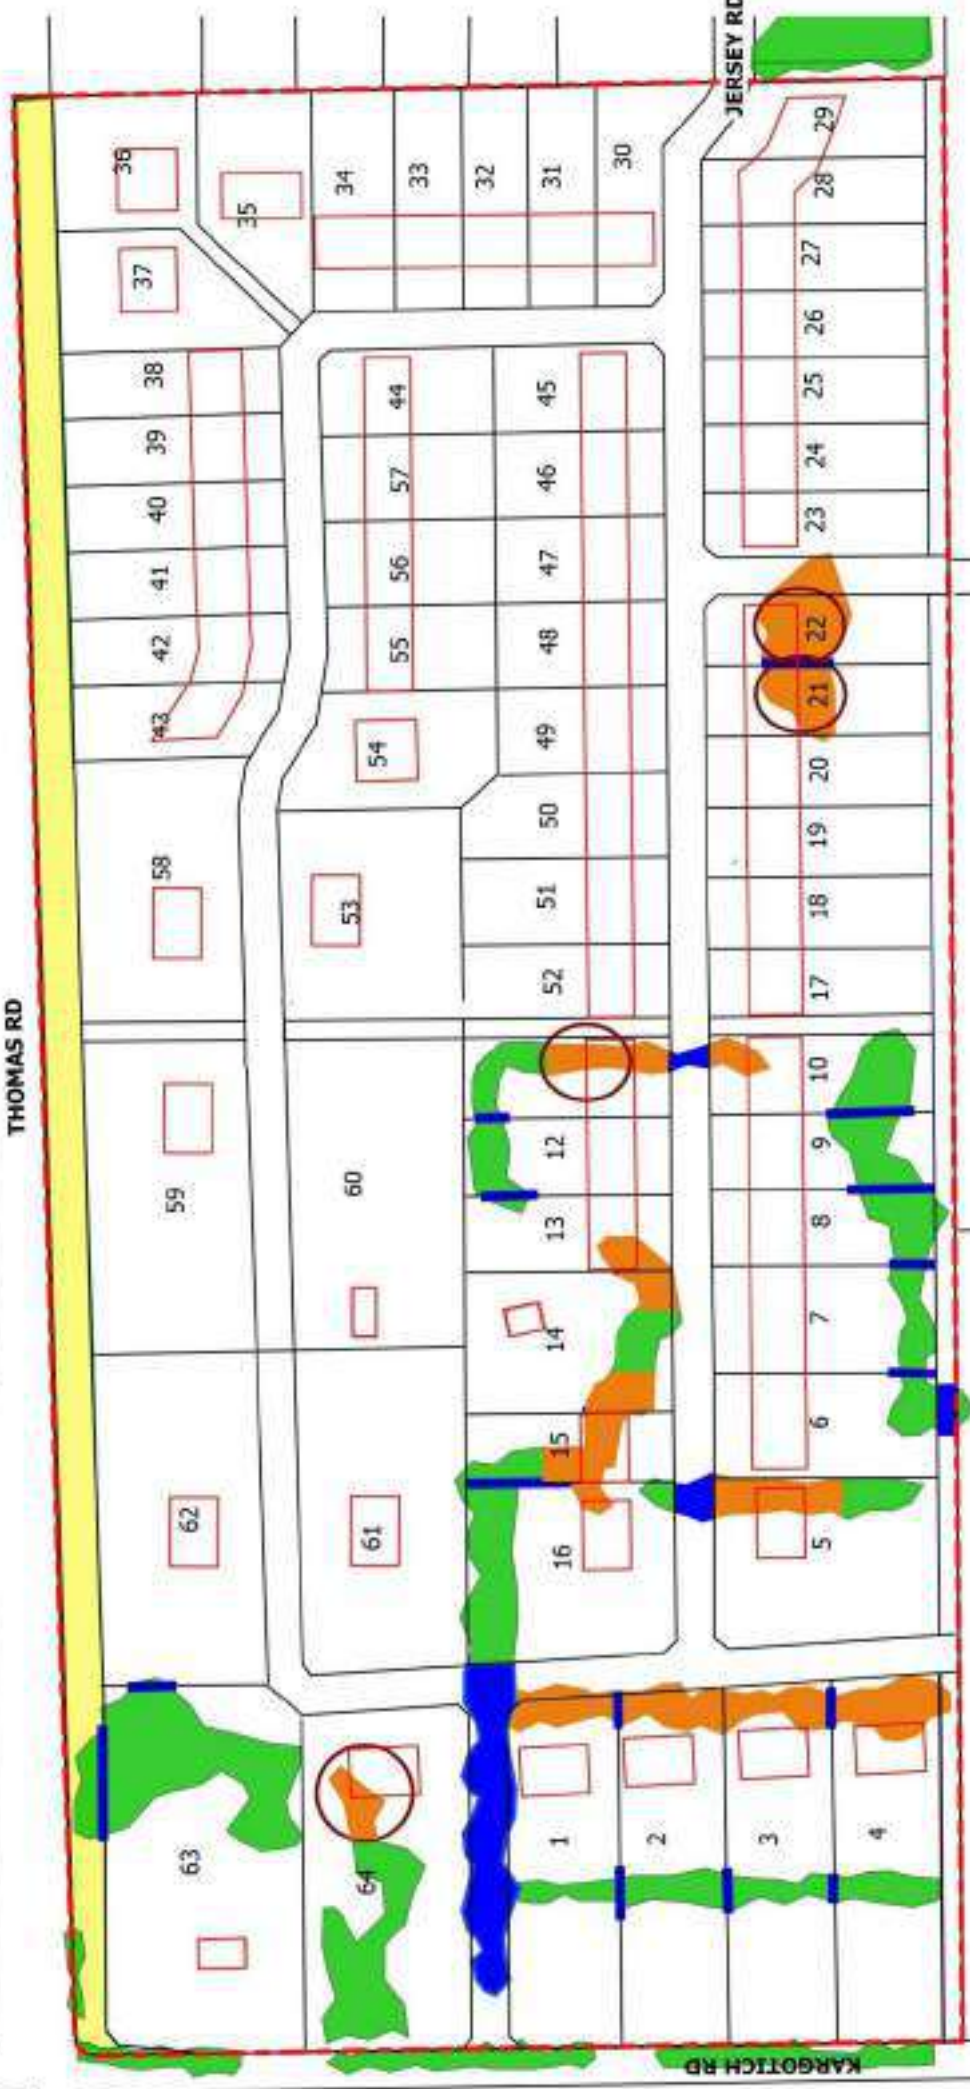
FIGURE 5
VEGETATION CLEARING & REVEGETATION

- LEGEND**
- SUBJECT LAND
 - BUILDING ENVELOPE
 - EXISTING VEGETATION (Excluding Grassland)
 - FENCE LINE / FIREBREAK CLEARING
 - ROAD RESERVE CLEARING
 - PARKLAND CLEARING FOR 20m ASSET PROTECTION ZONE
 - REVEGETATION - GRASSLAND
 - AREA TO BE MODIFIED TO LOW THREAT STATE
 - POTENTIAL CLEARING FOR HOUSE SITE

- a) The BAL contours have been prepared for all classified vegetation types except Grassland on the subject land. The pasture areas in the adjoining properties have been classified as 'grassland' as the applicant does not have any control over these areas;
- b) That the vegetation clearing and revegetation as shown in Figure 5 will occur.
- c) Vegetation Plot No 3 will traverse multiple boundaries and can be expected to be modified as part of the development of the subdivision such that it becomes Low Threat Vegetation;
- d) Vegetation Plot No 8 will be reduced in size to allow for a building envelope and will be less than 2500sqm and hence excluded vegetation (2.2.3.2(c);
- e) Vegetation Plot No 13 is the 20m road widening along Thomas Road which is likely to be left as unmanaged grassland.

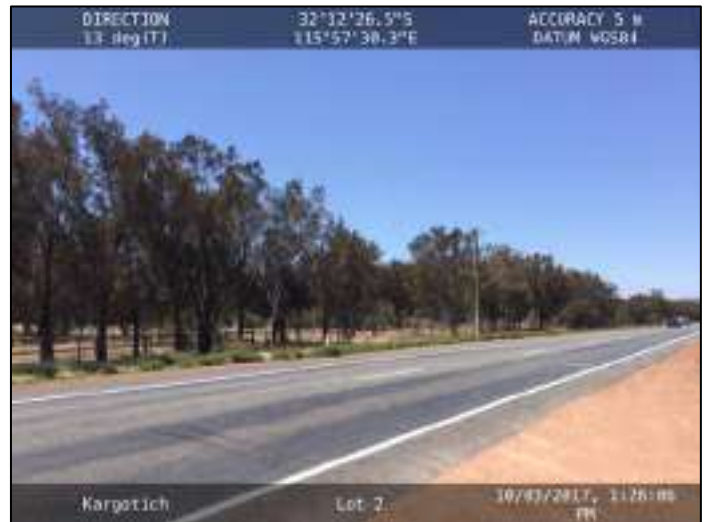
Photo No 2 Plot No 1

Non-homogeneous vegetation in adjacent road reserve and rural residential lots. Predominantly Sheoak being less than 10m in height with some Gums, Acacia scrub, and Melaleuca. Typically has grass understorey with some shrubs and moderate to high surface fuel loads greater than 15 tph.

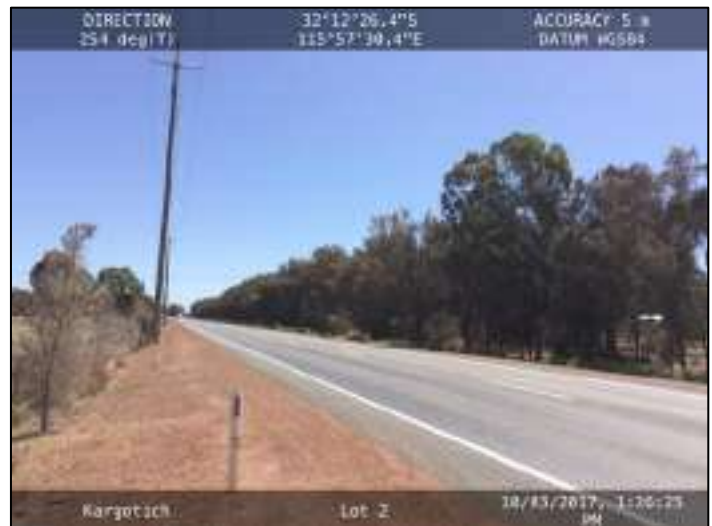
Photo No 3 Plot No 2

Non-homogeneous vegetation in adjacent road reserve and rural residential lots. Predominantly Sheoak being less than 10m in height with some Gums, Acacia scrub, and Melaleuca. Typically has grass understorey with some shrubs and moderate to high surface fuel loads greater than 15 tph.

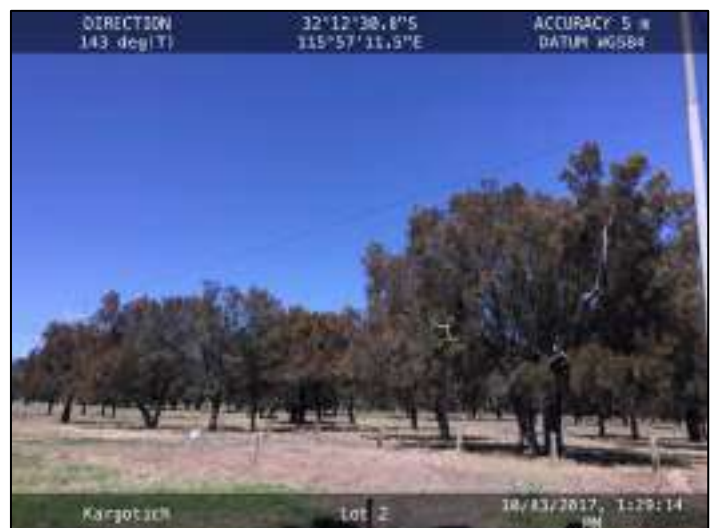
Photo No 4 Plot No 3

Sheoak woodland to 10m in height, less than 30% foliage coverage with grassland/pasture understorey. Parkland cleared with low surface fuel loads. Lower branches have been grazed/pruned.

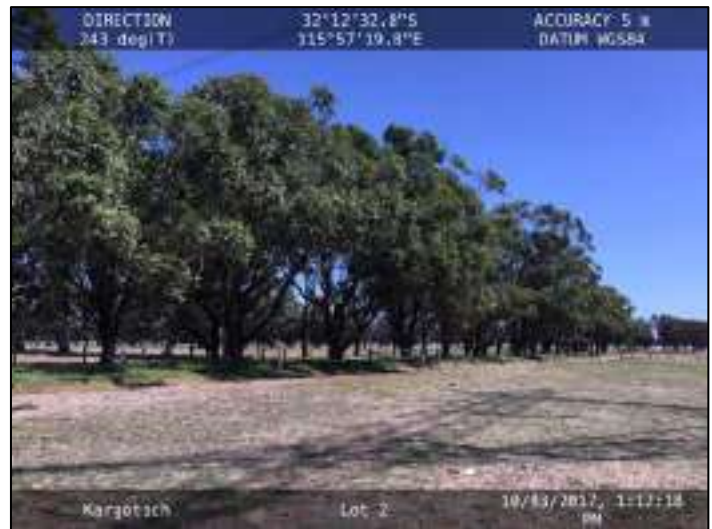
Photo No 5 Plot No 3

Double row of Eucalypts to 10m height. Does not constitute a windbreak. Foliage coverage greater than 50% with understorey comprising of unmanaged grassland with moderate fuel loads.

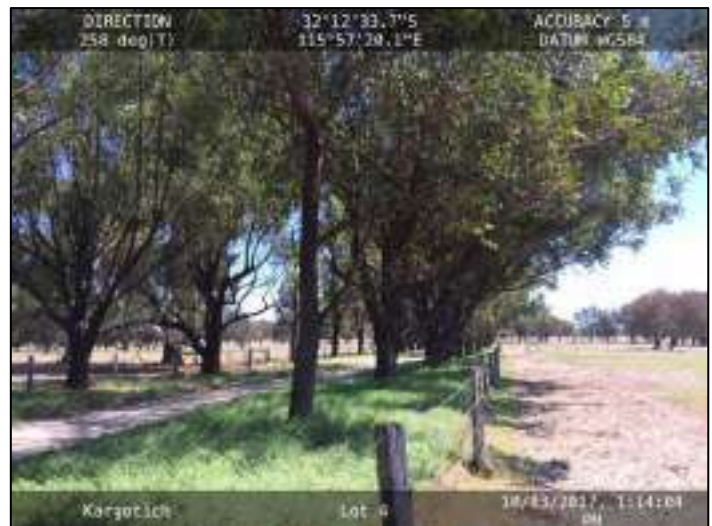
Photo No 6 Plot No 4

Double row of Eucalypts to 10m height. Does not constitute a windbreak. Foliage coverage greater than 50% with understorey comprising of unmanaged grassland with moderate fuel loads.

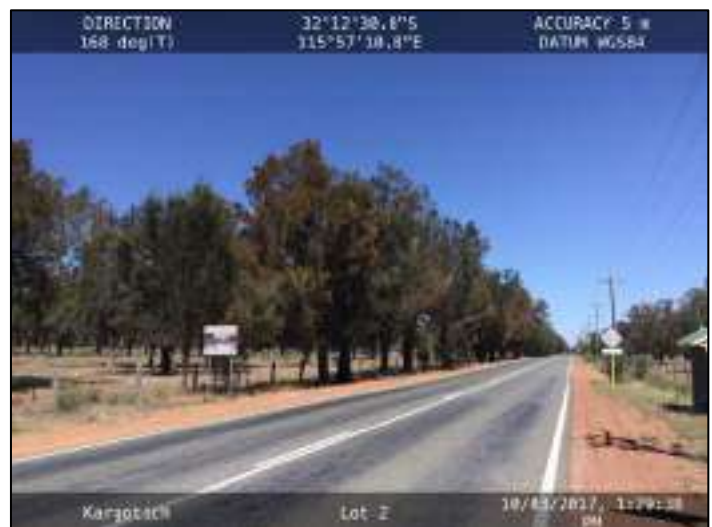
Photo No 7 Plot No 5

Predominantly Sheoak being less than 10m in height along roadside. Typically has grass understorey with moderate to high surface fuel loads greater than 15 tph.

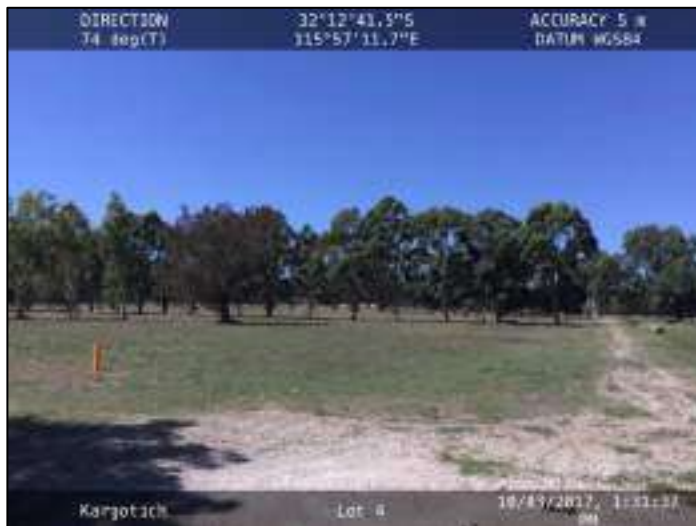
Photo No 8 Plot No 5

Windbreak being a single line of trees of introduced Eucalypts. Grassland/pasture underneath with low to moderate fuel loads.

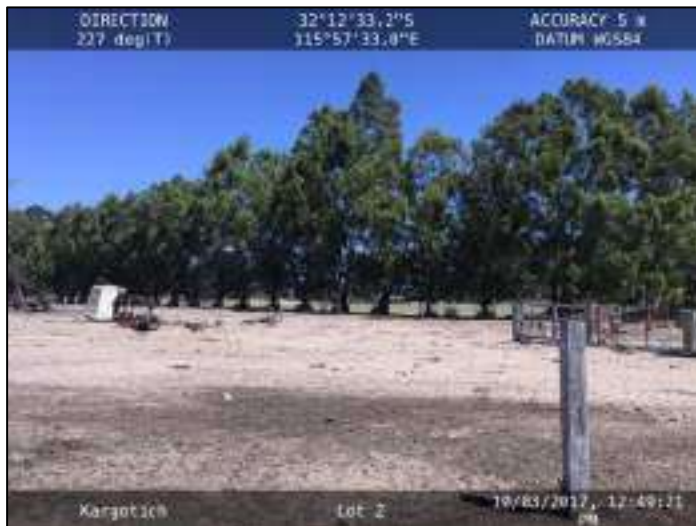
Photo No 9 Plot No 6

Windbreak being a single line of trees of introduced Eucalypts. Grassland/pasture underneath with low to moderate fuel loads.

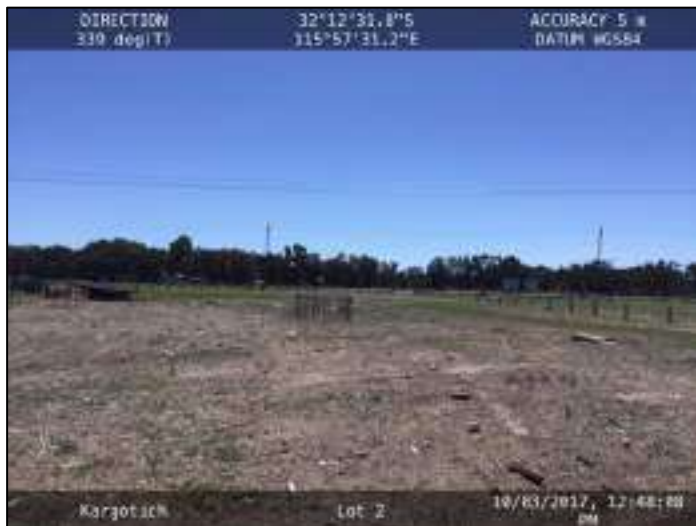
Photo No 10 Plot No 7

Intensely grazed paddock.

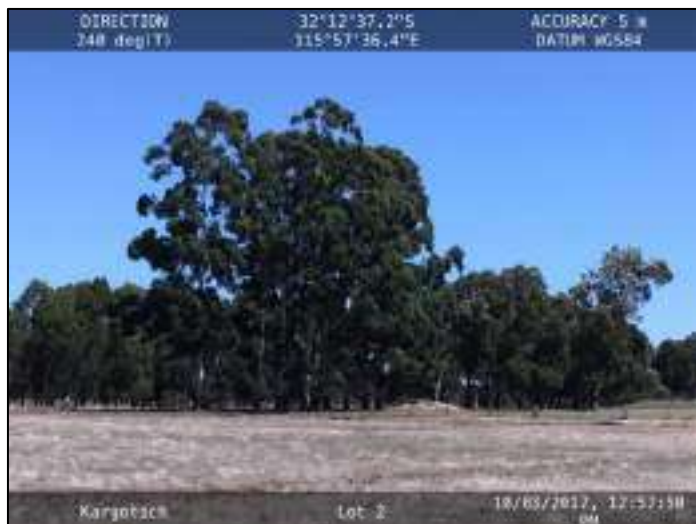
Photo No 11 Plot No 8

Eucalypt Woodland being wider than a windbreak. Introduced Eucalypts to 35m in height with foliage coverage which is potentially more than 30% but surface fuel loads are less than 15 tph.

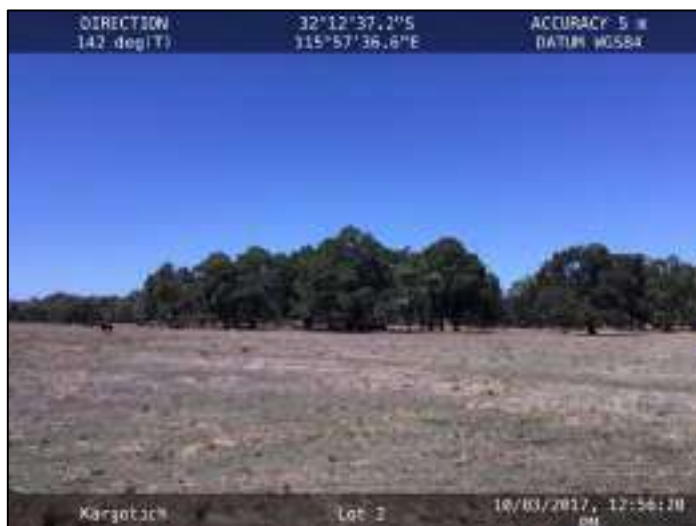
Photo No 12 Plot No 8

Copse of Eucalypts approximately 0.3ha and greater than 10m in height. Grazed understorey with some dead material and moderate surface fuel loads.

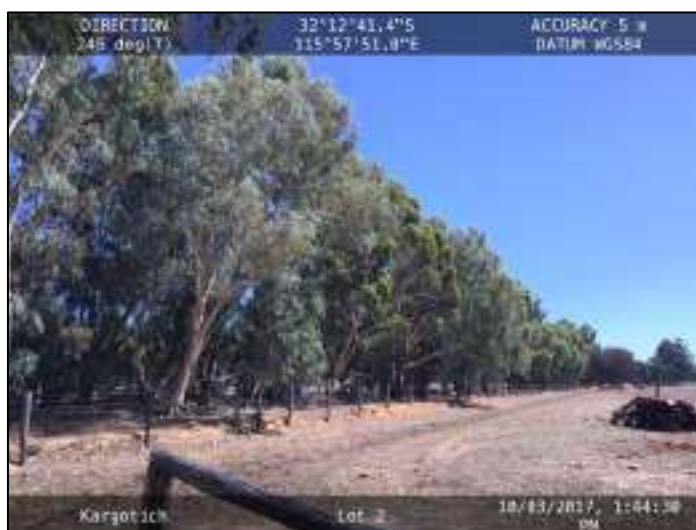
Photo No 13 Plot No 9

Multi row planting of Eucalypts greater than 10m in height. Little understorey but more continuous fuel layers with moderate surface fuel loads

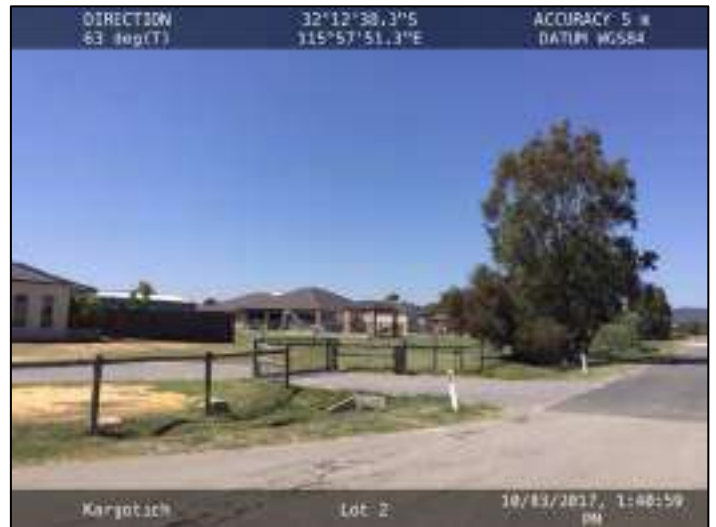
Photo No 14 Plot No 10

Managed subdivided land in Jersey Road.

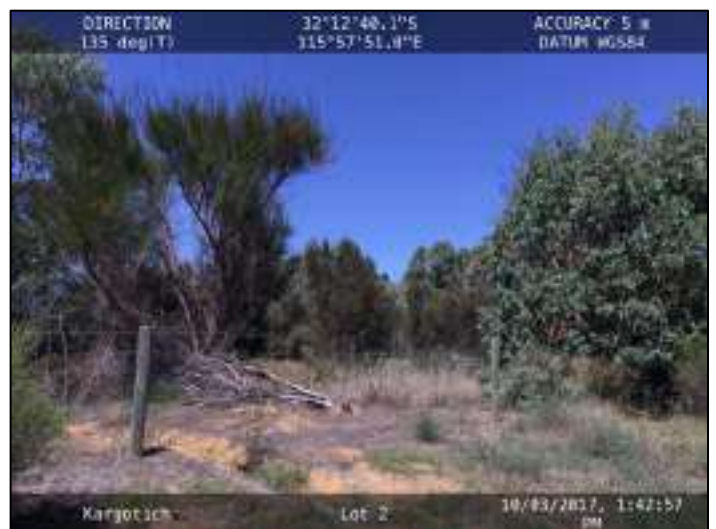
Photo No 15 Plot No 10

Drainage basin with mixed vegetation but predominantly scrub less than 4m in height with shrub understorey.

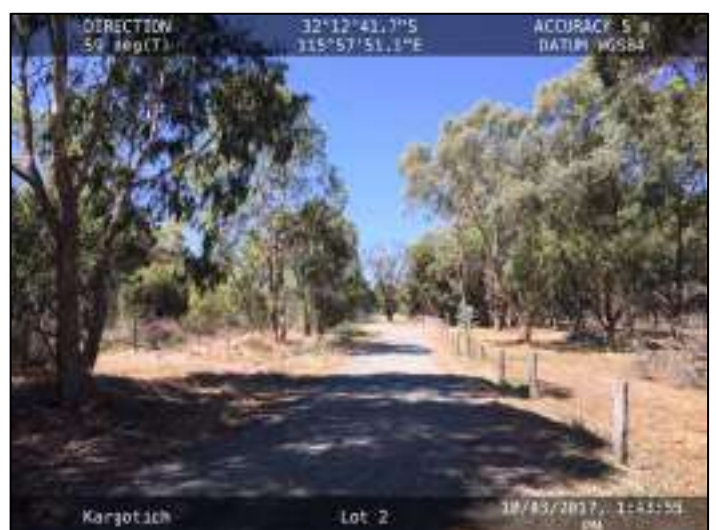
Photo No 16 Plot No 11

Multiple use path adjacent to the drainage basin extending east from the southern property boundary.

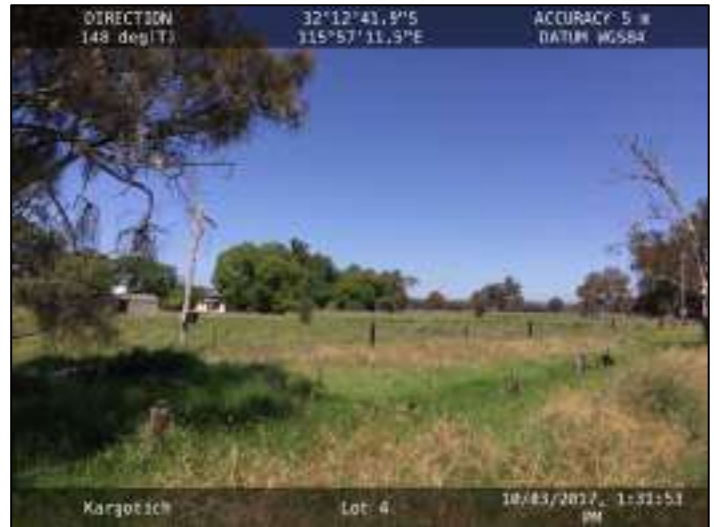
Photo No 17 Plot No 11

Pasture/unmanaged grassland on the adjoining land to the south.

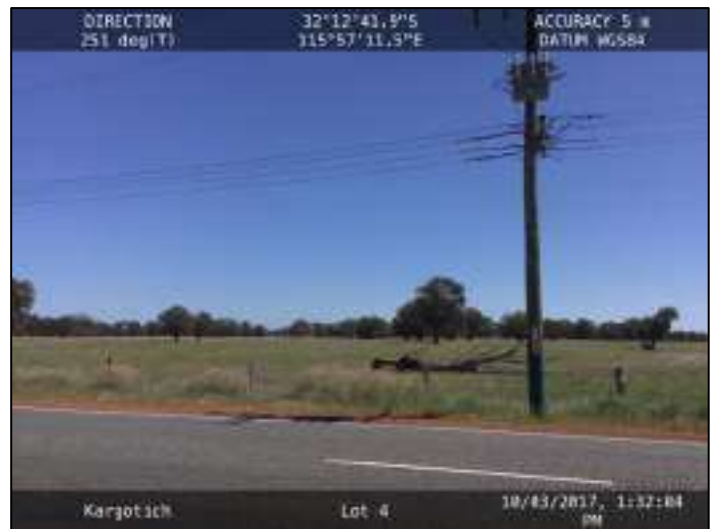
Photo No 18 Plot No 12

Grazed pasture on adjoining land on the western side of Kargotich Road.

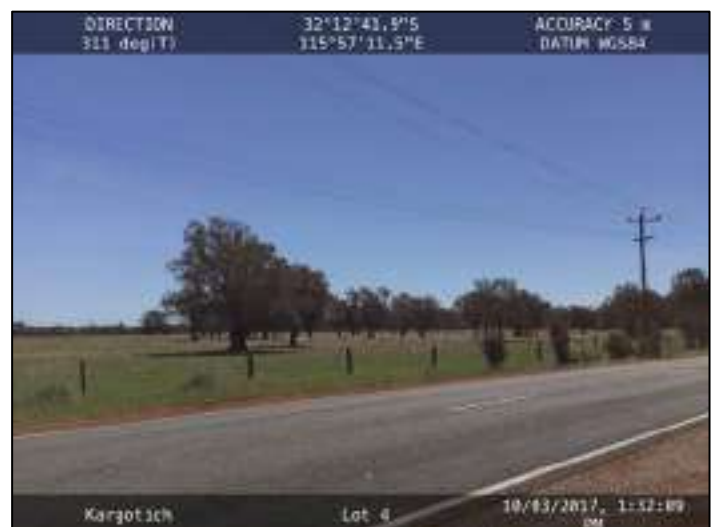
Sheoak woodland to approximately 10m in height with sparse low foliage coverage and grazed pasture. As Open Woodland it is classified on the basis of the understorey vegetation which is Class G Grassland.

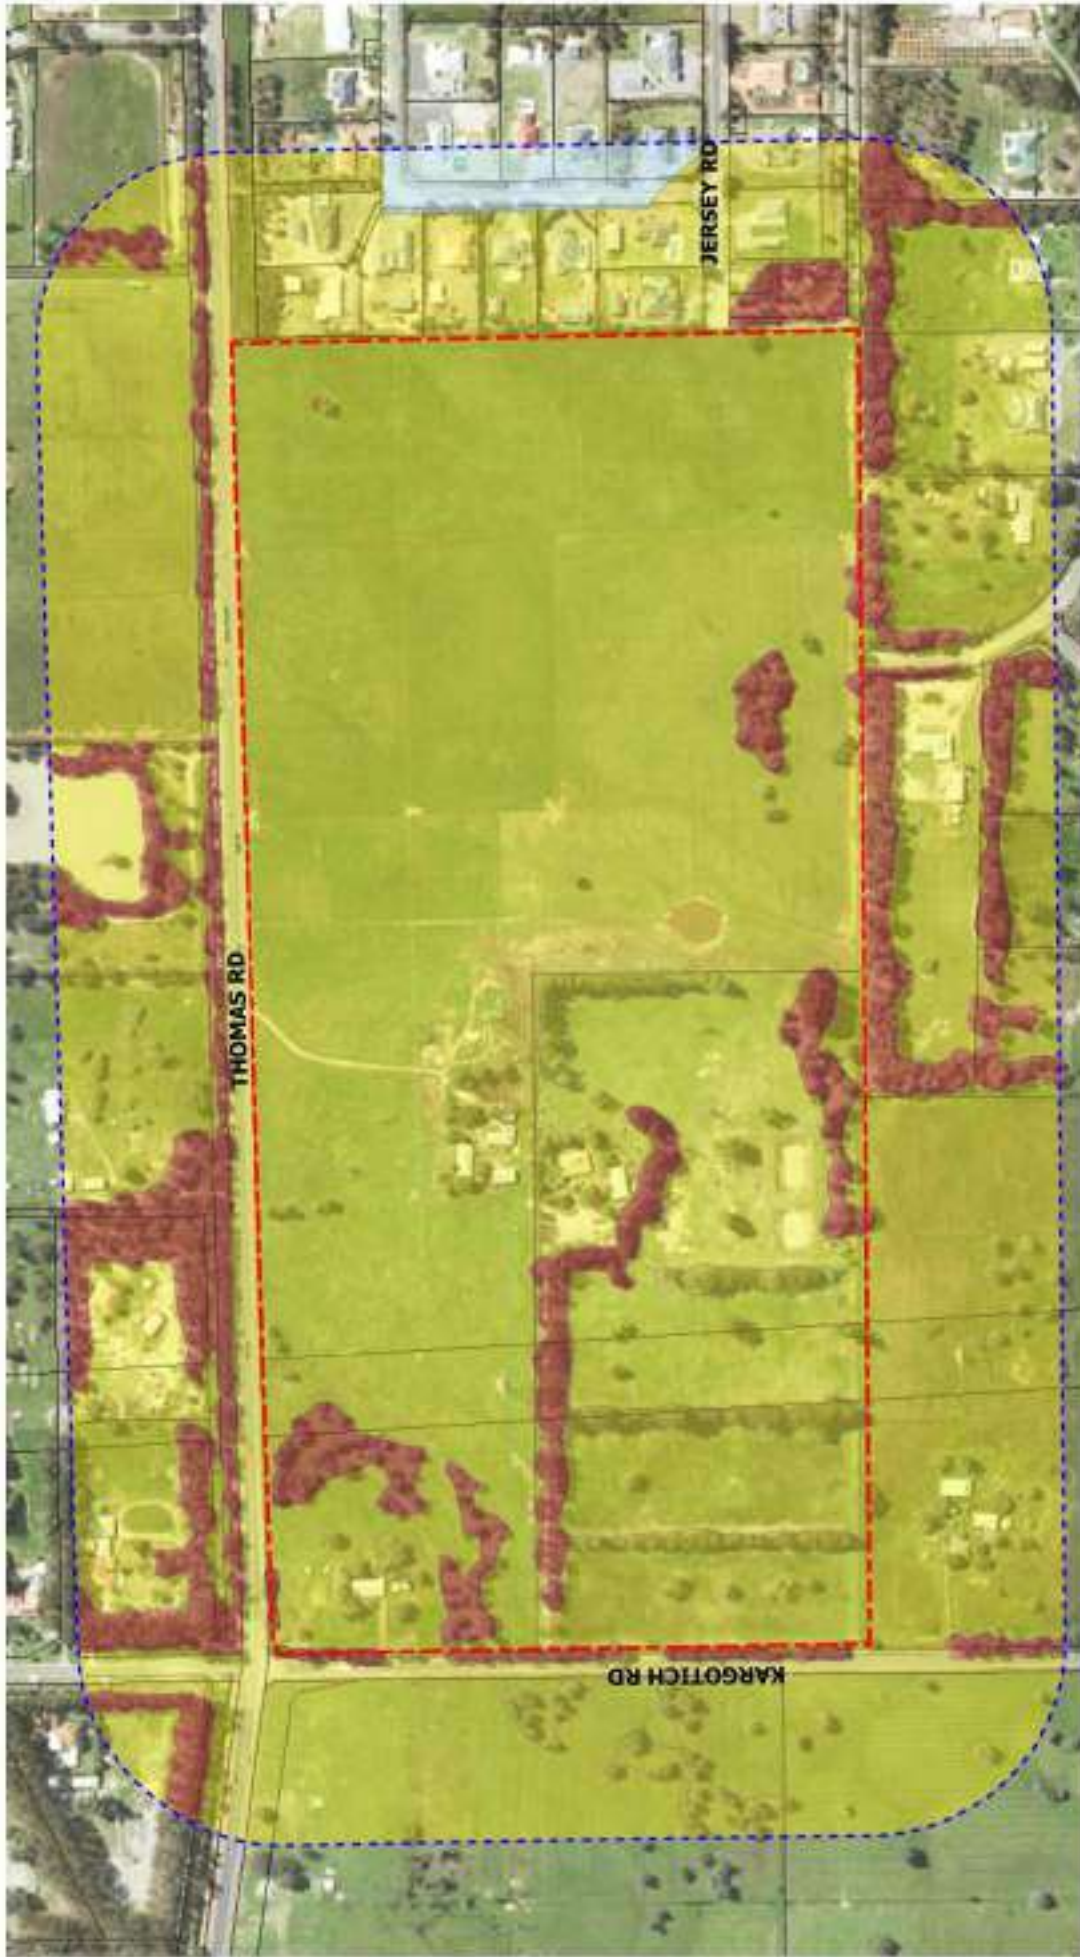
The bushfire hazard levels for the subject land are shown in Figure 7. The bulk of the land has a moderate hazard rating associated with the existing pasture areas. The existing bushland vegetation has an extreme hazard rating.

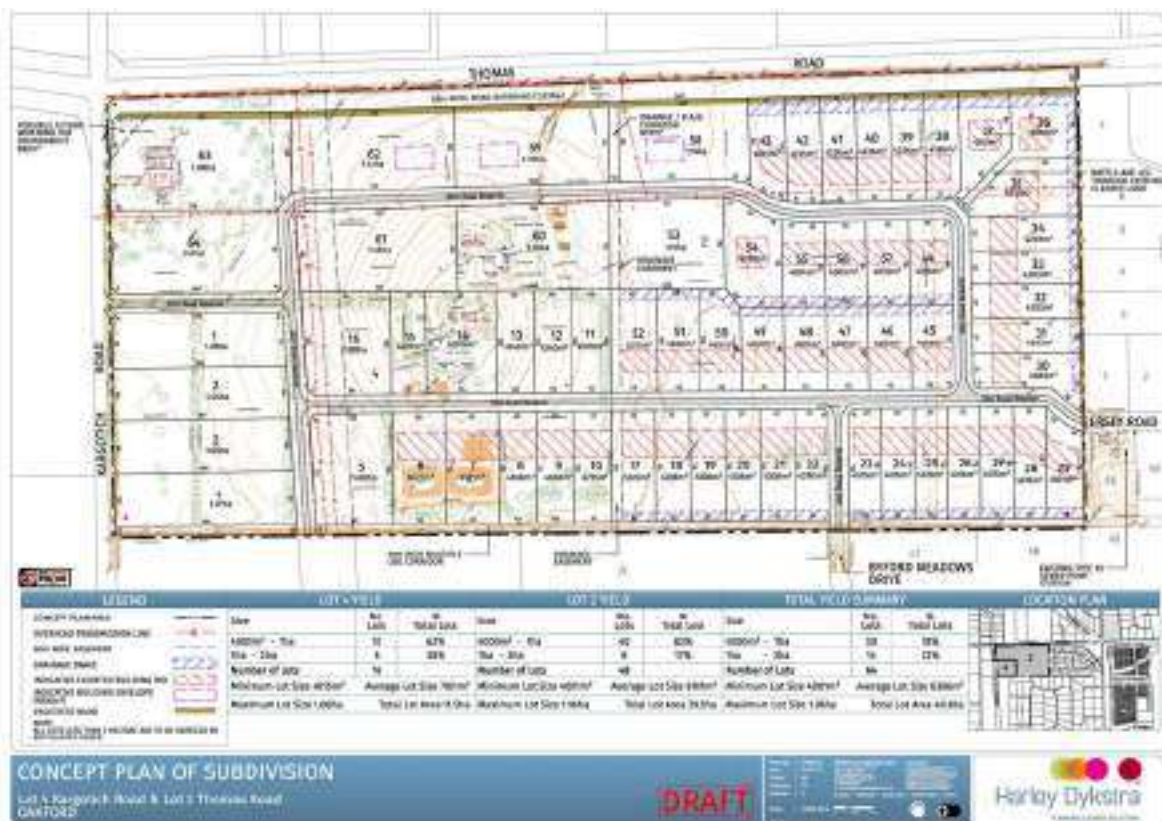
Figure 1-3 Subdivision Concept

Figure 1-2 provides the proposed structure plan with *Figure 1-3* showing the subdivision concept.
