LOCAL STRUCTURE PLAN

Lot 2 Thomas Road & Lot 4 Kargotich Road, Oakford

This structure plan is prepared under the provisions of the Shire of Serpentine-Jarrahdale Town Planning Scheme No. 2.

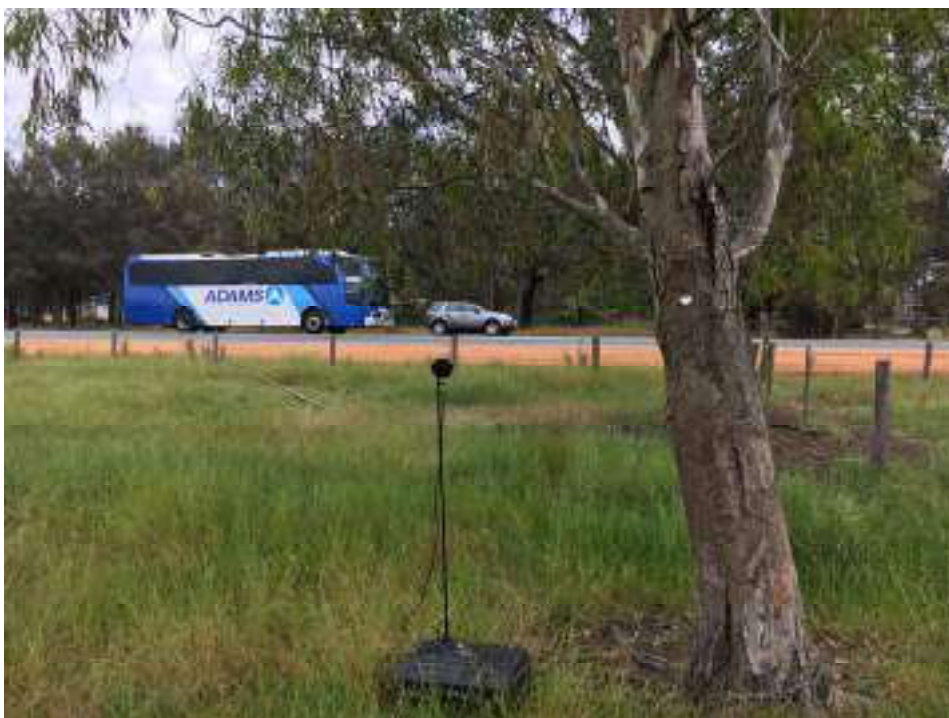
Figure 3-1 Photograph of Noise Data Logger

The instrument used was an ARL Ngara Type noise data logger, located approximately 30 metres from the edge of the road, with the microphone 1.4 metres above ground level. The logger was programmed to record hourly L_{A1} , L_{A10} , L_{A90} , and L_{Aeq} levels. This instrument complies with the instrumentation requirements of *Australian Standard 2702-1984 Acoustics – Methods for the Measurement of Road Traffic Noise*. The logger was field calibrated before and after the measurement session and found to be accurate to within +/- 1 dB. Lloyd George Acoustics also holds current laboratory calibration certificate for the loggers.

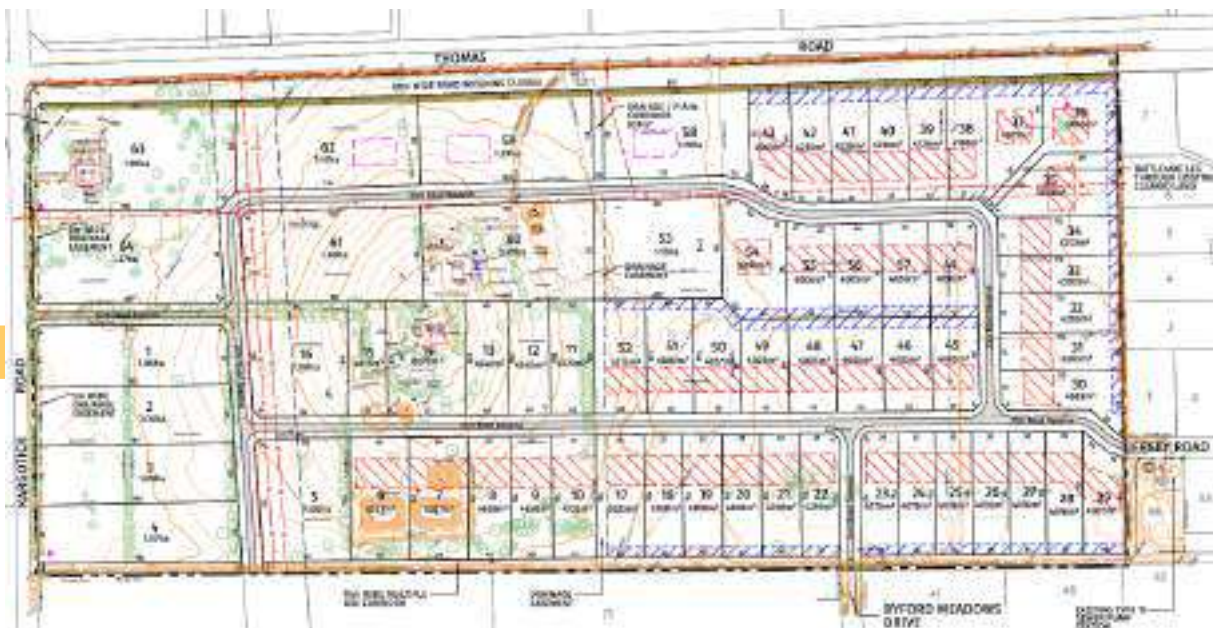
Below is an extract of the development layout as prepared by Harley Dykstra (21396-011). This shows a mix of lot sizes ranging from 4,000m² along the eastern side to 2ha along the west.

The road network provides frontage to all lots and connects in with existing Jersey Rd (west), Byford Meadows (south) and provides for a future connection via a road parallel to Kargotich. Consistent with the existing development to the east, it is likely the road network will be elevated above the natural surface and will comprise of a sealed pavement with shoulders. It is likely the intersections will be kerbed with appropriate treatment as needed.

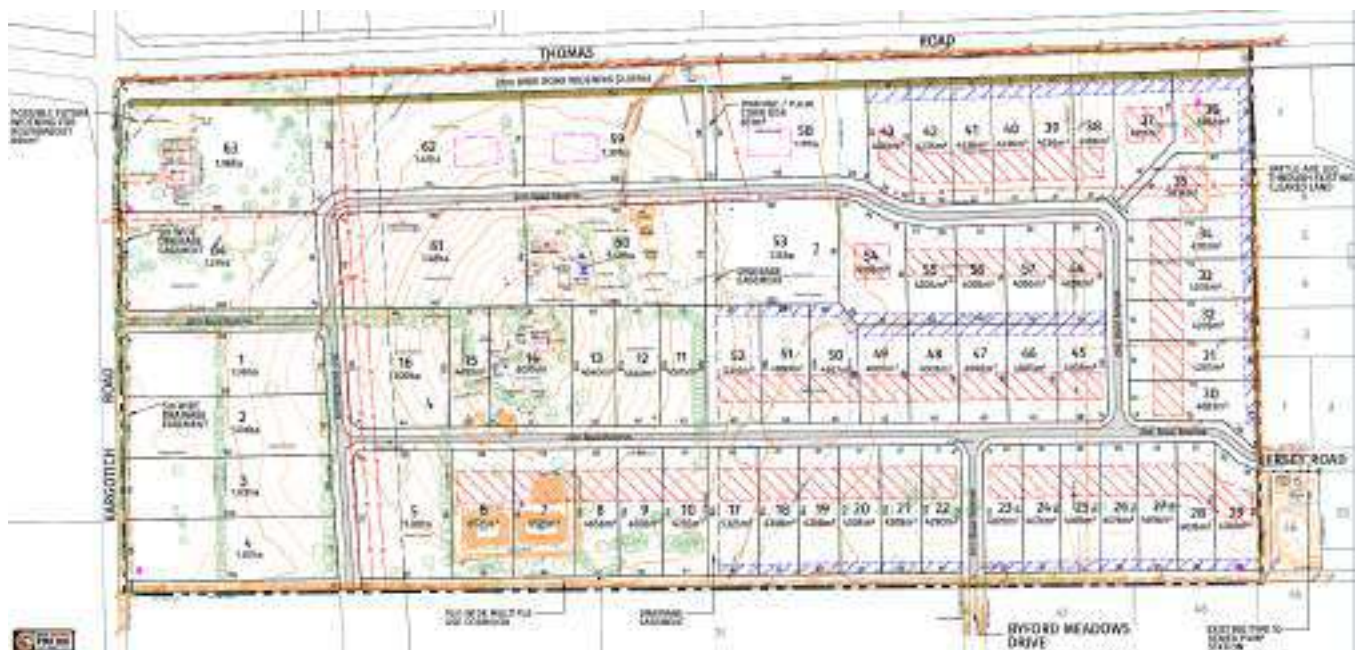
The proposed road network includes the westerly extension of Jersey Road (which currently services the Rural Living A subdivision to the east) and the northern extension of Byford Meadows Drive which connects to Abernethy Road. The proposed subdivision concept plan is shown in Figure 4.

Figure 4 Proposed concept plan of subdivision (source: Harley Dykstra, August 2019)

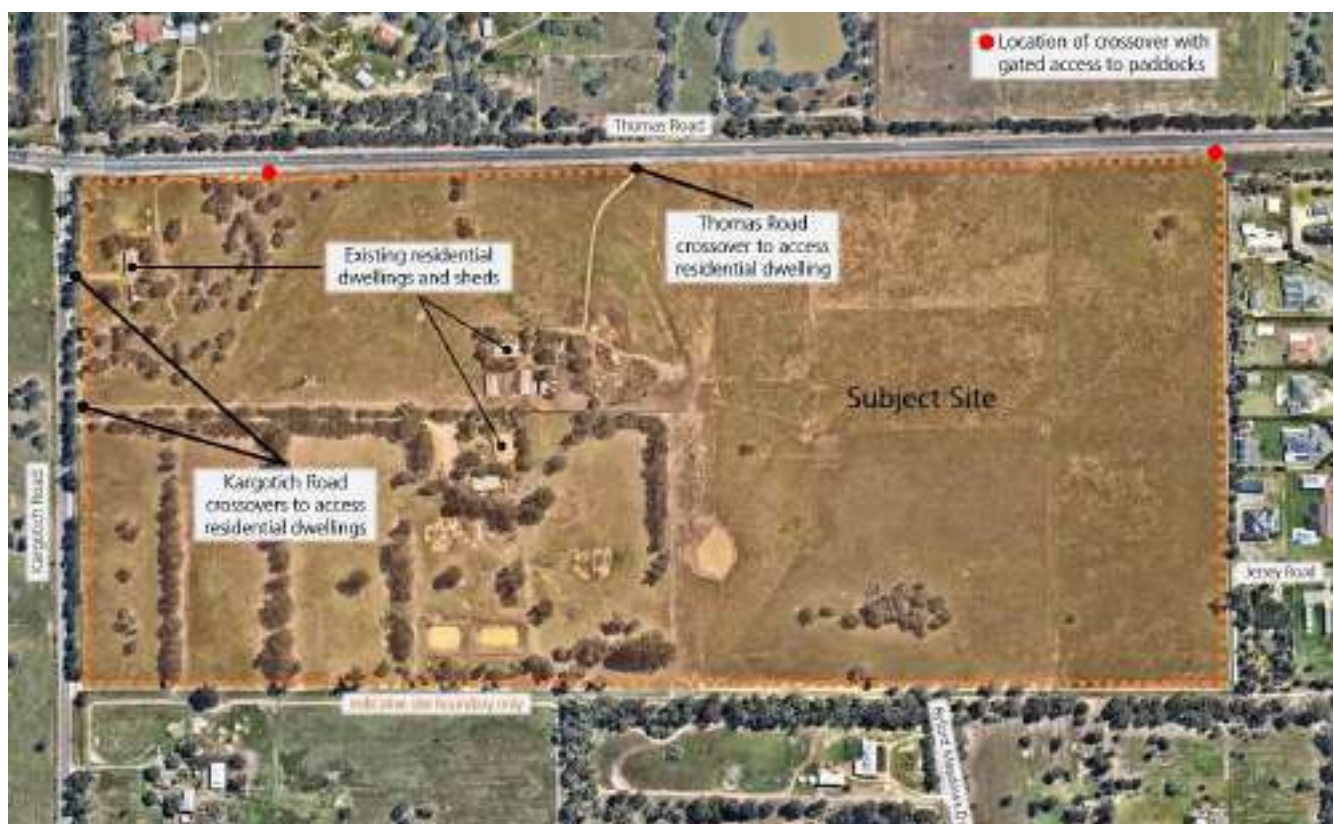
All points of existing vehicular access to the subject site are shown in Figure 6.

Figure 6 Existing crossovers providing access to the subject site (map source: Nearmap)

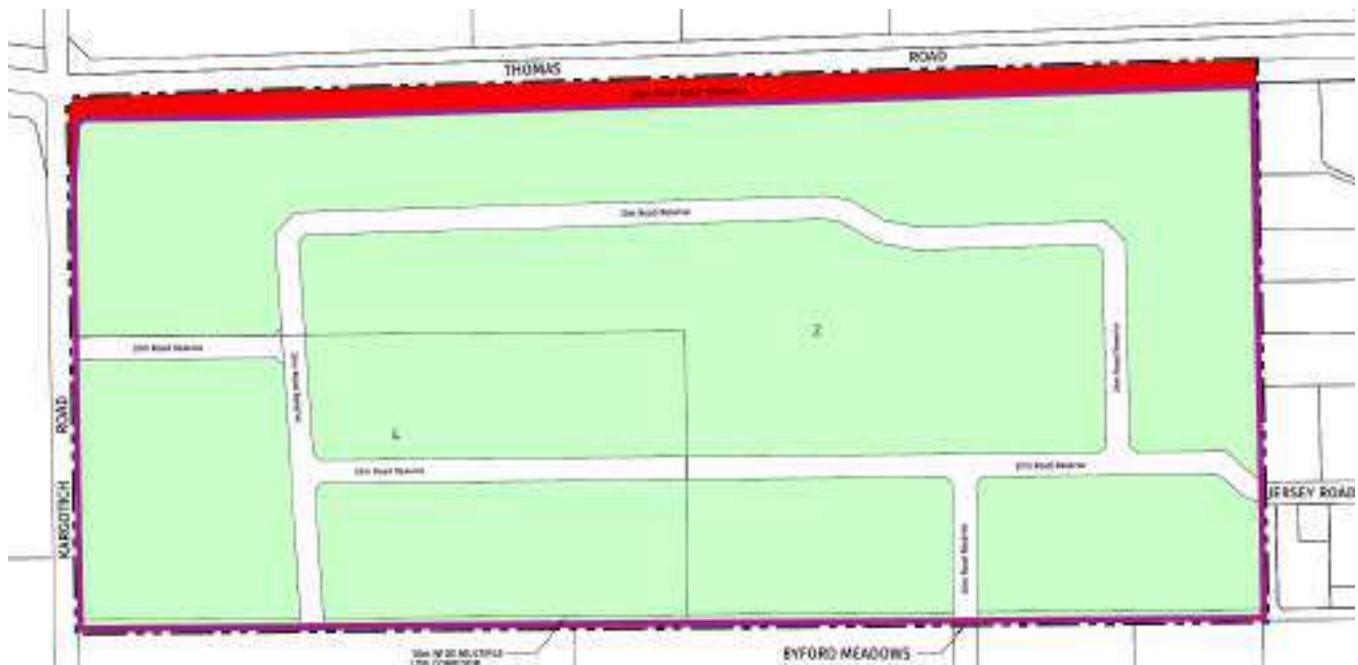
The internal road network is shown in the proposed Structure Plan, reproduced in Figure 10.

Figure 10 Proposed internal road network within subdivision concept plan (source: Harley Dykstra, July 2019)

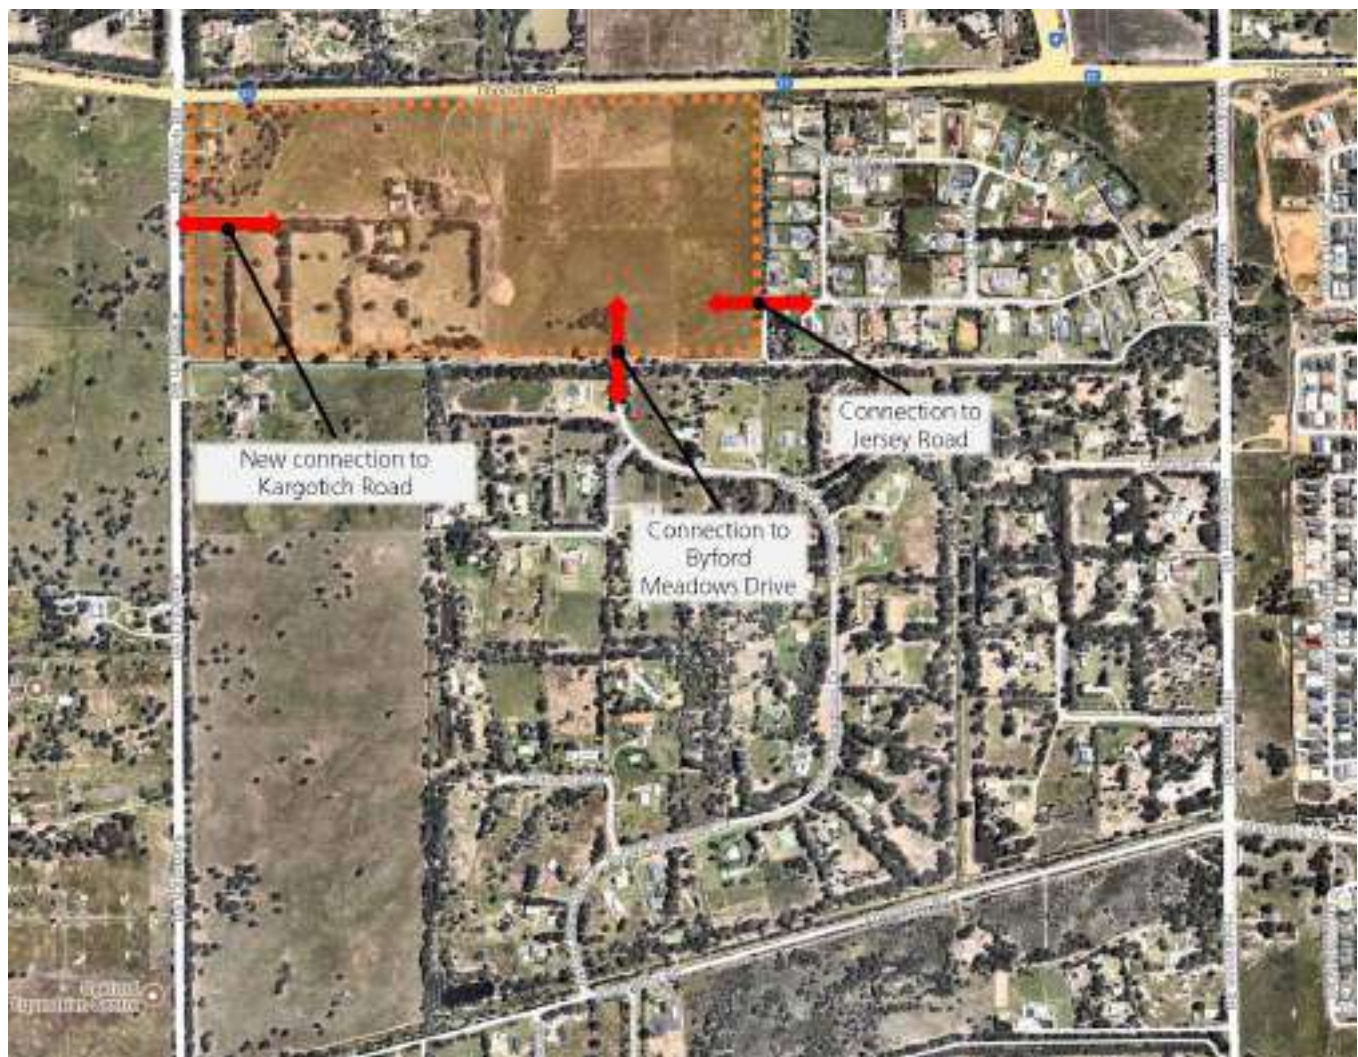
It is proposed that the internal road network will have three connections to the external road network. The three proposed connections to the external road network are explained below and shown in Figure 11 and Figure 12.

- New local road connection to Kargotich Road (proposed) – the internal subdivision road network will be directly connected to Kargotich Road through a local connection of approximately 180m in length. This local road will intersect with Kargotich Road approximately 220m to the south of Thomas Road. From Kargotich Road both Thomas Road and Abernethy Road can be accessed.

Figure 11 Proposed access arrangements for the subject site shown on aerial image (map source: Nearmap)

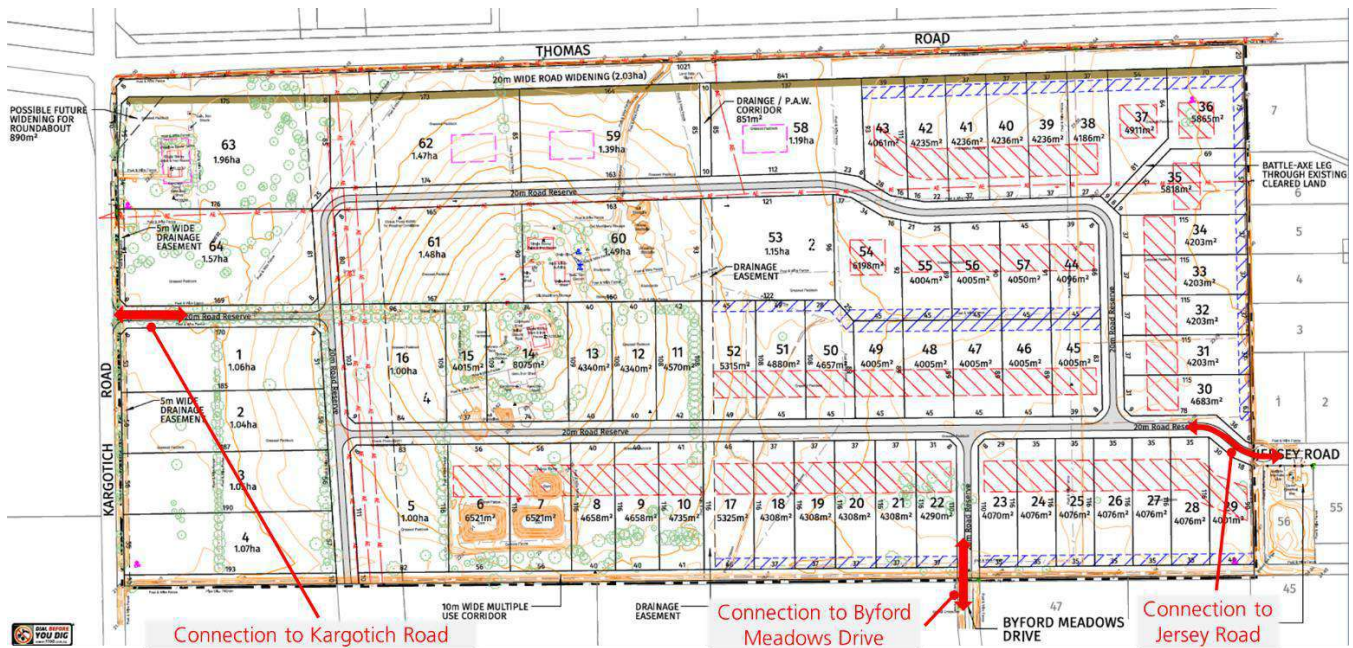
Figure 12 Proposed external access arrangements (source: Harley Dykstra, May 2019)

The proposed local road connection to Kargotich Road will take the form of a priority controlled T-intersection. The Kargotich Road north and south approaches to the intersection with the local road connection will require left and right turning deceleration lanes given its classification as a Regional Distributor road. It is also likely the speed limit of Kargotich Road will reduce to 80km/h between the intersection with Thomas Road and to the south of the intersection with the local road connection.

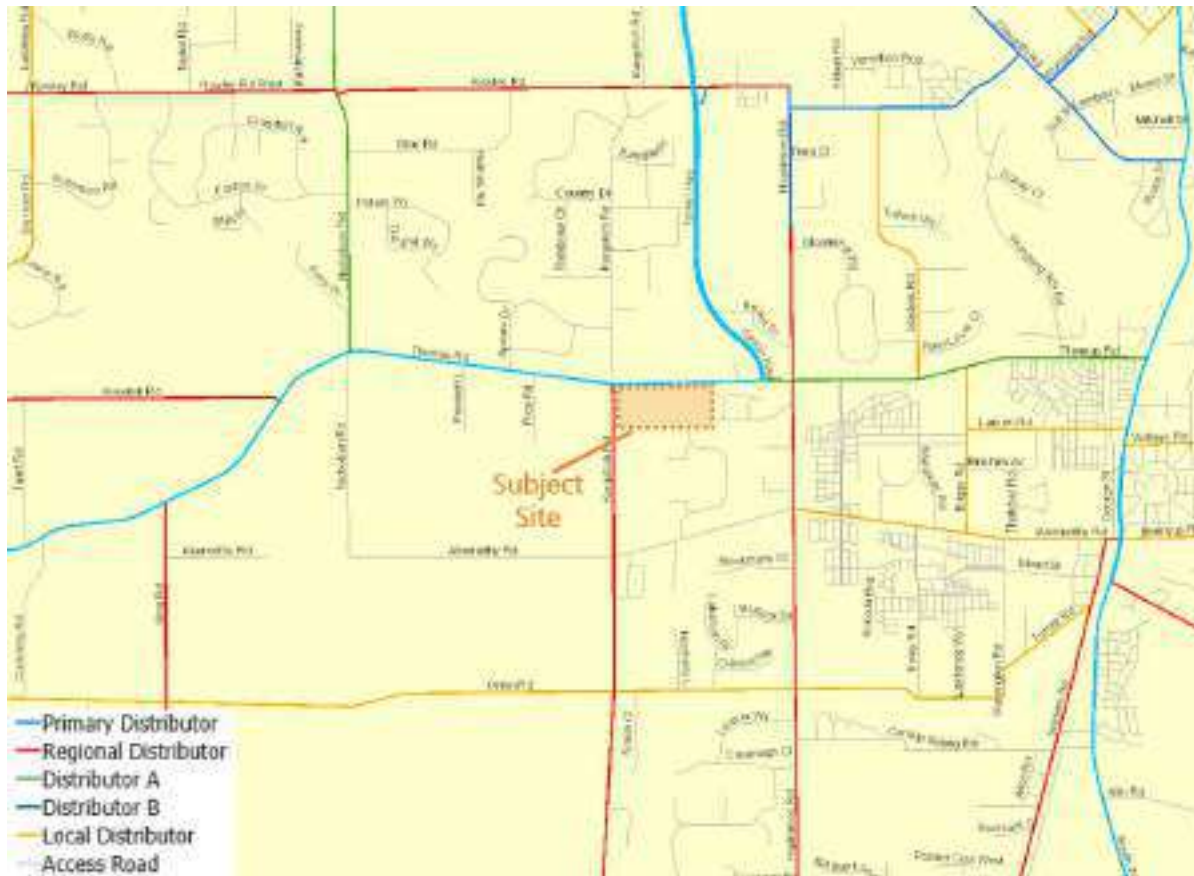
Figure 13 shows the location of the subject site in relation to the designation of roads within Main Roads WA Road Hierarchy, and Figure 14 shows the posted speed limits on the road network surrounding the site.

Figure 13 Location of subject site within Main Roads WA Road Hierarchy (source: Main Roads WA)

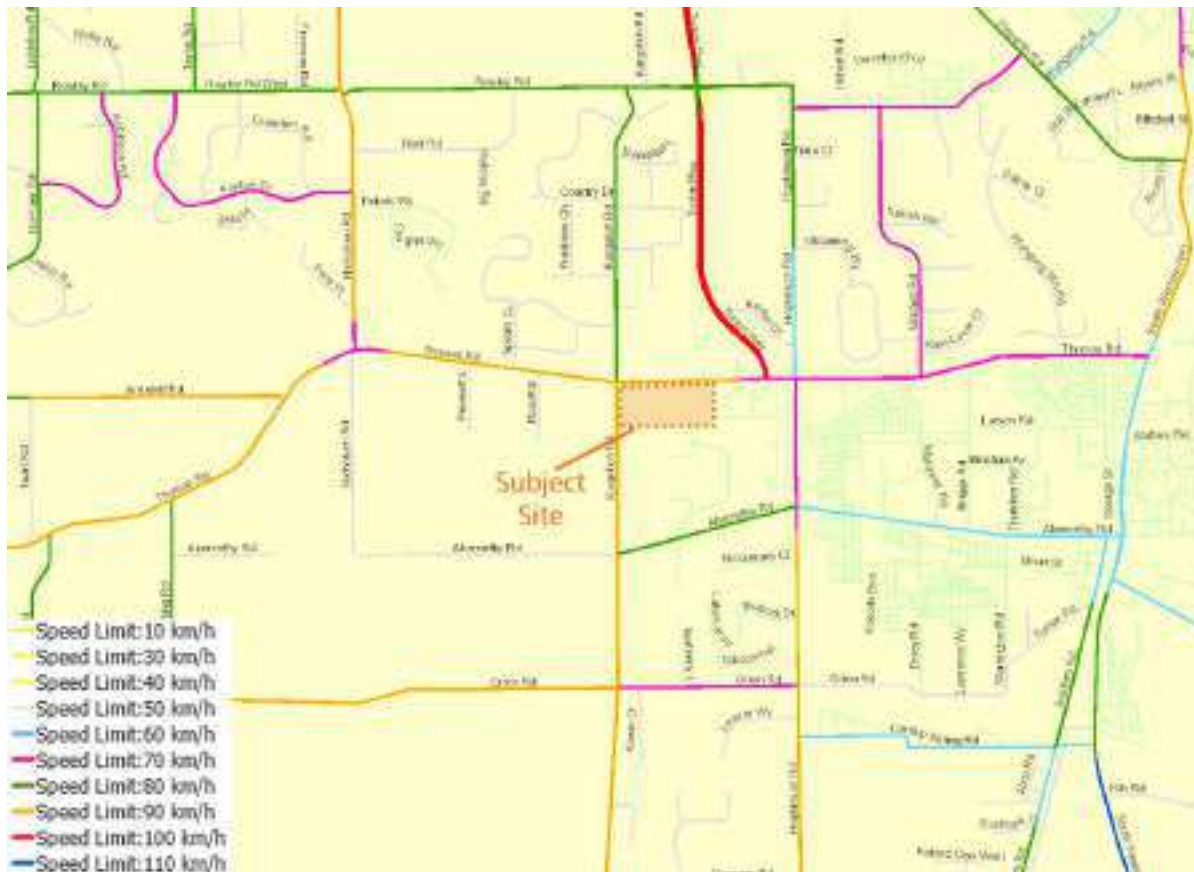
Figure 14 Posted speed limits on road network surrounding the subject site (source: Main Roads WA)

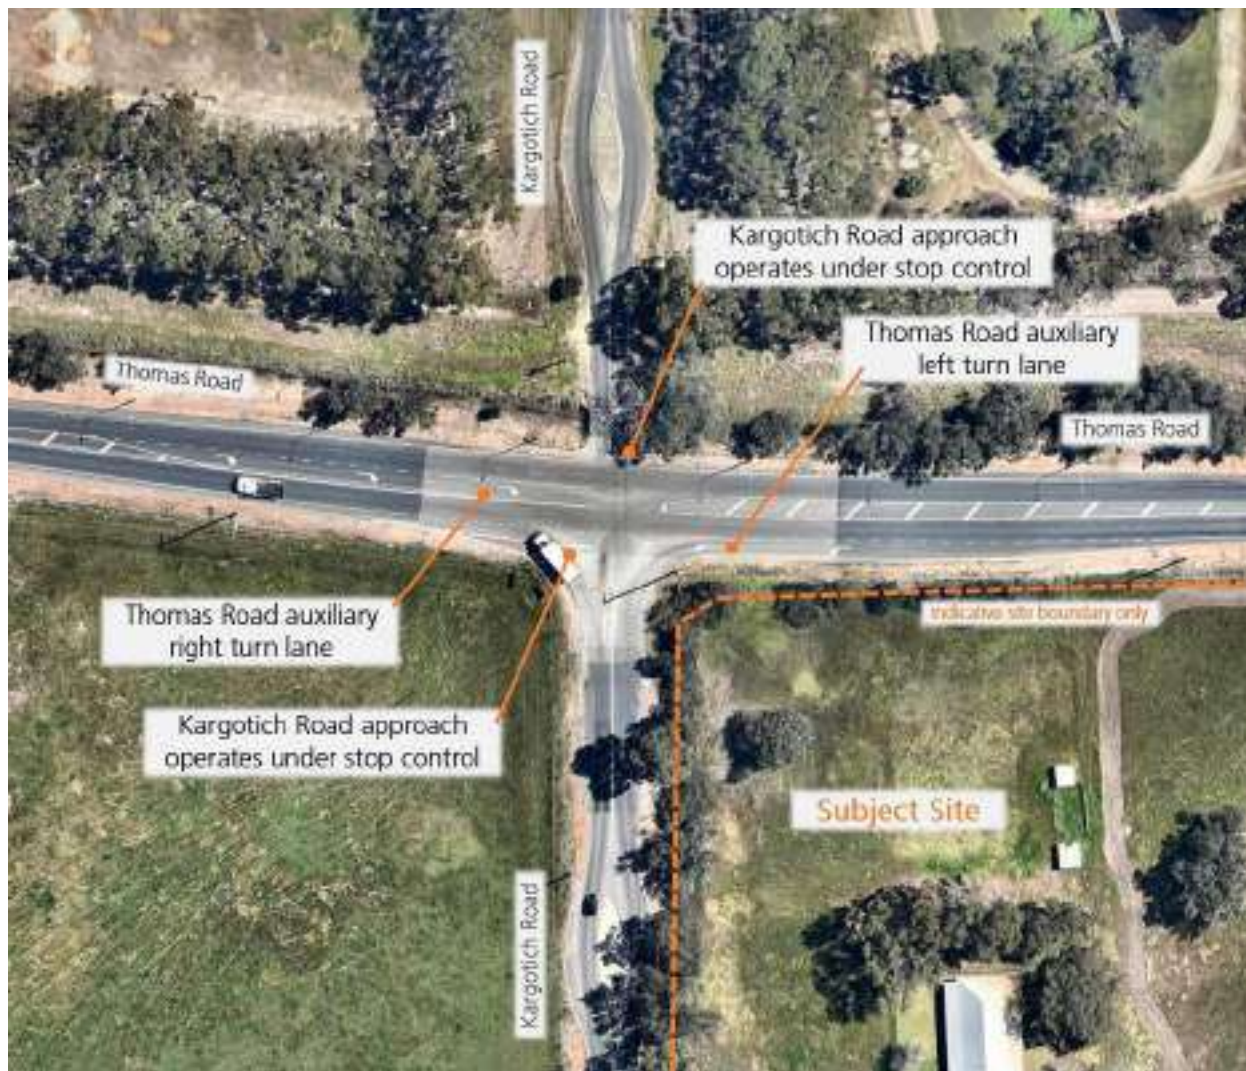
The intersection of Thomas Road and Kargotich Road is within immediate proximity of the subject site. The intersection is four-way with stop sign control. Thomas Road has priority with vehicles travelling along Kargotich Road approaching Thomas Road are required to stop before continuing if it is safe to do so.

The configuration of the Thomas Road and Kargotich Road intersection is shown in Figure 15 and the two blister island treatments on the Kargotich Road approaches to the intersection are shown in Figure 16.

Figure 15 Crossroads intersection of Thomas Road and Kargotich Road (map source: Nearmap)

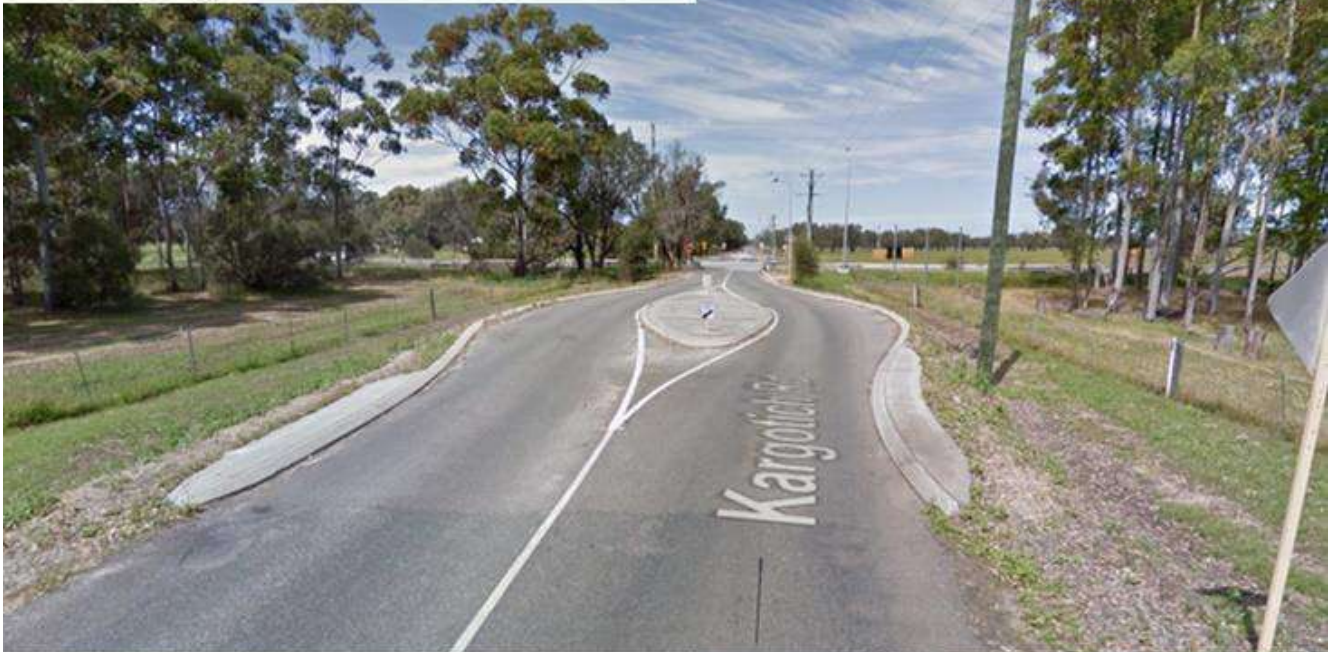
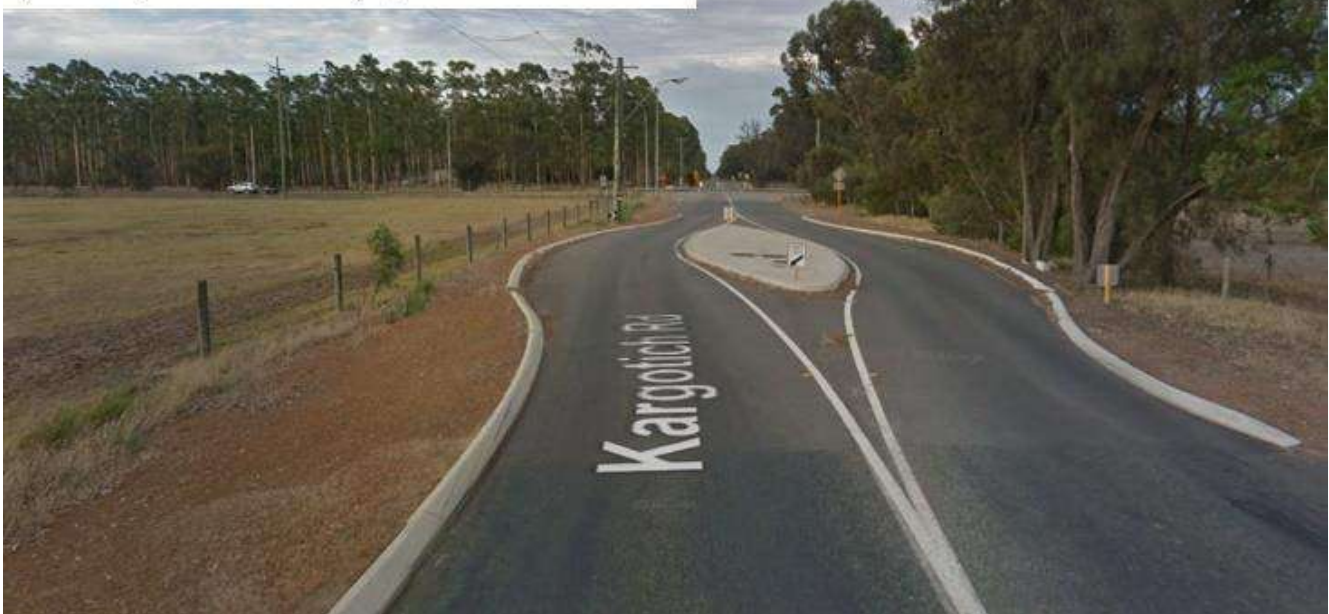
Figure 16 Blister island treatments on Kargotich Road approaches to Thomas Road (source: Google Street View)

Kargotich Road (north) – view of blister island on southbound approach to Thomas Road intersection

Kargotich Road (south) – view of blister island on northbound approach to Thomas Road intersection (with subject site on the right)

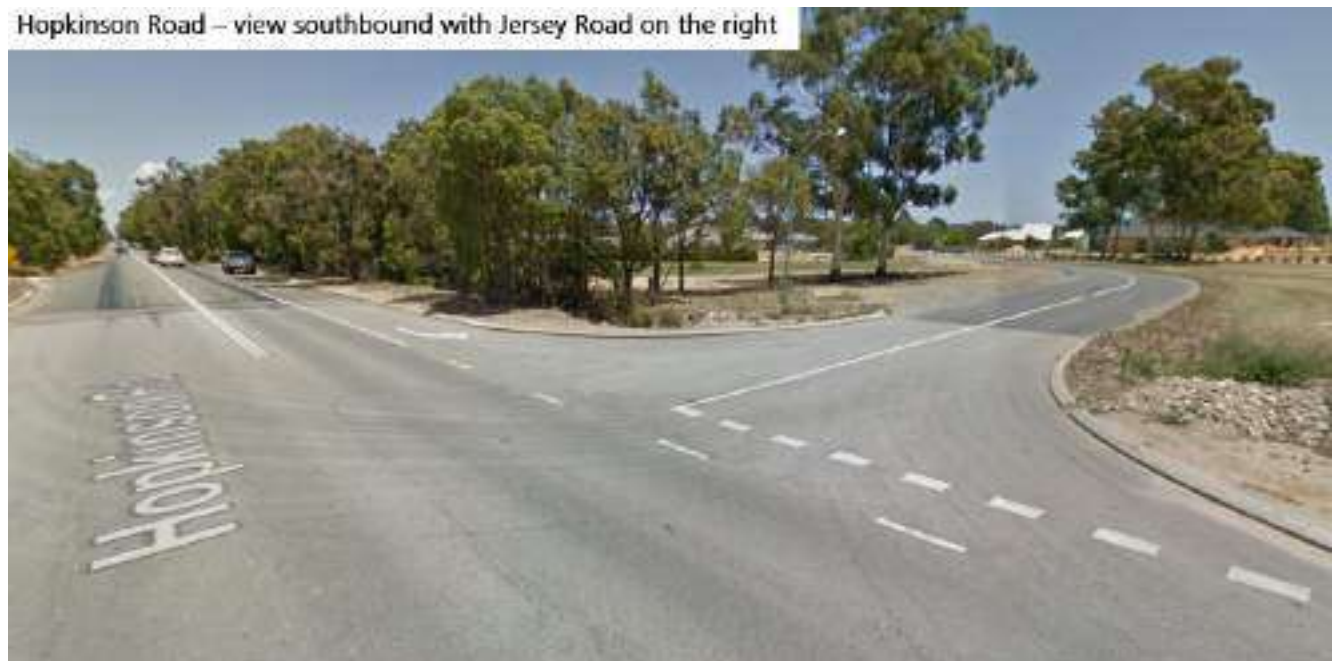
Hopkinson Road features a northbound left turn auxiliary lane of approximately 75m, which enables northbound vehicles on Hopkinson Road turning left and traveling westbound on Jersey Road, to safely deaccelerate outside of the northbound through lane on Hopkinson Road. The intersection is shown in Figure 17.

Figure 17 Jersey Road and Hopkinson Road intersection (source: Google Street View)

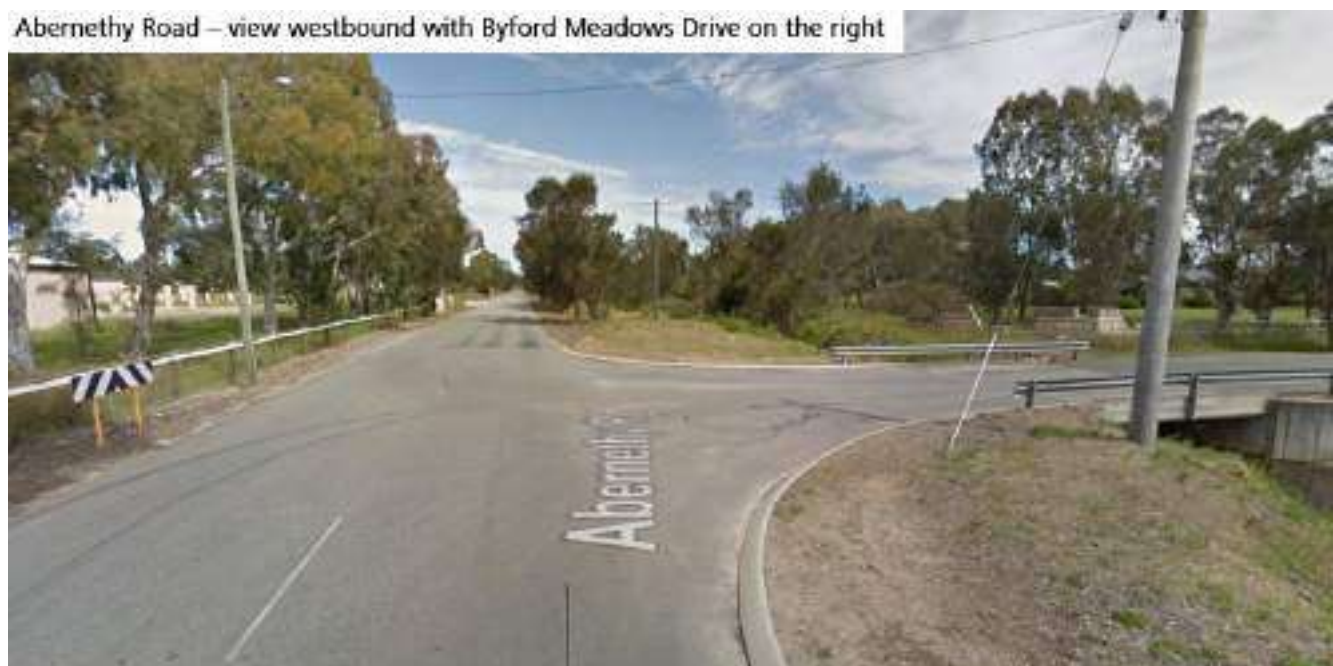
The intersection of Byford Meadows Drive and Abernethy Road is an uncontrolled T-intersection with Abernethy Road having priority and Byford Meadows Drive forming the minor arm of the intersection. Vehicles travelling along Byford Meadows Drive approaching Abernethy Road are required to stop before continuing if it is safe to do so. The intersection is shown in Figure 18.

Figure 18 Byford Meadows Drive and Abernethy Road intersection (source: Google Street View)

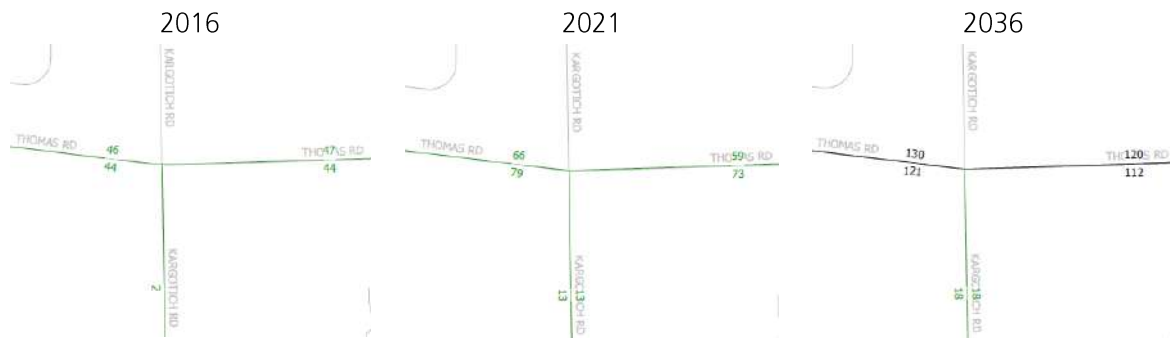
Figure 1 – ROM24 Link Volume Plots for 2016, 2021 and 2036

As shown in Figure 1, the modelled road network for 2016 and 2021 includes Thomas Road and Kargotich Road (south of Thomas Road) with a single lane in each direction and Tonkin Highway terminates at Thomas Road. The 2036 modelled Road network shows Thomas Road with two lanes in each direction with Tonkin Highway extended south of Thomas Road.
