Mundijong Sales Yard

Building and incidental structures inspection report

June 2020

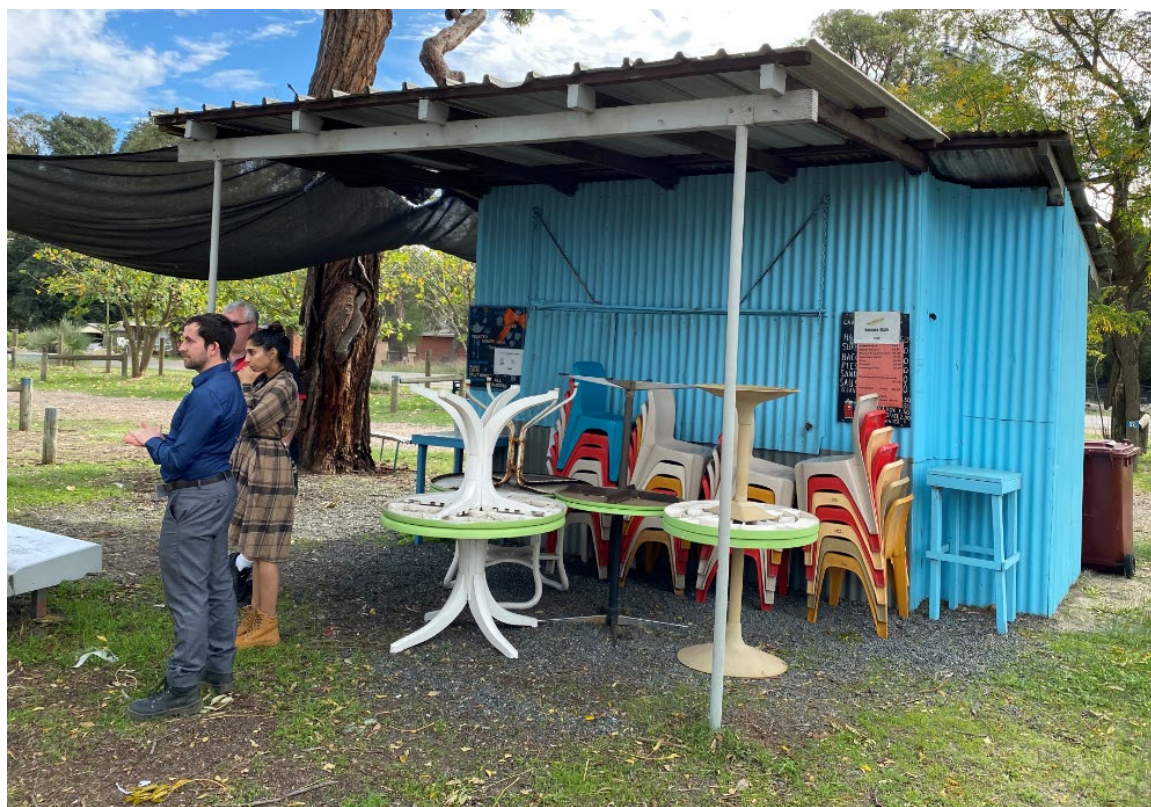
Structure A - Kitchen with server window

Description	Small timber frame structure with corrugated sheet metal cladding. the tenants have advised it is the original building from circa 1965
-------------	---

Addition of a lean to with Steel posts and timber frame with a sheet metal roof. Additional shade cloth hung from side of building to a tree	
Condition	The building appears to be in good condition, solid timbers roof frame in good condition, internal wall lining (if original) may be asbestos based on age. Server y hatch door is hinged horizontally from the top and opens outwards with the hatch door held in place with a chain.

Build date	1965	
Approval	unknown	
Recommendation	<p>Test internal linings for containment of asbestos. Undisturbed asbestos poses a low risk but should be registered.</p> <p>The server hatch door poses a health and safety risk. As it is held up in an open position on a chain, if it fell it could cause an injury to a customer. Replace with a roller door.</p> <p>Remove Shade clothe attached from building to a tree, consider installing a more appropriate structure if required.</p>

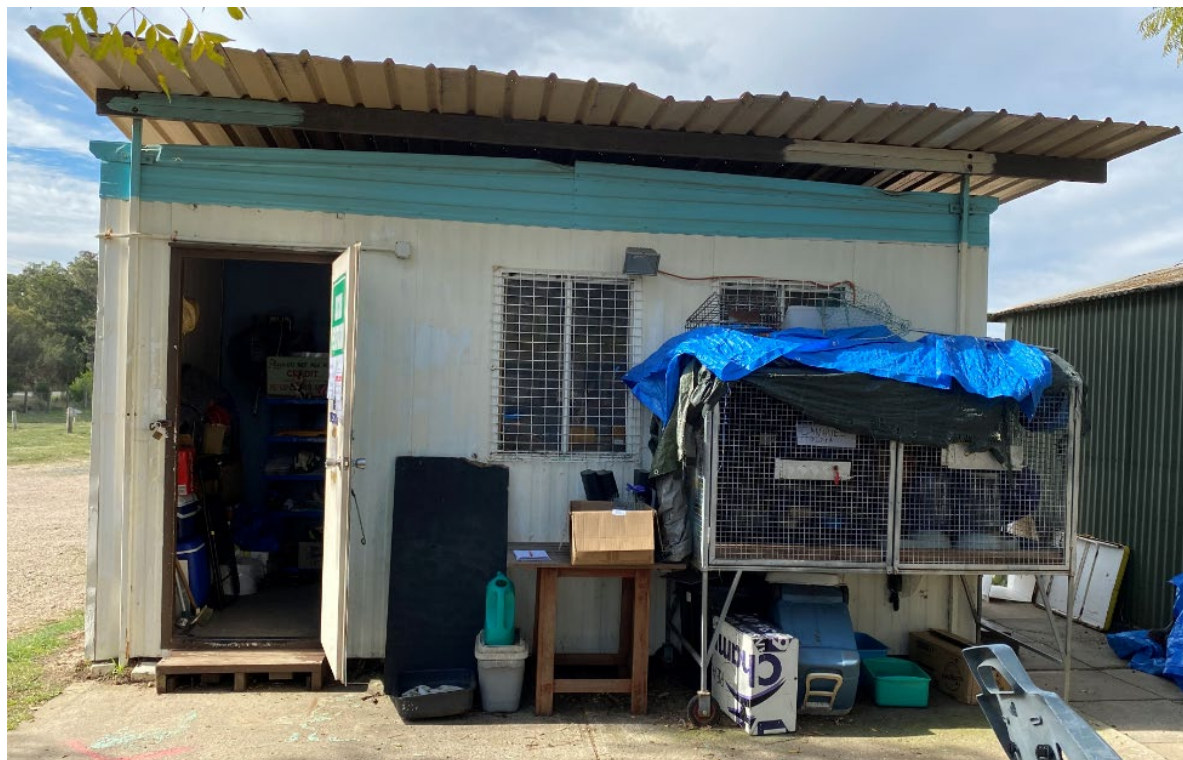
**Structure B - Office building**

Description	Transportable building of timber frame and Structural steel supports, sheet metal external cladding and timber sheet wall lining internally
Condition	Ceiling is sagging and wall lining is deteriorating in places. The building is non-compliant with present day accessibility standards for a class 5 office. (Door Width: 770mm in lieu of 850mm, the entrance height: 190mm step in lieu of a ramp)

Build date	1995
Approval	None on record
Recommendation	Deteriorated internal wall and ceiling lining to be replaced, requires retrospective building approval. Will likely require the widening of the doorway to 850mm clear and install a step ramp to comply with accessibility requirements for an office.

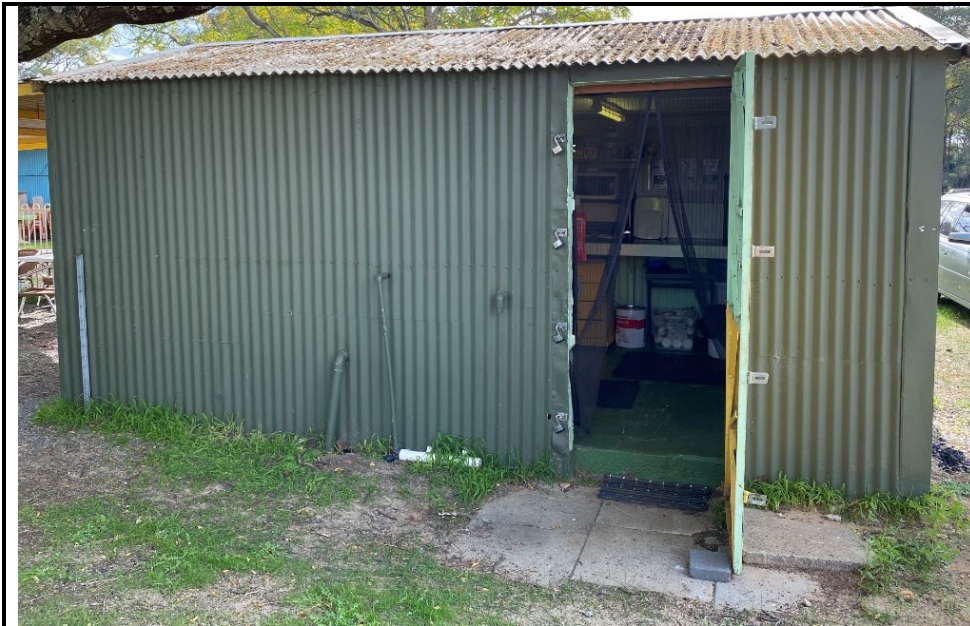
Structure C - Kitchen with server window

Description	Timber frame shed with sheet metal cladding and concrete slab on ground, possible fibre cement sheet roof or asbestos.
Condition	<ul style="list-style-type: none"> – Concrete slab on ground in poor condition, has multiple cracks through it and it is uneven. This building appears to be a shed converted into a commercial kitchen. As a shed, it is unlikely to have a damp proof membrane beneath the slab so water may permeate the slab from below and cause cracking of the concrete due to expansion and contraction. The slab appears to be unusually thick, it is likely a poured slab on top of an existing slab, the door extends approx. 140mm down from finished floor level to finished ground level. Impervious and uneven floors can lead to unsanitary conditions in a food preparation area. – The ceiling level is below the 2.4m required for a habitable space such as a kitchen. – There is no roof gutters so water run-off will fall to the base of the wall, further adding to the issues of the floor slab. – The server door hinged from the top is opened upwards and held open with steel nuts threaded onto bolts protruding downward from ceiling of a lean to structure. This poses a health and safety risk to customers if the nuts were not tightened properly or the thread failed. – The step and door do not comply with today's accessibility standards but may not have been required at the time of construction if an approval is in place.

<p>Server door hinged from the top is opened upwards and held open with steel nuts threaded onto bolts protruding downward from ceiling</p>	
Build date	1974
Approval	unknown
Recommendation	<p>Remove existing floor to ground level if it is found to not be solid concrete and pour a reinforced concrete floor with a damp proof membrane beneath. Finish with a slip resistant linoleum floor covering or washable water resistant coating.</p> <p>Install roof guttering and downpipes which direct storm water to an appropriate disposal method such as a soak well.</p> <p>It is recommended to replace the horizontal hinged server door with a roller door for safety purposes.</p> <p>If retrospective approval is sought then the building would have to comply as a class 6 kitchen by todays standards. The floor, ceiling height and accessibility will require further attention to bring into compliance as well as the installation of a fire extinguisher and consideration to energy efficiency.</p>

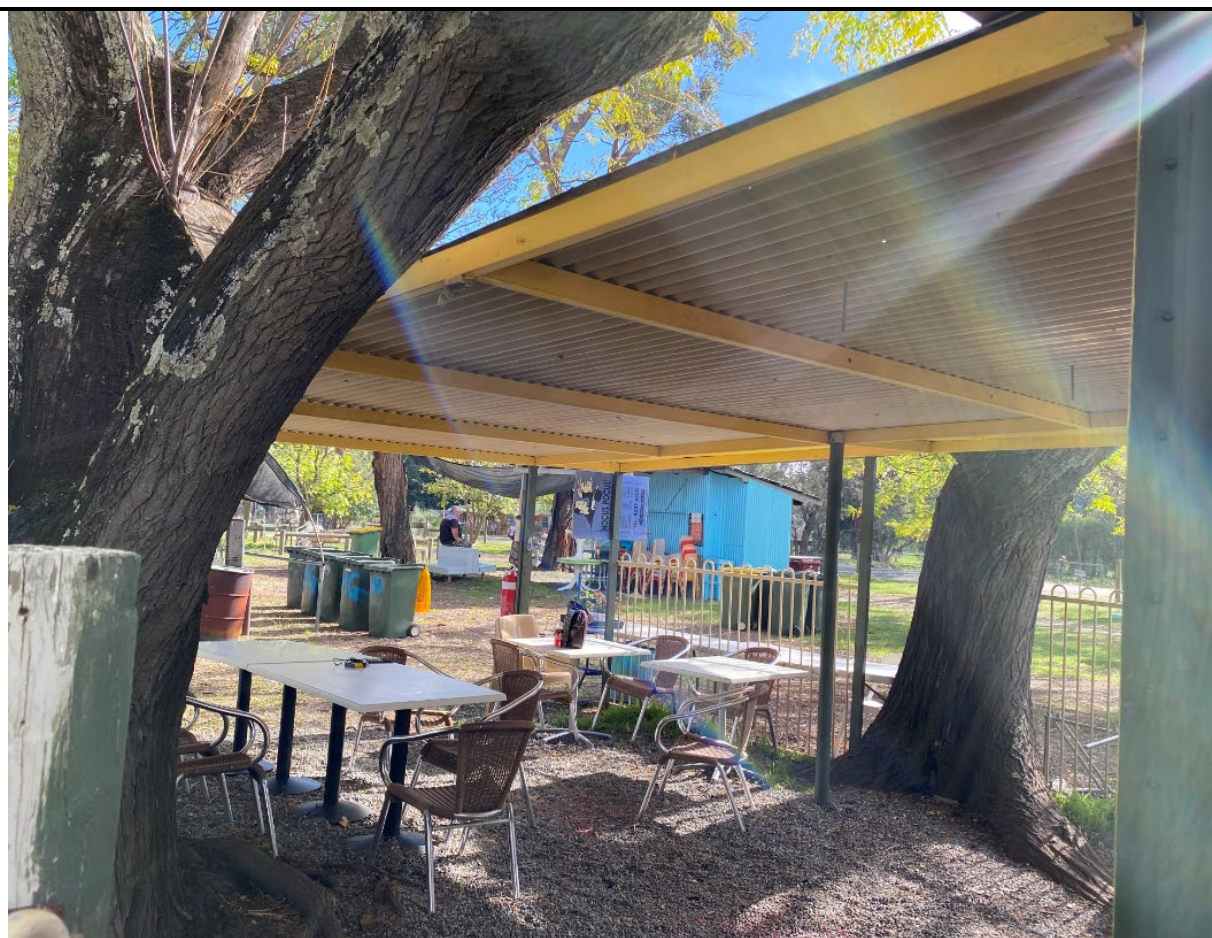
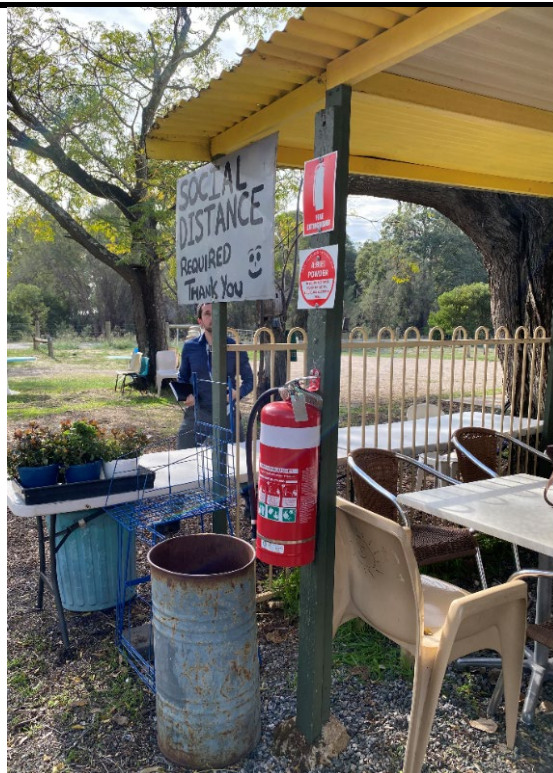
Structure D - Patio area adjoining Kitchen server

Description	A flat roof steel frame patio with sheet metal roof cladding and approx. 75mm x 38mm rectangular steel hollow patio tube posts. The flat roof patio is attached to the kitchen with server building (Structure C) and also attached to the rear of a stock yard Shed (structure E) by a cantilevered attachment
Condition	The structure appears to be in good condition although the steel tubing used as upright columns is generally used as roof beams or rafters with larger square hollow sections used as posts. Structural beams of structure E where patio is attached by Cantilevered attachment is exposed to weather and continue to deteriorate.

Build date	unclear
Approval	None on record
Recommendation	Engage a suitably qualified structural engineer to inspect and certify the patio structure. Modifications may be required in order to certify the structural adequacy of the patio structure. Install roof guttering to capture storm water run-off and direct it away from the footings of any structures such as to a soak well.

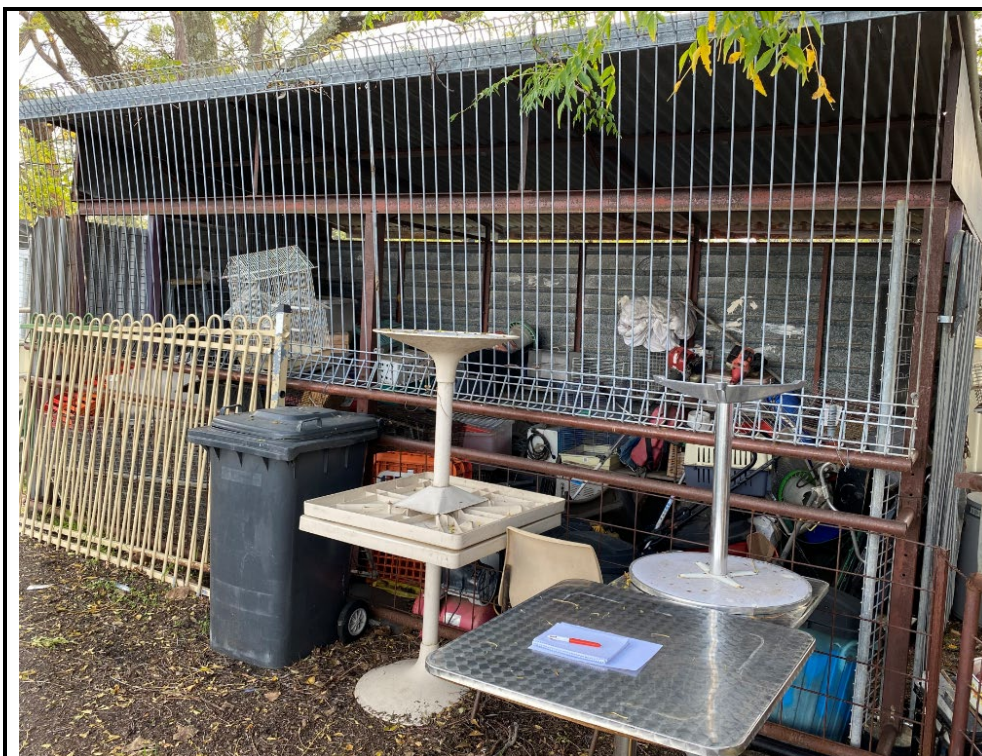
**Structure E - Stockyard Shelter**

Description	Steel frame semi enclosed Structure with a flat roof, sheet metal wall cladding on three sides and a sheet metal roof. The structure appears to be used adhoc for storage.
Condition	The structural frame of hollow square steel columns and C section beams has no rust protection and is severely rusted. Access was not available to view all structural members due to the items being stored

Structural steel post exposed to weather and corroded from inside
Build date	1974
Approval	unknown
Recommendation	<ul style="list-style-type: none"> – Have a suitably qualified structural engineer recommend the members to be replaced and correct sizing of replacement members – Coat the new steel frame with a corrosion resistant paint

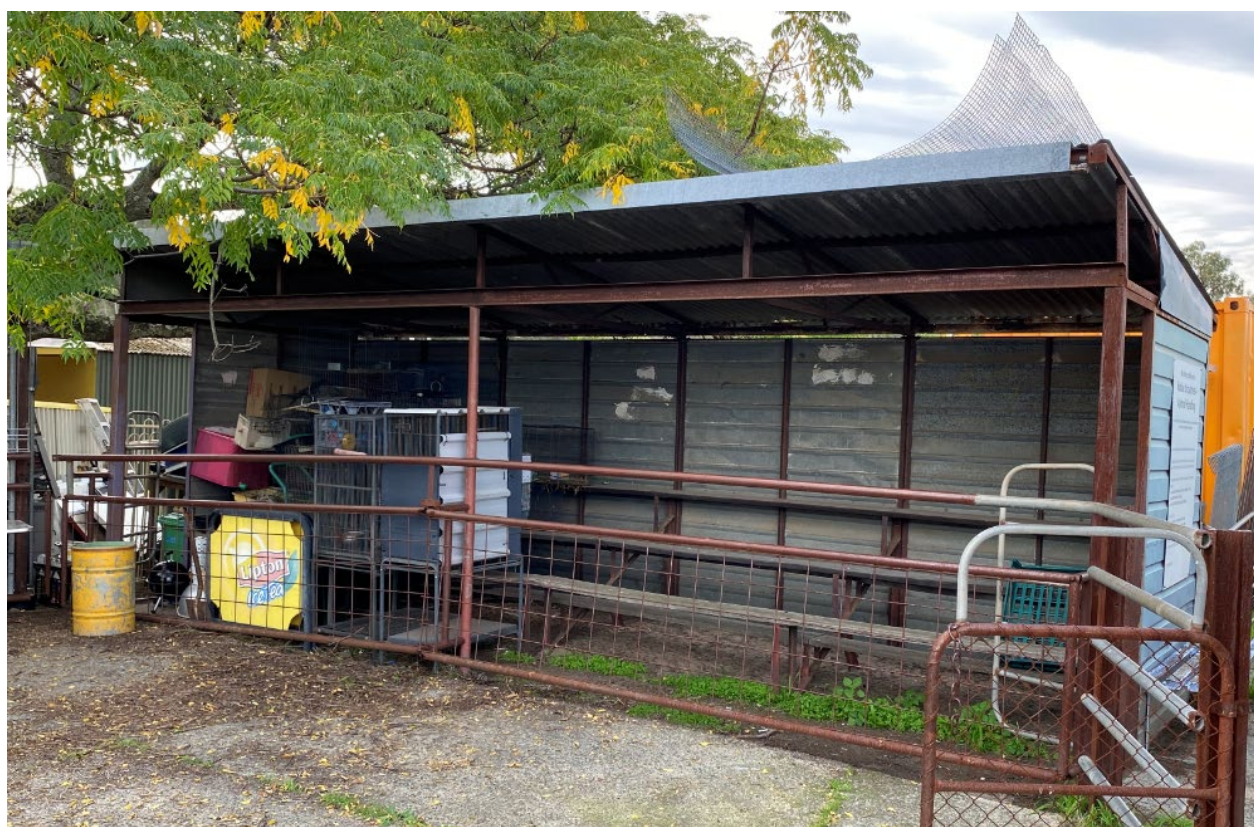
Structure F - second stock yard shelter

Description	Steel frame semi enclosed Structure with a flat roof, sheet metal wall cladding on three sides and a sheet metal roof. Tiered seating of steel frame with timber bench. Part of structure being used for storage
Condition	The structural frame of hollow square steel columns and C section beams has no rust protection and is severely rusted. The base of the column can be physically busted through by hand, corrosion and flaking of the steel has occurred from within the post.

Build date	1974
Approval	Unknown
Recommendation	<ul style="list-style-type: none"> – Do not allow access to members of the public – Have a suitably qualified structural engineer recommend the members to be replaced and correct sizing of replacement members – Coat the new steel frame with a corrosion resistant paint

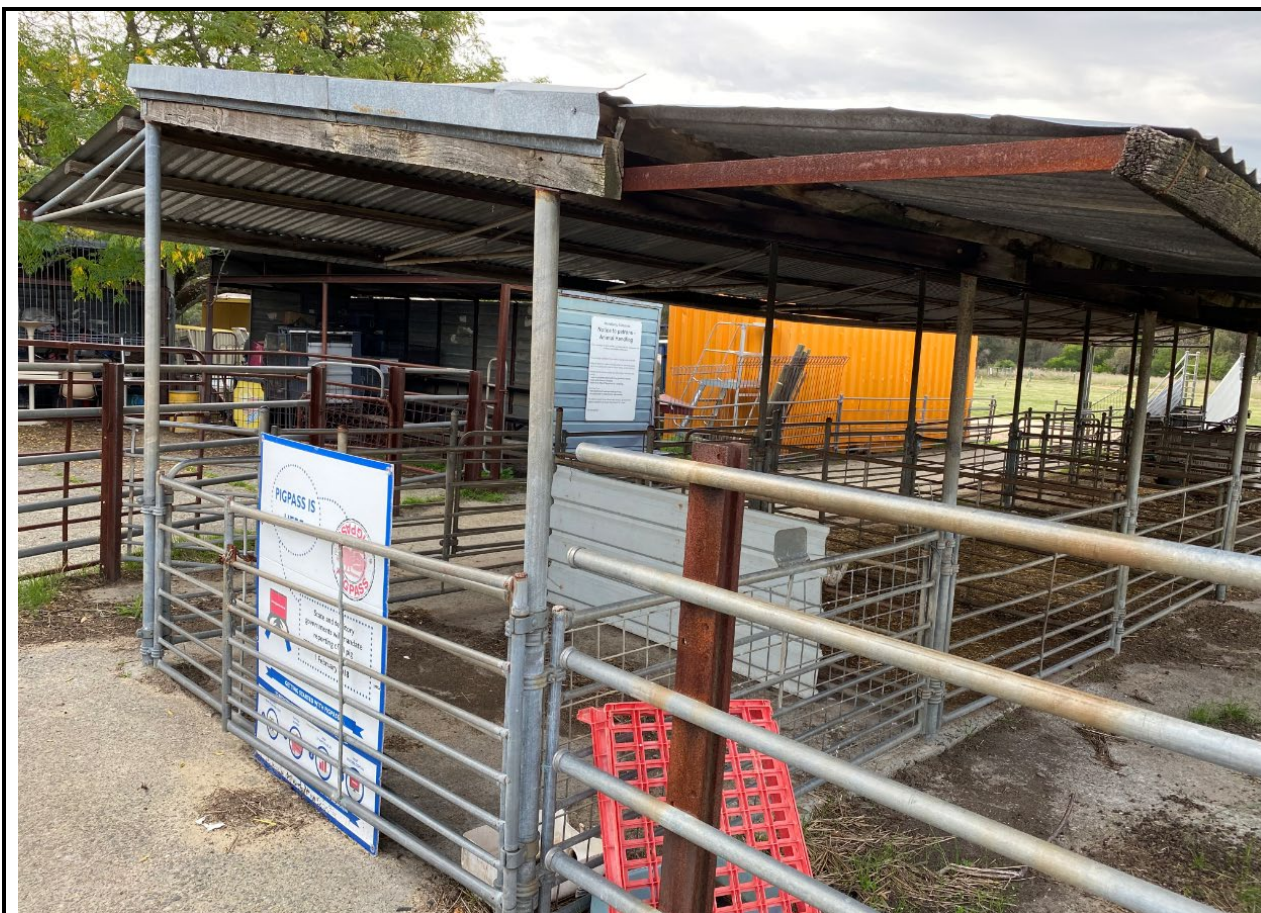
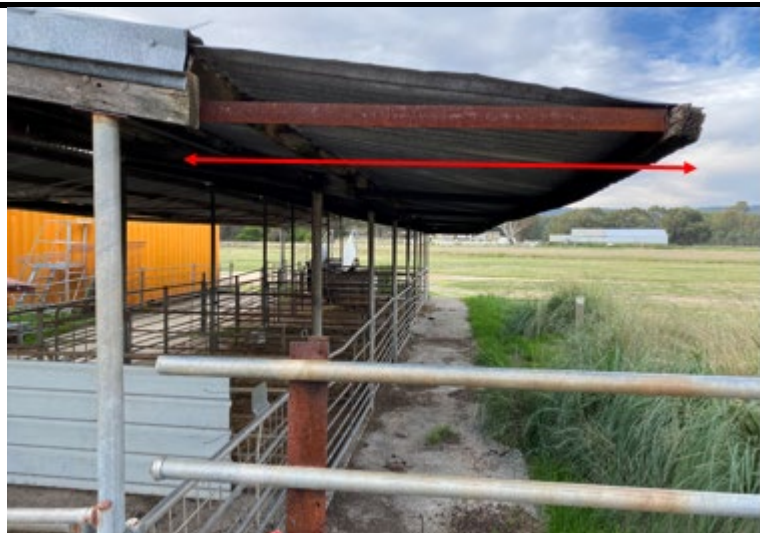
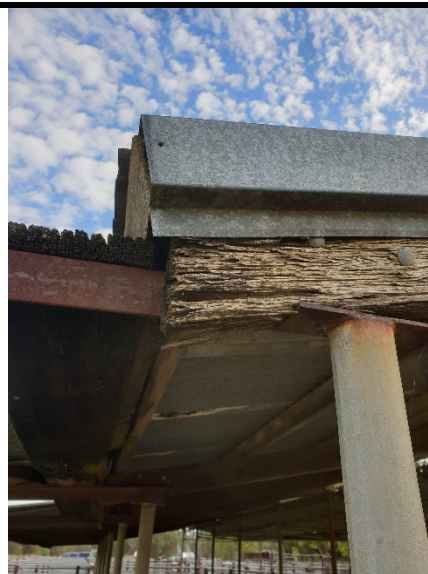
Structure G - Roof covered Stock Yard

Description	Steel posts, steel truss and timber roof beam structure low pitch gable roof with cantilevered lean-to roof additions, all with sheet metal cladding
Condition	<ul style="list-style-type: none"> – The steel frame live-stock pens and gates are in good condition. – The roof is missing sheets in places, – Roof gutters sagging in places – structural timbers are rotten and deteriorated – it appears some posts and roof truss members may have been installed as replacement members – there is a lean-to type roof structure that is cantilevered 1.37m in length from the post – it is unclear where any wash down of the sales yard concrete pad goes to. There would be animal droppings and urine that would be hosed to a suitable drainage containment point as opposed to direct drainage into the soil

Build date	1974
Approval	unknown
Recommendation	<ul style="list-style-type: none"> – Remove any deteriorated roof timbers. – Have a suitably qualified structural engineer inspect the existing steel frame for compliance and recommend sizes of any required replacement members – Check fasteners of sheet metal roof and ensure – Further investigation required into where wash down water is drained to or how animal waste is disposed of

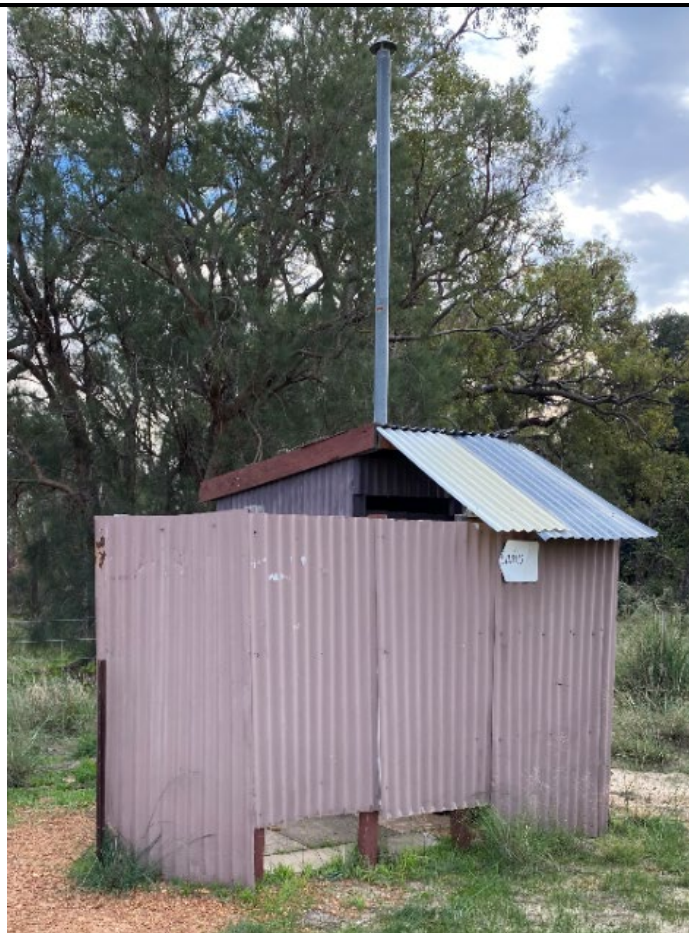
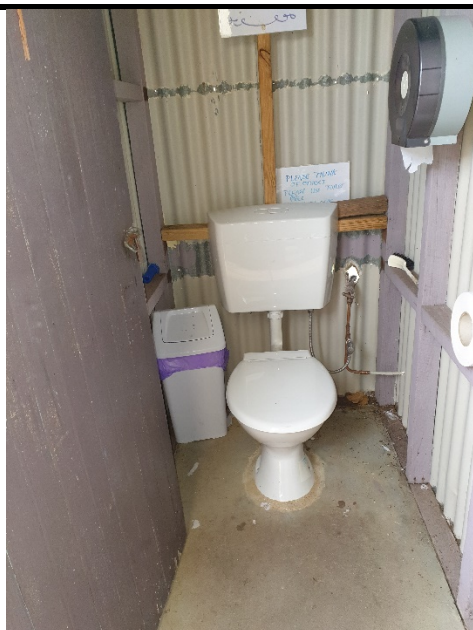
Female toilets

Description	Timber frame corrugated sheet metal walls and roof sanitary facility with plumbed water closet and wash hand basin
Condition	<ul style="list-style-type: none"> – The toilets are in poor condition and are an open outhouse style as opposed to a weather proof building. – some timbers are rotting, – there is a mix match of roof sheeting and the concrete slabs entering the facility and around the wash hand basin are uneven. – The sanitary facility does not comply with accessibility requirements and does not have an accessible path of travel to them. – There is no power or light – The effluent disposal system is functional but it is unknown what condition it is in

Build date	1965
Approval	unknown
Recommendation	<ul style="list-style-type: none"> – Replace toilet facilities with a compliant accessible sanitary facility – Engage a licensed plumber to inspect the effluent disposal system and verify its condition and if the tanks require pumping out.

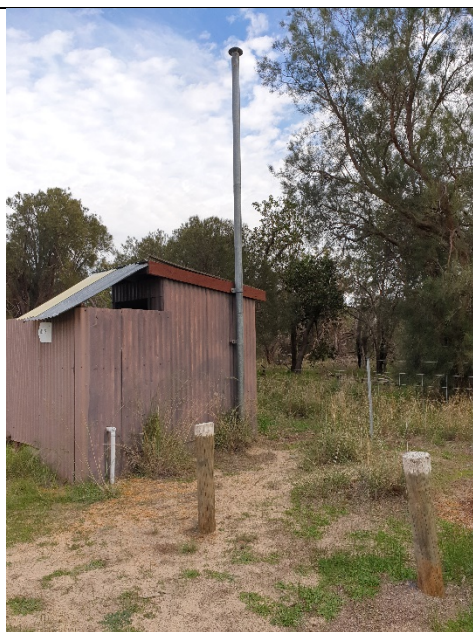
A large hole in what appears to be a ventilation stack

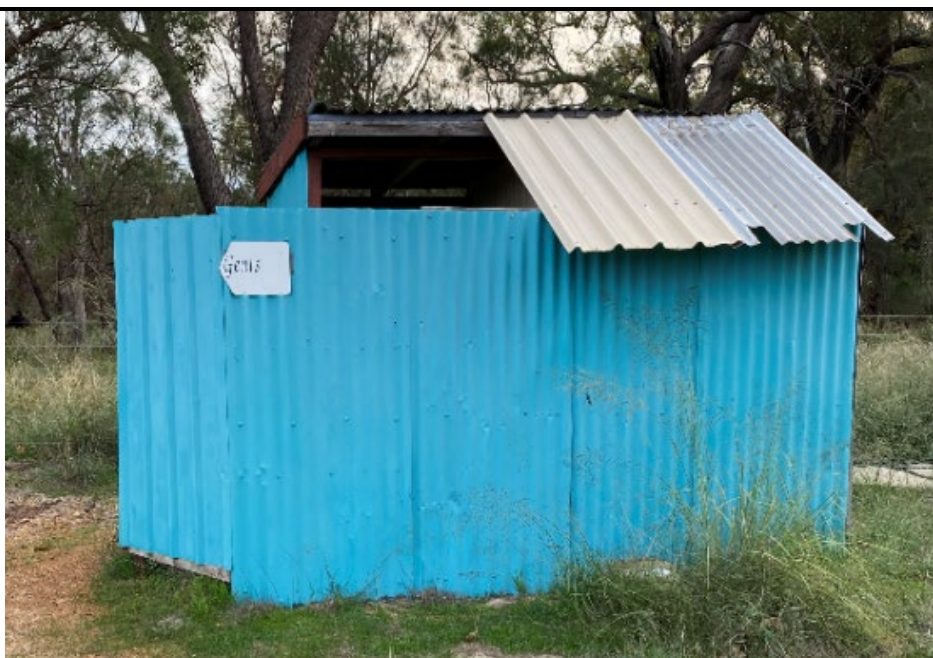
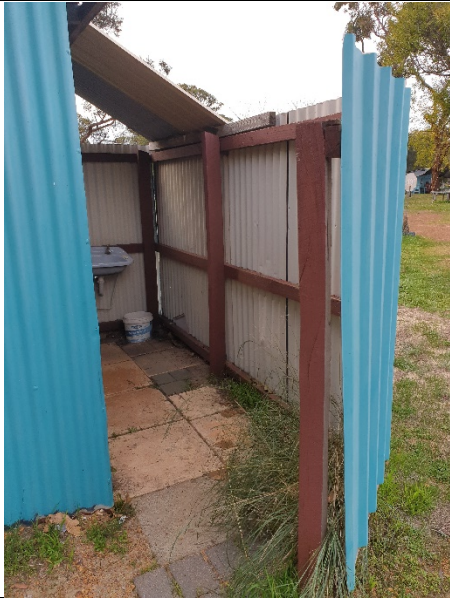
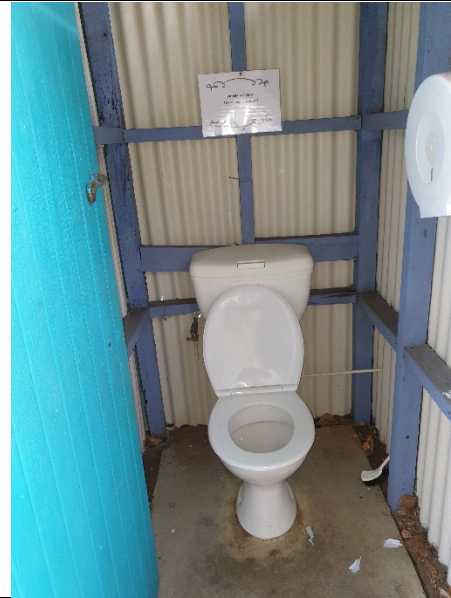
Structure H2 - Male toilets

Description	Timber frame corrugated sheet metal walls and roof sanitary facility with plumbed water closet, wash hand basin, the urinal is likely a masonry wall construction with a cement render finish urinal
Condition	<ul style="list-style-type: none"> – The toilets are in poor condition and are an open outhouse style as opposed to a weather proof building. – There are a number of timbers are rotting, – The base of the urinal is cracking and has debris in the drain, there is a garden tap above the urinal with a garden hose connection sitting in the drainage channel in lieu of a flush mechanism, – there is a mix match of roof sheeting – the concrete slabs entering the facility and around the wash hand basin are uneven. – There is no power or light <p>The sanitary facilities does not comply with accessibility requirements and does not have an accessible path of travel to them.</p>

Build date	1965
Approval	unknown
Recommendation	Replace toilet facilities with a compliant accessible sanitary facility

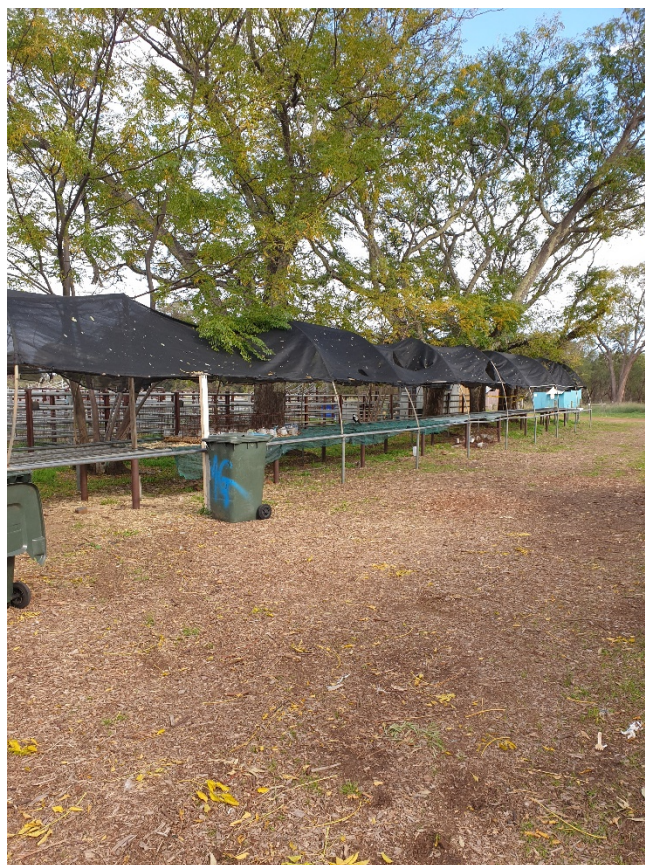
Structure I - Steel frame dome structure for grow tunnels	
Description	Dome shaped tunnels of tubular steel with a loose shade cloth roof
Condition	<p>The tubular step frame is buckled in places and out of shape. A dome shape obtains its structural adequacy through its form and rigid shape, buckles and weak points could cause the structure to fail in a wind event if this structure is ever re-covered with polypropylene as a grow tunnel</p> <p>At present there is a loosely hung piece of shade cloth across the structure.</p>

End elevation of steel frame tunnel, out of shape from a wide semi circle dome to a narrow oval	
Build date	unclear
Approval	None on record
Recommendation	have the structure inspected by a structural engineer to recommend remedial work to the tunnel to ensure structural adequacy prior to installing an impermeable material that would then be subject to wind loading
