# Mundijong Sales Yard

## Building and incidental structures inspection report

**June 2020**

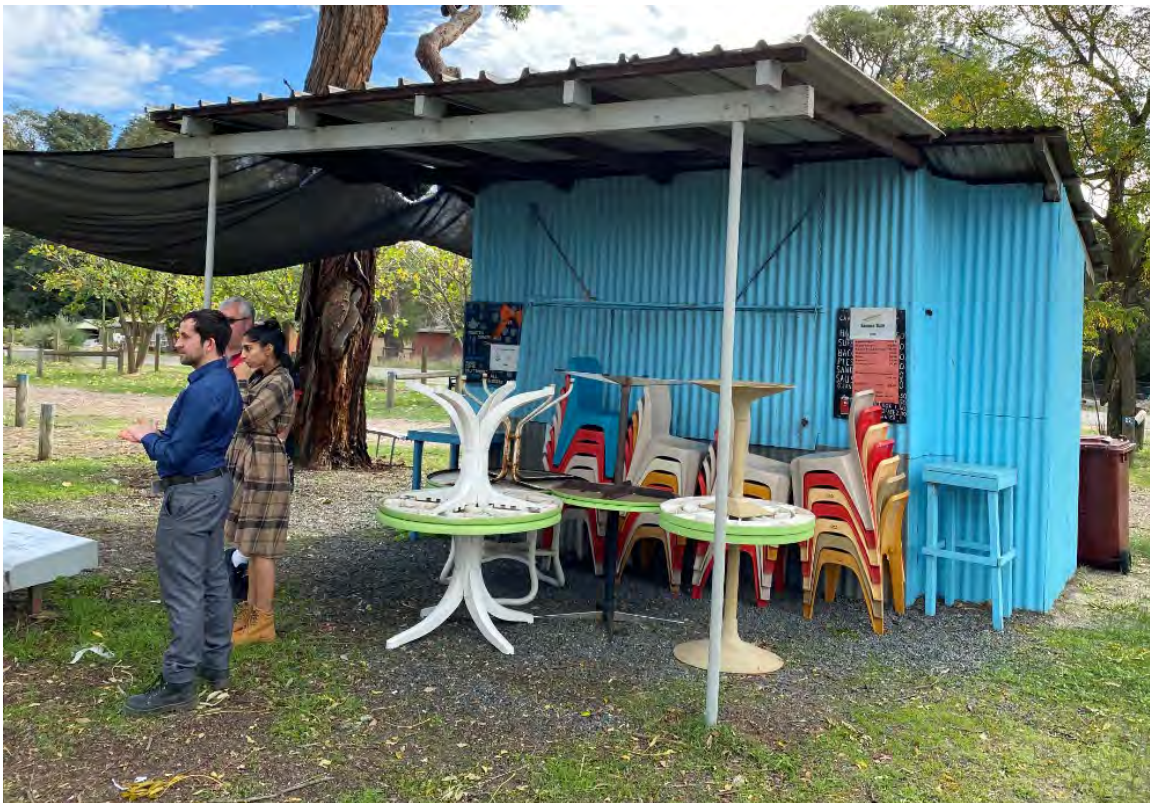
### Structure A - Kitchen with server window

| Description | Small timber frame structure with corrugated sheet metal cladding. the tenants have advised it is the original building from circa 1965 |

| | Addition of a lean to with Steel posts and timber frame with a sheet metal roof. Additional shade cloth hung from side of building to a tree | |
| Condition | The building appears to be in good condition, solid timbers roof frame in good condition, internal wall lining (if original) may be asbestos based on age. Server y hatch door is hinged horizontally from the top and opens outwards with the hatch door held in place with a chain. | |

| Recommendation | <p>Test internal linings for containment of asbestos. Undisturbed asbestos poses a low risk but should be registered.</p> <p>The server hatch door poses a health and safety risk. As it is held up in an open position on a chain, if it fell it could cause an injury to a customer. Replace with a roller door.</p> <p>Remove Shade cloth attached from building to a tree, consider installing a more appropriate structure if required.</p> | |

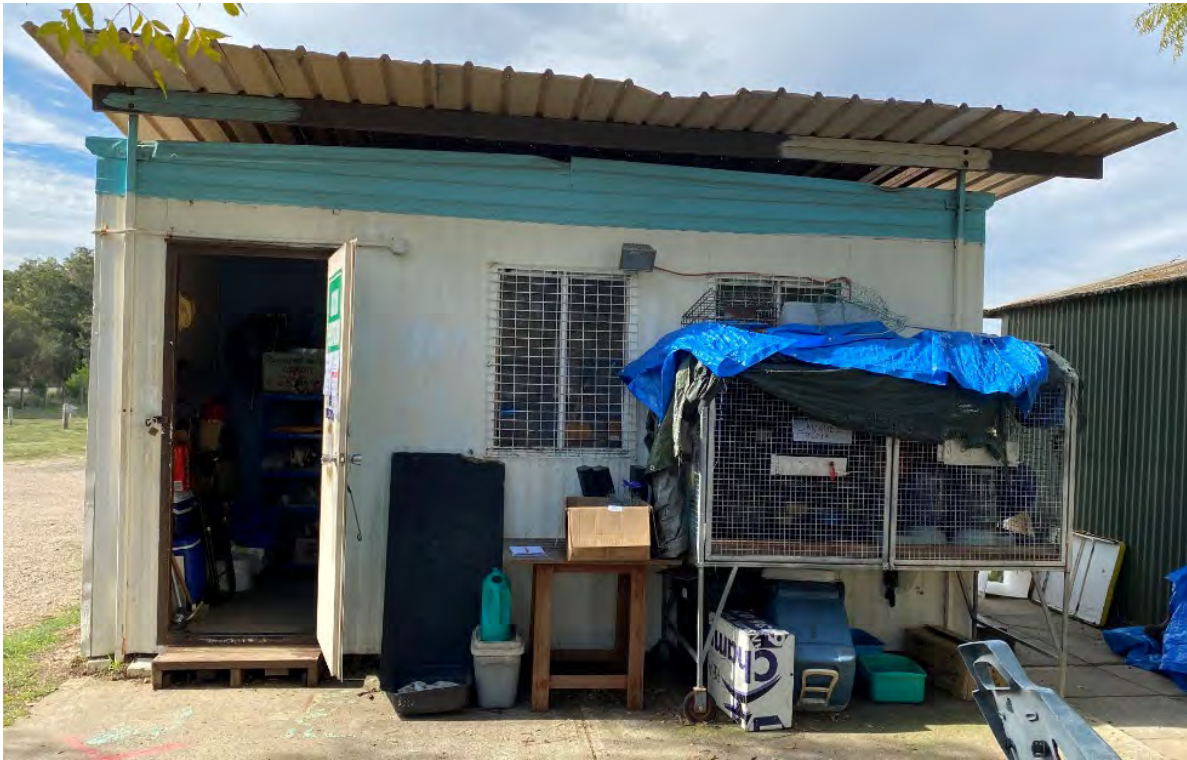
**Structure B - Office building**

| Description | Transportable building of timber frame and Structural steel supports, sheet metal external cladding and timber sheet wall lining internally |
| Condition | Ceiling is sagging and wall lining is deteriorating in places. The building is non-compliant with present day accessibility standards for a class 5 office. (Door Width: 770mm in lieu of 850mm, the entrance height: 190mm step in lieu of a ramp) |

| Recommendation | Deteriorated internal wall and ceiling lining to be replaced, requires retrospective building approval. Will likely require the widening of the doorway to 850mm clear and install a step ramp to comply with accessibility requirements for an office. |

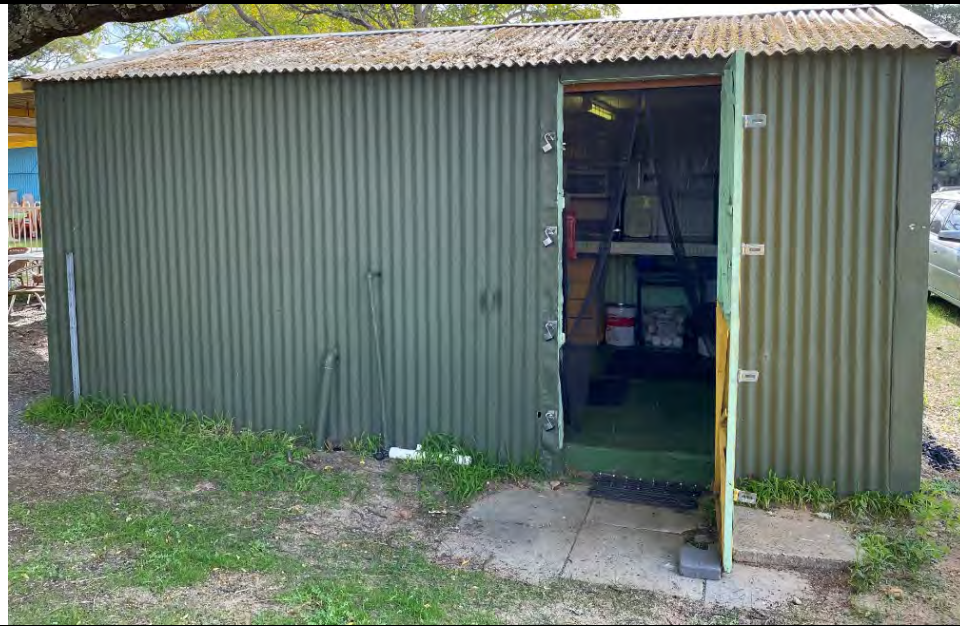
**Structure C - Kitchen with server window**

| Description | Timber frame shed with sheet metal cladding and concrete slab on ground, possible fibre cement sheet roof or asbestos. |
| Condition | <ul style="list-style-type: none"> <li>– Concrete slab on ground in poor condition, has multiple cracks through it and it is uneven. This building appears to be a shed converted into a commercial kitchen. As a shed, it is unlikely to have a damp proof membrane beneath the slab so water may permeate the slab from below and cause cracking of the concrete due to expansion and contraction. The slab appears to be unusually thick, it is likely a poured slab on top of an existing slab, the door extends approx. 140mm down from finished floor level to finished ground level. Impervious and uneven floors can lead to unsanitary conditions in a food preparation area.</li> <li>– The ceiling level is below the 2.4m required for a habitable space such as a kitchen.</li> <li>– There is no roof gutters so water run-off will fall to the base of the wall, further adding to the issues of the floor slab.</li> <li>– The server door hinged from the top is opened upwards and held open with steel nuts threaded onto bolts protruding downward from ceiling of a lean to structure. This poses a health and safety risk to customers if the nuts were not tightened properly or the thread failed.</li> <li>– The step and door do not comply with todays accessibility standards but may not have been required at the time of construction if an approval is in place.</li> </ul> |

| Recommendation | <p>Remove existing floor to ground level if it is found to not be solid concrete and pour a reinforced concrete floor with a damp proof membrane beneath. Finish with a slip resistant linoleum floor covering or washable water resistant coating.</p> <p>Install roof guttering and downpipes which direct storm water to an appropriate disposal method such as a soak well.</p> <p>It is recommended to replace the horizontal hinged server door with a roller door for safety purposes.</p> <p>If retrospective approval is sought then the building would have to comply as a class 6 kitchen by todays standards. The floor, ceiling height and accessibility will require further attention to bring into compliance as well as the installation of a fire extinguisher and consideration to energy efficiency.</p> |

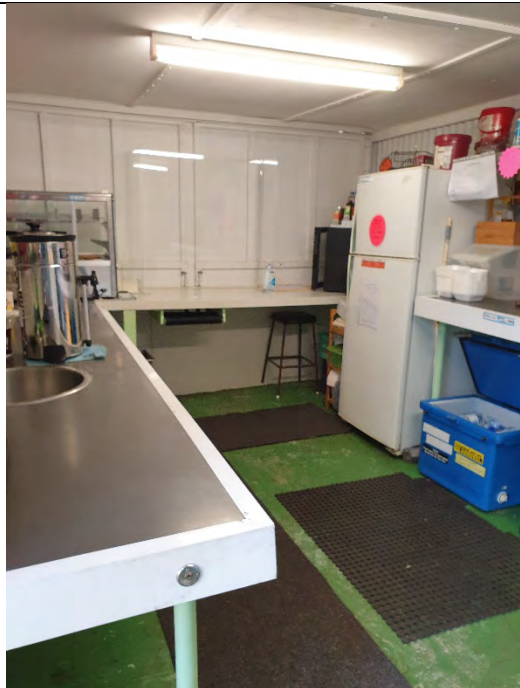
Kitchen fit out internally

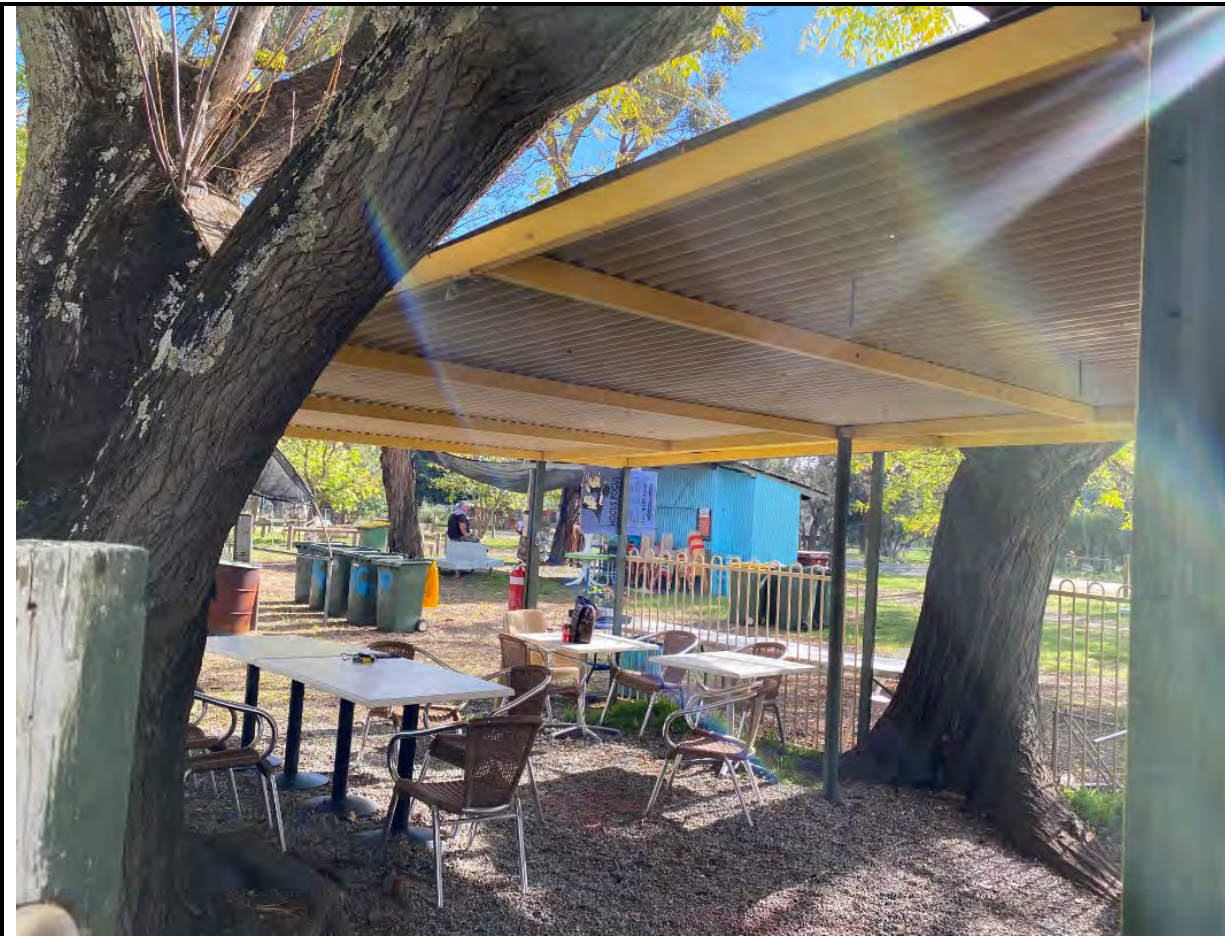
**Structure D - Patio area adjoining Kitchen server**

| Description | A flat roof steel frame patio with sheet metal roof cladding and approx. 75mm x 38mm rectangular steel hollow patio tube posts. The flat roof patio is attached to the kitchen with server building (Structure C) and also attached to the rear of a stock yard Shed (structure E) by a cantilevered attachment |
| Condition | The structure appears to be in good condition although the steel tubing used as upright columns is generally used as roof beams or rafters with larger square hollow sections used as posts. Structural beams of structure E where patio is attached by Cantilevered attachment is exposed to weather and continue to deteriorate. |

| Recommendation | Engage a suitably qualified structural engineer to inspect and certify the patio structure. Modifications may be required in order to certify the structural adequacy of the patio structure.<br>Install roof guttering to capture storm water run-off and direct it away from the footings of any structures such as to a soak well. |

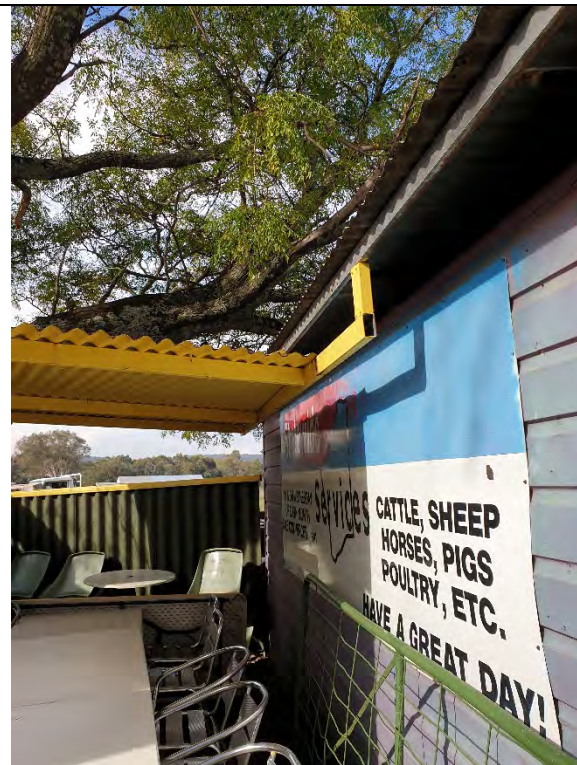
Patio structure attached to the rear of a stock yard shelter

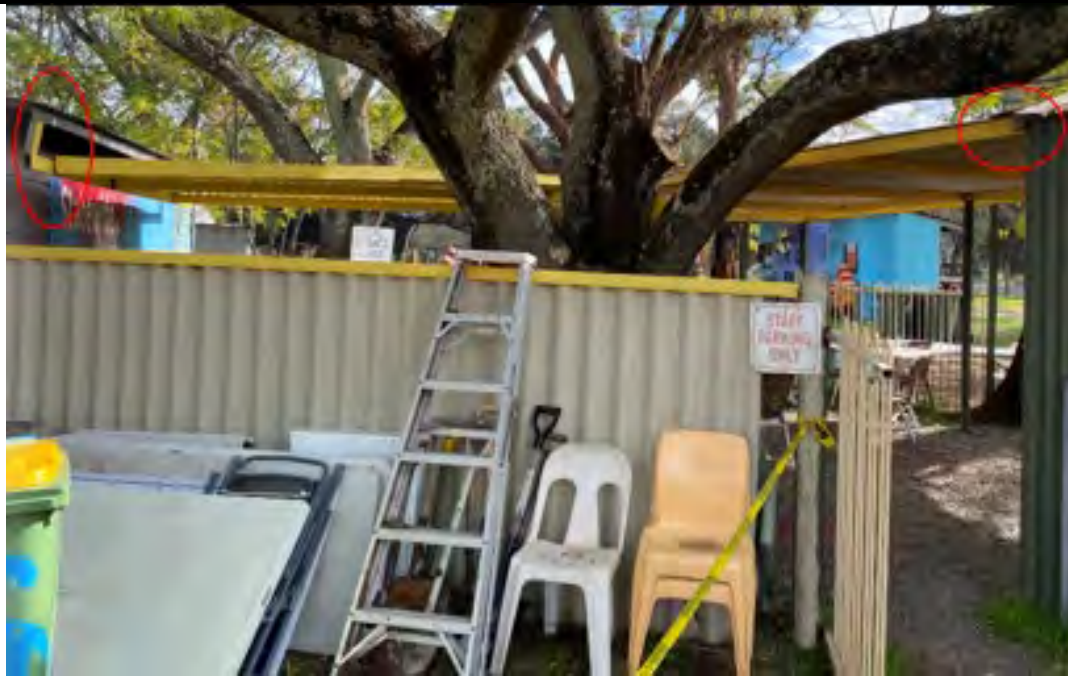
Patio connected to two buildings

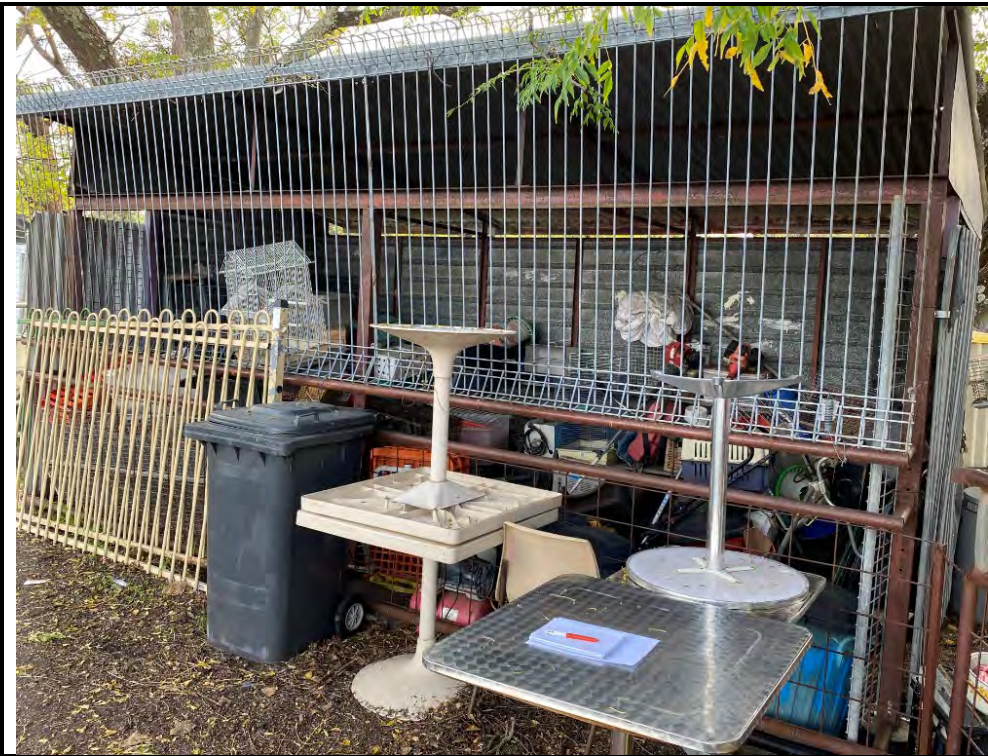
| Structure E - Stockyard Shelter | |

| Structure E - Stockyard Shelter | |
|---|---|
| Description | Steel frame semi enclosed Structure with a flat roof, sheet metal wall cladding on three sides and a sheet metal roof. The structure appears to be used adhoc for storage. |
| Condition | The structural frame of hollow square steel columns and C section beams has no rust protection and is severely rusted. Access was not available to view all structural members due to the items being stored |

| Recommendation | <ul style="list-style-type: none"> <li>– Have a suitably qualified structural engineer recommend the members to be replaced and correct sizing of replacement members</li> <li>– Coat the new steel frame with a corrosion resistant paint</li> </ul> |

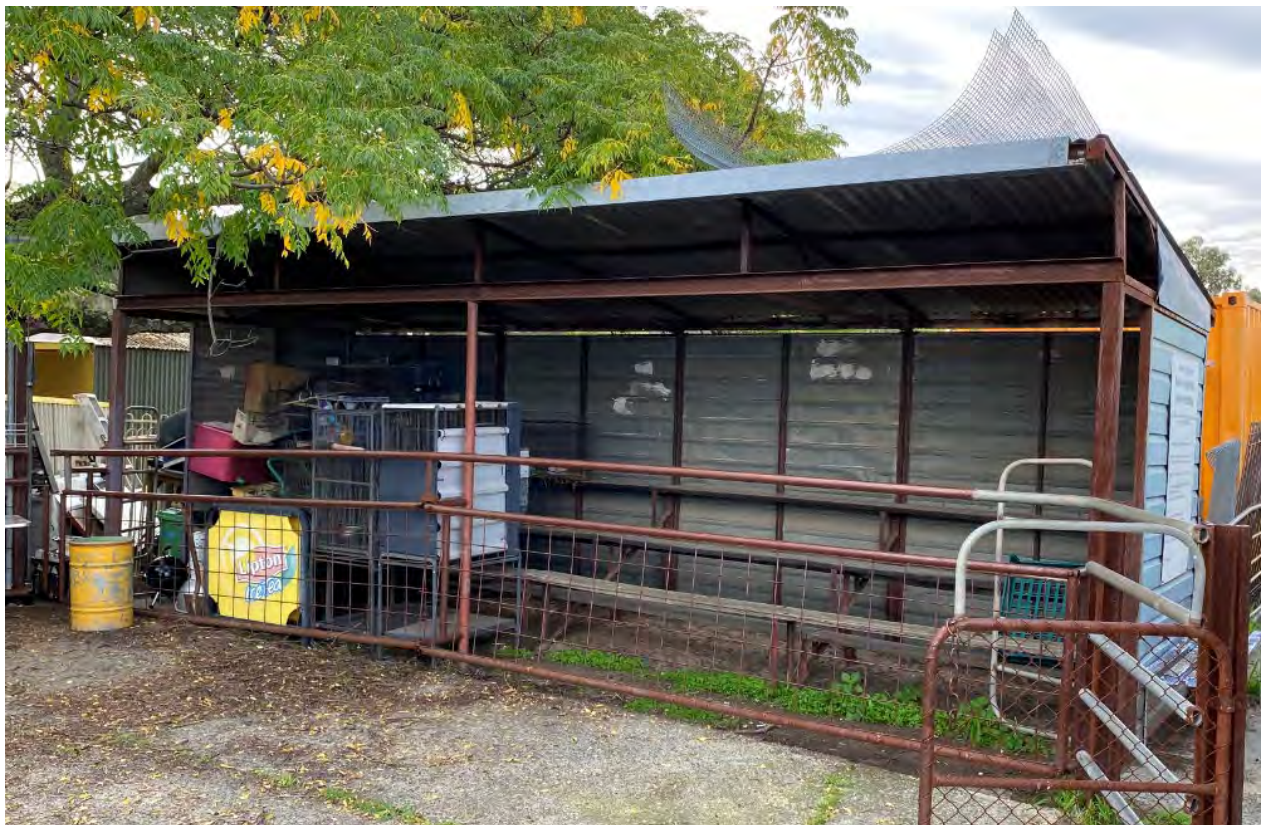
**Structure F - second stock yard shelter**

| Description | Steel frame semi enclosed Structure with a flat roof, sheet metal wall cladding on three sides and a sheet metal roof. Tiered seating of steel frame with timber bench. Part of structure being used for storage |
| Condition | The structural frame of hollow square steel columns and C section beams has no rust protection and is severely rusted. The base of the column can be physically busted through by hand, corrosion and flaking of the steel has occurred from within the post. |

| Recommendation | <ul style="list-style-type: none"> <li>– Do not allow access to members of the public</li> <li>– Have a suitably qualified structural engineer recommend the members to be replaced and correct sizing of replacement members</li> <li>– Coat the new steel frame with a corrosion resistant paint</li> </ul> | |

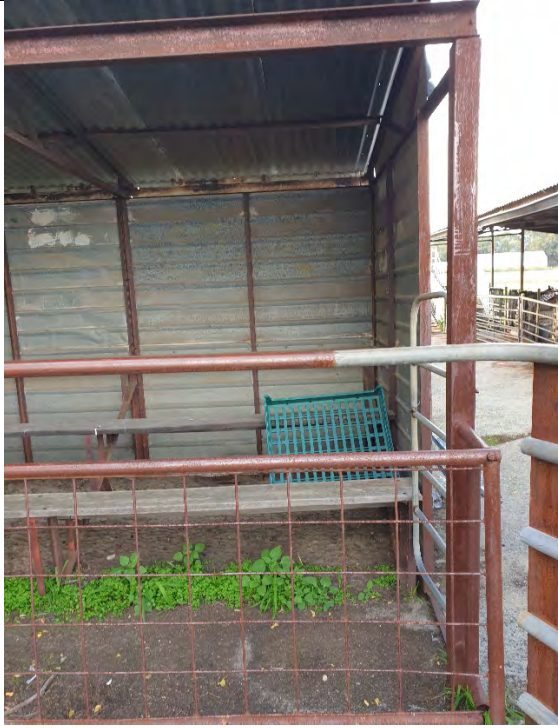
| <p>Attachment of roof sheeting corroded</p> | | <p>Front elevation of stockyard shelter for members of the public</p> |

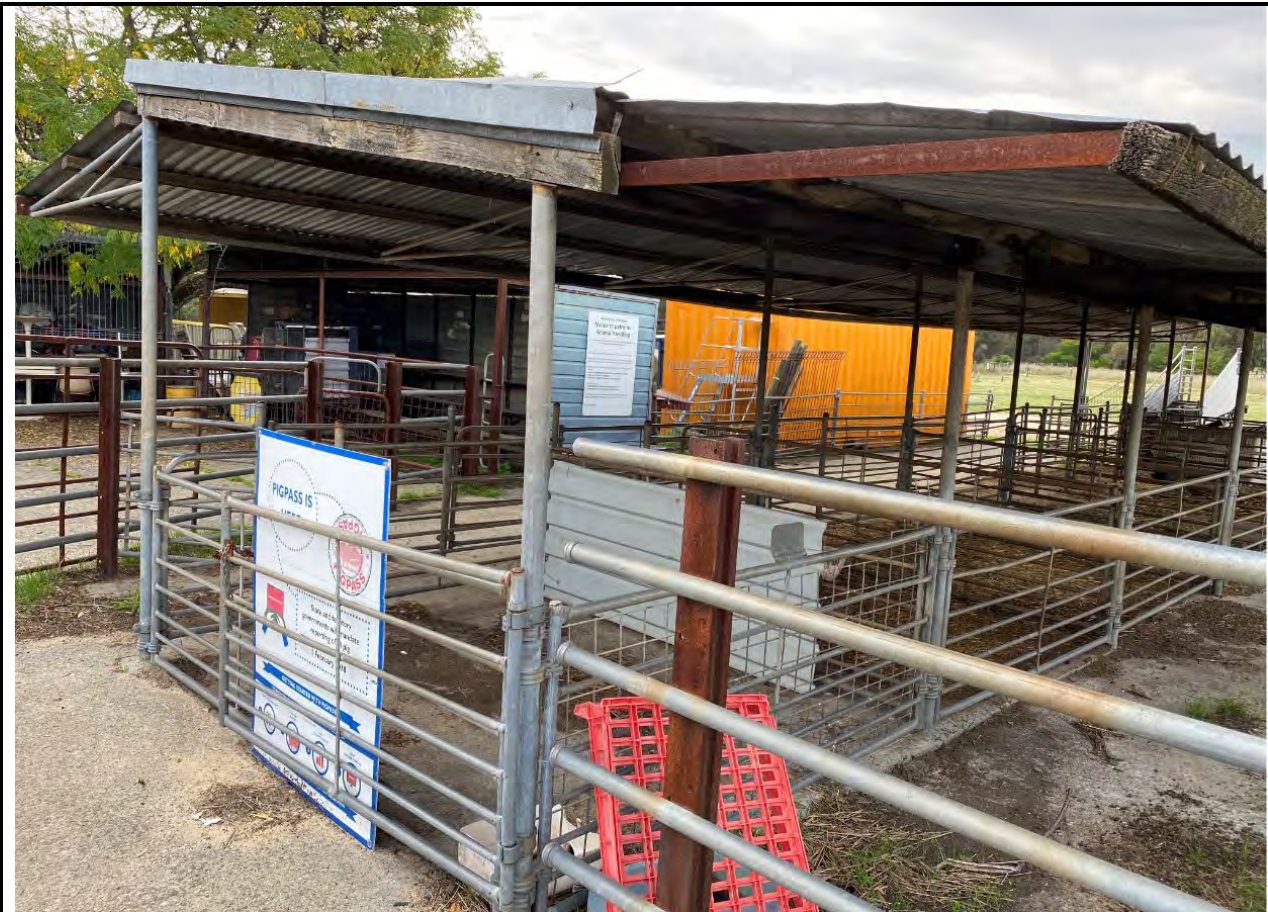
**Structure G - Roof covered Stock Yard**

| Description | Steel posts, steel truss and timber roof beam structure low pitch gable roof with cantilevered lean-to roof additions, all with sheet metal cladding |
| Condition | <ul style="list-style-type: none"> <li>– The steel frame live-stock pens and gates are in good condition.</li> <li>– The roof is missing sheets in places,</li> <li>– Roof gutters sagging in places</li> <li>– structural timbers are rotten and deteriorated</li> <li>– it appears some posts and roof truss members may have been installed as replacement members</li> <li>– there is a lean-to type roof structure that is cantilevered 1.37m in length from the post</li> <li>– it is unclear where any wash down of the sales yard concrete pad goes to. There would be animal droppings and urine that would be hosed to a suitable drainage containment point as opposed to direct drainage into the soil</li> </ul> |

| Recommendation | <ul style="list-style-type: none"> <li>– Remove any deteriorated roof timbers.</li> <li>– Have a suitably qualified structural engineer inspect the existing steel frame for compliance and recommend sizes of any required replacement members</li> <li>– Check fasteners of sheet metal roof and ensure</li> <li>– Further investigation required into where wash down water is drained to or how animal waste is disposed of</li> </ul> |

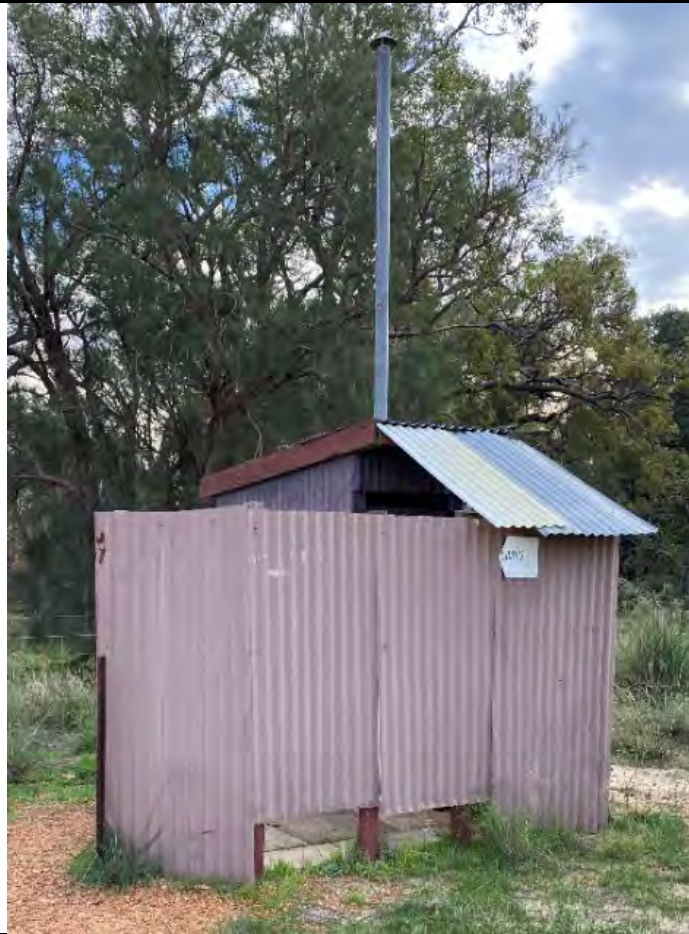
**Structure H1 - Female toilets**

| Description | Timber frame corrugated sheet metal walls and roof sanitary facility with plumbed water closet and wash hand basin |
| Condition | <ul style="list-style-type: none"> <li>– The toilets are in poor condition and are an open outhouse style as opposed to a weather proof building.</li> <li>– some timbers are rotting,</li> <li>– there is a mix match of roof sheeting and the concrete slabs entering the facility and around the wash hand basin are uneven.</li> <li>– The sanitary facility does not comply with accessibility requirements and does not have an accessible path of travel to them.</li> <li>– There is no power or light</li> <li>– The effluent disposal system is functional but it is unknown what condition it is in</li> </ul> |

| Recommendation | <ul style="list-style-type: none"> <li>– Replace toilet facilities with a compliant accessible sanitary facility</li> <li>– Engage a licensed plumber to inspect the effluent disposal system and verify its condition and if the tanks require pumping out.</li> </ul> |

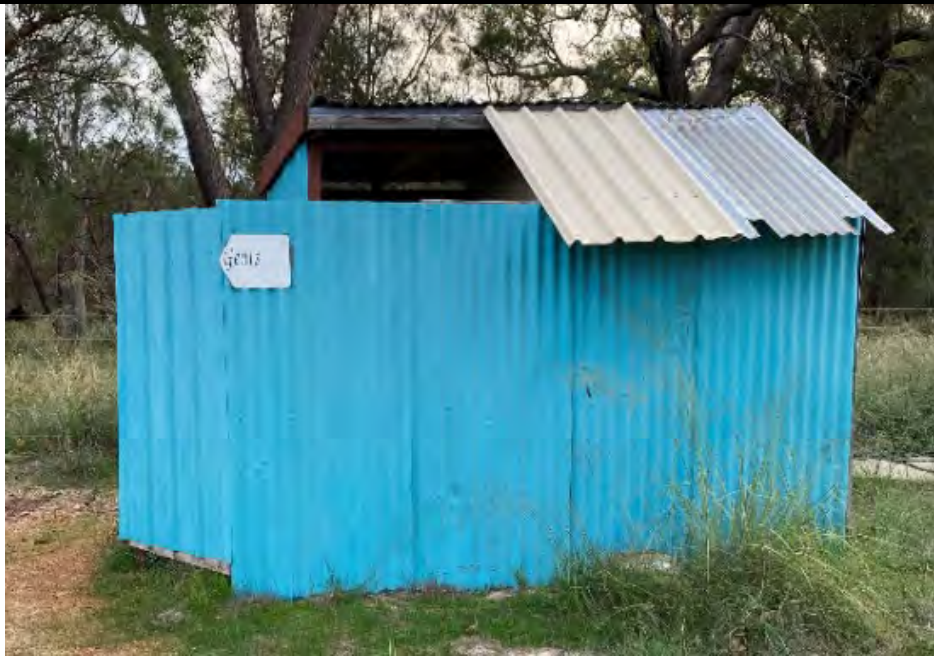
**Structure H2 - Male toilets**

| Description | Timber frame corrugated sheet metal walls and roof sanitary facility with plumbed water closet, wash hand basin, the urinal is likely a masonry wall construction with a cement render finish urinal |
| Condition | <ul style="list-style-type: none"> <li>– The toilets are in poor condition and are an open outhouse style as opposed to a weather proof building.</li> <li>– There are a number of timbers are rotting,</li> <li>– The base of the urinal is cracking and has debris in the drain, there is a garden tap above the urinal with a garden hose connection sitting in the drainage channel in lieu of a flush mechanism,</li> <li>– there is a mix match of roof sheeting</li> <li>– the concrete slabs entering the facility and around the wash hand basin are uneven.</li> <li>– There is no power or light</li> </ul> <p>The sanitary facilities does not comply with accessibility requirements and does not have an accessible path of travel to them.</p> |

| Recommendation | Replace toilet facilities with a compliant accessible sanitary facility |
