Shire of Serpentine Jarrahdale
Serpentine Jarrahdale Community Recreation
Centre
Building Condition Audit & Life Cycle Costing

12 February 2021

Serpentine Jarrahdale Community Recreation Centre Building Condition Audit Report_Rev0

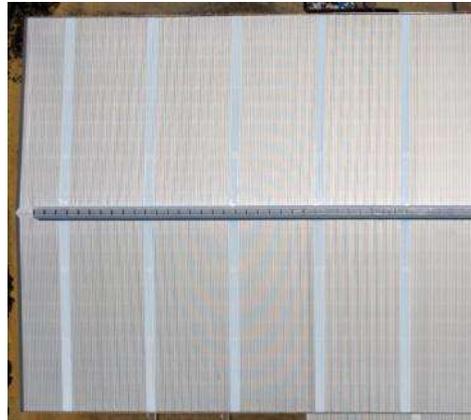
Reference No	Location / Element	Works Type	Description	Photographs	Cost Est.	Year
B001	Sports Court	Observation	The Sports Court roof is in overall good condition.

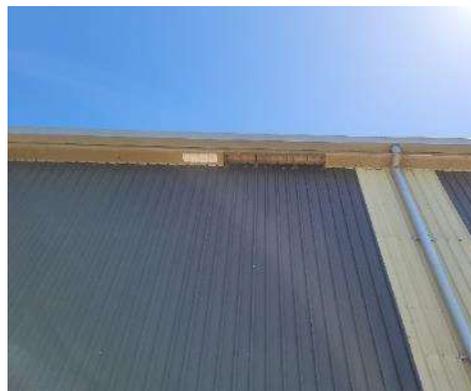
N/A	N/A
B002	Sports Court	Repair	There is a section of mesh flashing missing.

\$1,612	2021

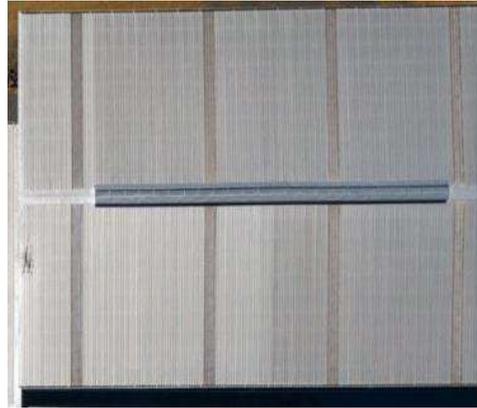
Reference No	Location / Element	Works Type	Description	Photographs	Cost Est.	Year
B003	Extreme Sports Court - Roof	Renewal	<p>The Extreme Sports Court roof is in good condition overall. Though with deterioration evident to the fibreglass roofing sections (See below).</p> <p>Cost given is for replacement of fibreglass sections as part of renewals.</p>

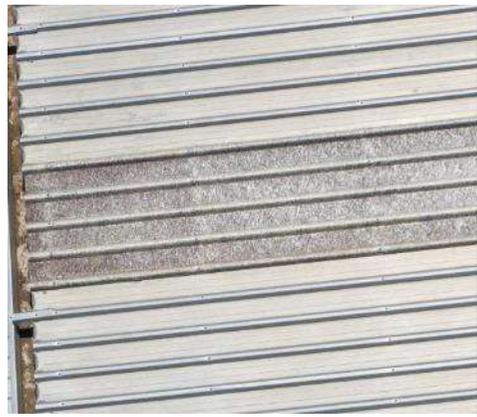
\$8,070	2022
			<p>Deterioration to fibreglass roofing sections. Cost for replacement as part of renewal works.</p>

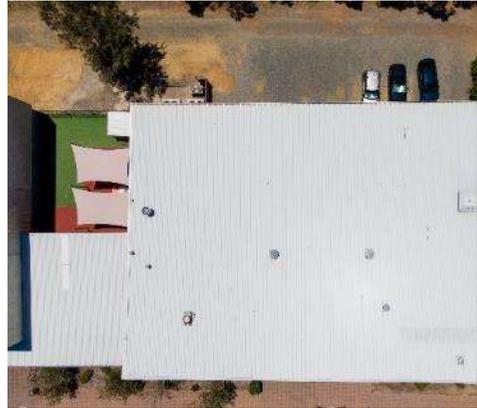
Reference No	Location / Element	Works Type	Description	Photographs	Cost Est.	Year
B004	Multipurpose Rooms - Roof	Observation	The Multipurpose rooms roof is in good condition. There is minor water staining to ceiling tiles evident possibly because of leakage from the roof.

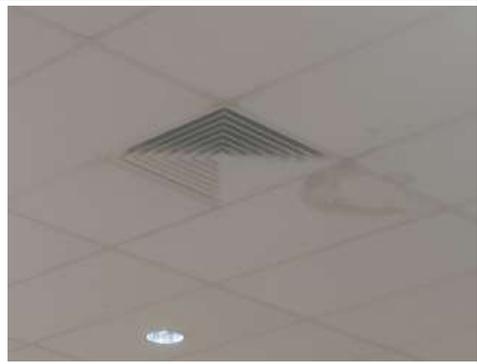
N/A	N/A
B005	Multipurpose Rooms - Roof	Repair	Minor water staining to ceiling in Multipurpose room either a result of leakage from the roof or the mechanical system ductwork. Cost is to investigate source of water staining to ceiling tiles.

\$250	2021

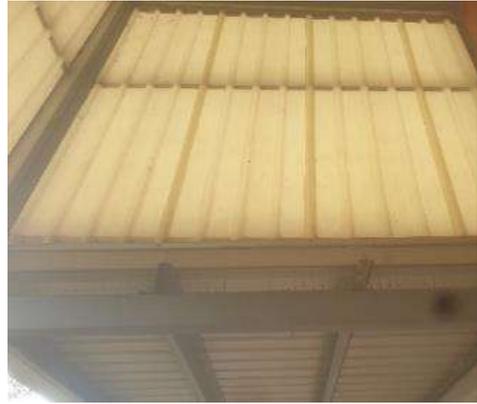
Reference No	Location / Element	Works Type	Description	Photographs	Cost Est.	Year
B006	Multipurpose Rooms - Roof	Repair	Deterioration to Bird Spikes leading to increased presence of birds.

\$900	2021
B007	Gymnasium - Roof	Renewal /Repair	<p>The Gymnasium Roof is in overall average condition. The surface has deteriorated and exhibits some surface discolouration and corrosion. The external exposed structure including beams and trusses are corroded.</p> <p>Note cost is for renewal of roof covering at end of life. It may be possible to extend the life of this roof through cleaning, minor repairs and removal of redundant equipment.</p>

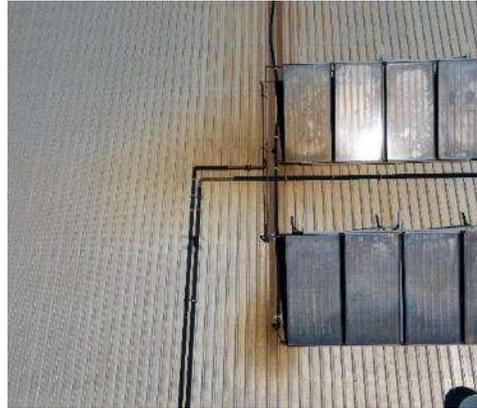
Reference No	Location / Element	Works Type	Description	Photographs	Cost Est.	Year
			Additional photograph highlighting surface deterioration including discolouration and corrosion.

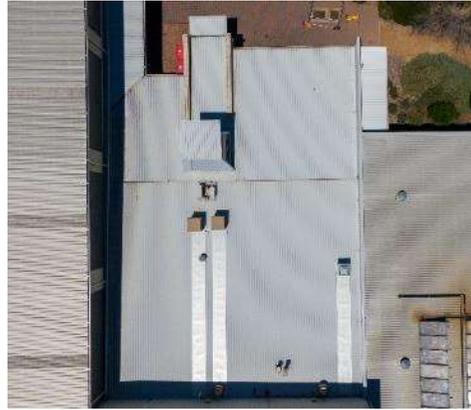
Reference No	Location / Element	Works Type	Description	Photographs	Cost Est.	Year
B009	Administration and Cafe	Observation	The Administration and Café roof is in average condition though with some internal leakage visible in the skylight structure and within the Café area.

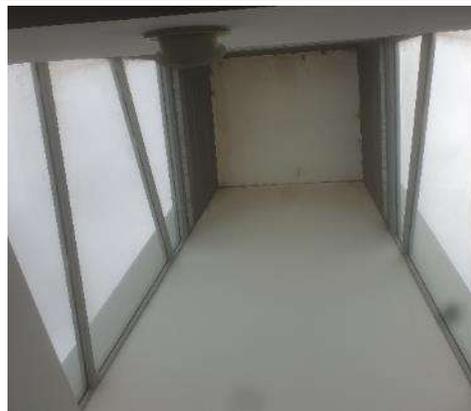
N/A	N/A
B0010	Administration and Cafe	Repair	Minor water staining evident internally within the skylight. Cost is to investigate source of water staining to ceiling tiles.

\$2,400	2021

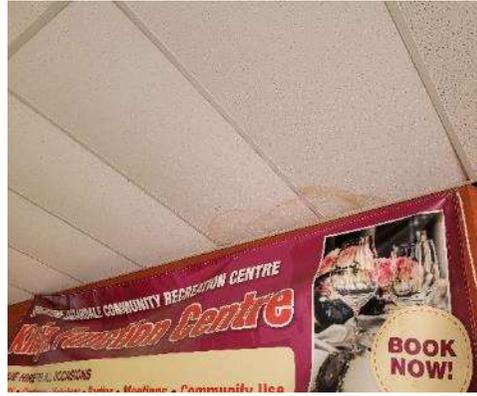
Reference No	Location / Element	Works Type	Description	Photographs	Cost Est.	Year
B011	Administration and Cafe	Repair	Water staining to ceiling tiles in Café and entrance location. Cost is to investigate source of water staining to ceiling tiles (included above)

\$200	2021

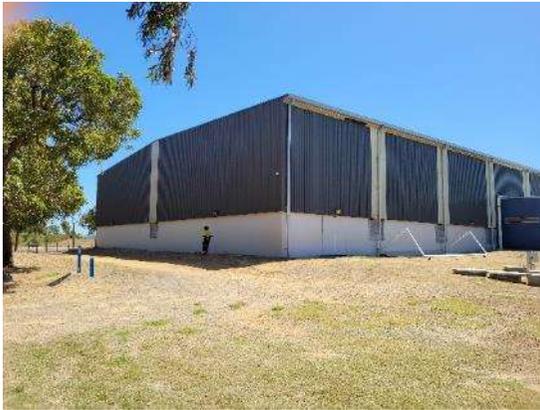
Reference No	Location/Element	Works Type	Description	Photographs	Cost Est.	Year
EW001	Sports Court – External Walls	Renewal	The Sports Court external walls are in overall good condition though with defects as follows.

\$16,373	2027
EW002	Sports Court – External Walls	Repair	Minor deterioration to tilt panel joints.

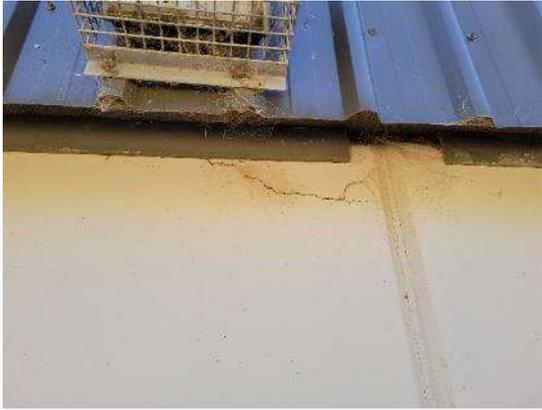
Reference No	Location/Element	Works Type	Description	Photographs	Cost Est.	Year
EW003	Sports Court – External Walls	Repair	Localised cracking evident to the east wall concrete panel. Recommend inspection and monitoring.

An allowance has been made overall of \$3,500 for structural inspection (See EW005)	2021
EW004	Sports Court – External Walls	Repair	Corrosion to mesh and steel structure at panel and metal cladding interface.

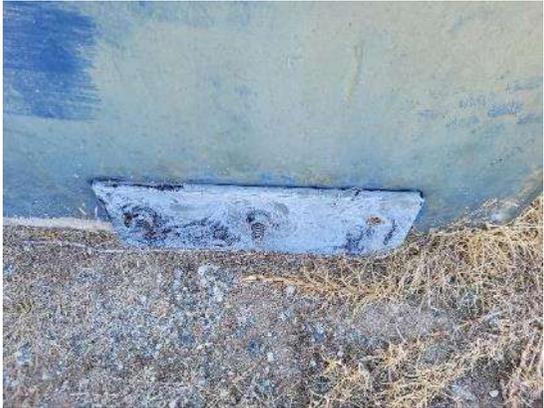
Reference No	Location/Element	Works Type	Description	Photographs	Cost Est.	Year
EW005	Sports Court – External Walls	Repair	Loose and missing bolts and displacement of tilt panel base plates. It is recommended that a Structural Engineer carry out an inspection.

\$3,500 (Probable order of cost for Structural Engineer)	2021
EW006	Extreme Sports Court – External Walls	Renewal	The Extreme Sports Court external walls are in overall good condition though with defects as follows. Allowance in renewal plan made for painting.

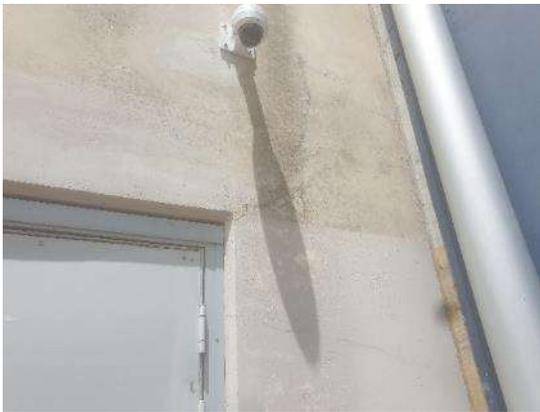
\$640	2021
EW008	Extreme Sports Court – External Walls	Repair	Cracking evident propagating from the top edge of the fire exit door.

An allowance has been made overall of \$3,500 for structural inspection (See EW005)	2021

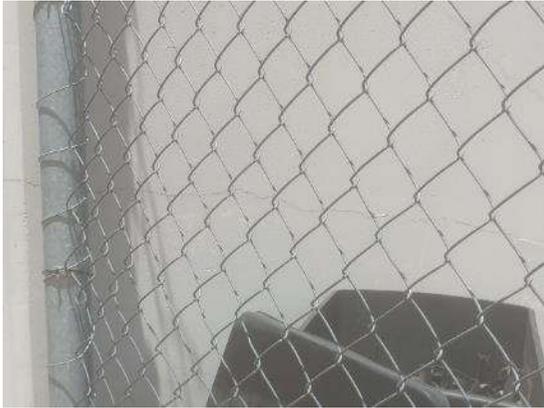
Reference No	Location/Element	Works Type	Description	Photographs	Cost Est.	Year
EW009	Extreme Sports Court – External Walls	Repair	Cracking adjacent to the roller shutter door.

An allowance has been made overall of \$3,500 for structural inspection (See EW005)	2021
EW010	Extreme Sports Court – External Walls		Loose and missing bolts and displacement of tilt panel base plates.

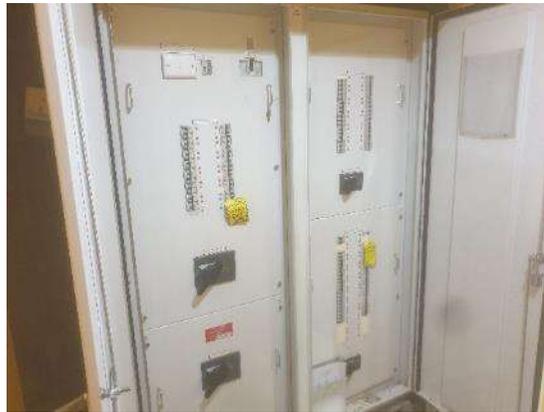
Reference No	Location/Element	Works Type	Description	Photographs	Cost Est.	Year
E001	Light and Power	Observation / Repair	<p>Electrical distribution Boards throughout are in good condition.</p> <p>The Building Main Switchboard has in place two Out of Service tags.</p> <p>Recommend inspection to confirm suitable isolation/disconnection.</p> <p>There is installed a sump pump and small associated pit within the Switchboard cupboard due to building ground water/drainage problems.</p>

\$220	2021

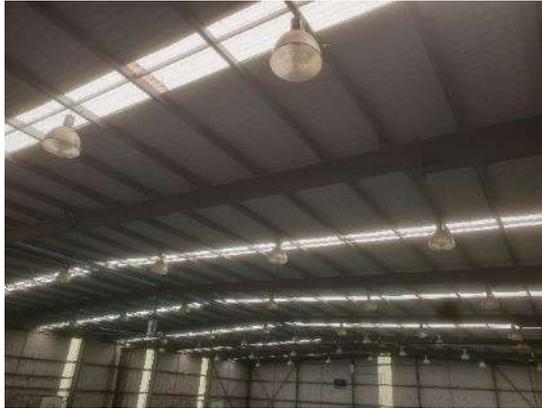
Reference No	Location/Element	Works Type	Description	Photographs	Cost Est.	Year
E002	Sports Court – Light and Power	Renewal	<p>The High Bay Discharge lighting is approaching end of life and is recommended for planning for renewal.</p> <p>It is recommended that they are replaced with LED type fittings.</p>

\$27,819	2022
E003	Extreme Sports Court – Light and Power	Renewal	<p>The lighting directly above the beach volleyball has been replaced with LED type High Bay fittings. The remainder are the original light fittings.</p> <p>The original High Bay Discharge lighting is approaching end of life and is recommended for planning for renewal.</p>

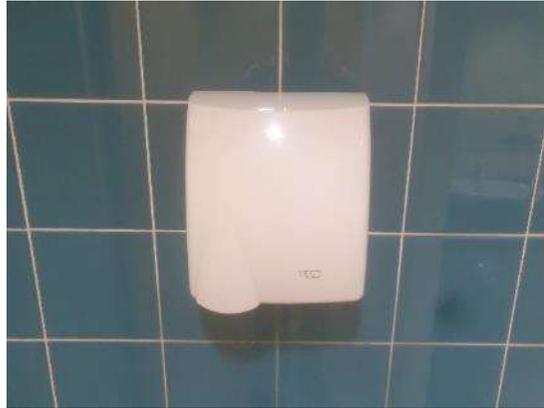
Reference No	Location/Element	Works Type	Description	Photographs	Cost Est.	Year
E004	Toilets and Changing Rooms – Light and Power	Renewal	HPM handryers throughout the toilets and changing rooms are either Out of Service or ineffective in operation. Note cost is for replacement with Dyson type or similar.

\$6,000	2021
E005	Throughout	Renewal	The emergency lighting including exit signs are in good condition. An allowance, based on industry serviceable life expectancy, has been made for renewal in 2028.

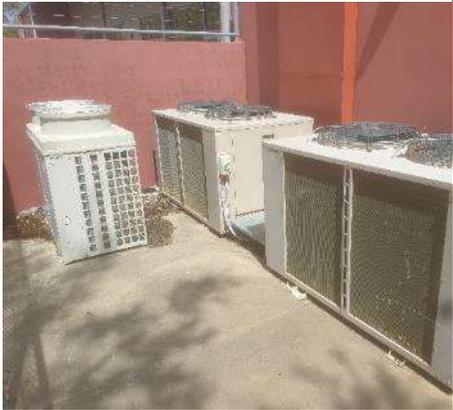
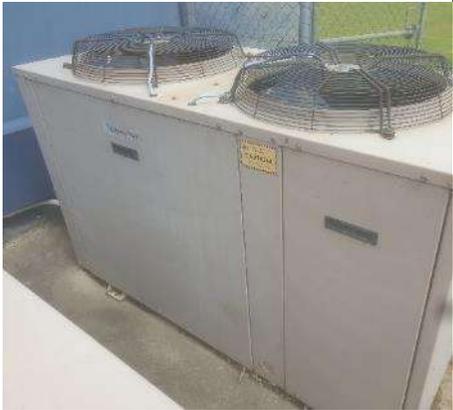
Reference No	Location / Element	Works Type	Description	Photographs	Cost Est.	Year
M001	Packaged Air Conditioning Units	Renewal	<p>The Packages Air Conditioning Units throughout are old (circa)2004 and are effectively at/or approaching end of life. The units are R22 Refrigerant charged. The units in the South Enclosure visually are in poor condition. The units in the North Enclosure are in average condition.</p> <p>The Split Air Conditioning Units are in average condition but again are old and approaching end of life.</p>

<p>\$106,995 (South Enclosure 3xLarge Packaged 41kW Units)</p> <p>\$15,236 (South 3xSplit Units)</p> <p>\$74,066 (North Enclosure 2xLarge Packaged 41kW Units)</p> <p>\$10,158 (Roof above Café 2xSplit Units)</p>	<p>2022</p> <p>2024</p> <p>2024</p> <p>2024</p>

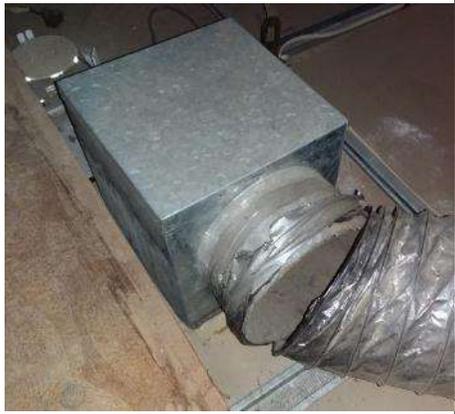
\$9,704	2025
M003	Toilet Exhaust	Repair	Flexible duct has become detached discharging toilet exhaust into common roof space.

\$110	2021

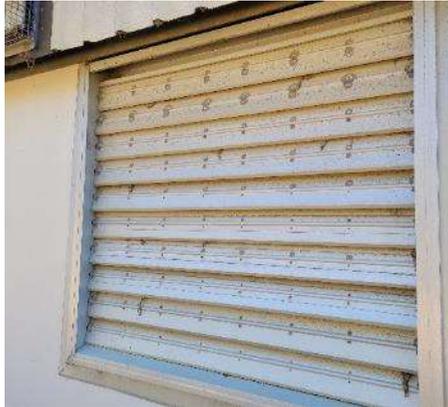
Reference No	Location / Element	Works Type	Description	Photographs	Cost Est.	Year
M004	External Sports and Extreme Sports Courts – Fresh Air Louvers	Repair	<p>External fresh air louvers are corroded.</p> <p>Recommend that they have corrosion treatment and also lubrication/maintenance to ensure operation.</p> <p>Note that a PPM task has been included for future annual inspection to include verifying operation, cleaning and lubrication.</p>

\$1,540	2021
M005	Kitchen – Supply Louver	Repair	Supply air grille has become detached from the ceiling.

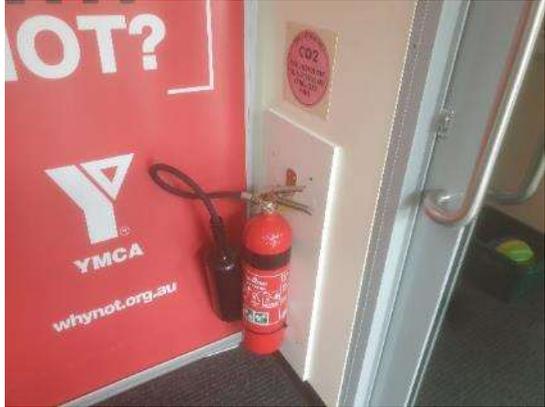
Reference No	Location/Element	Works Type	Description	Photographs	Cost Est.	Year
F002	Throughout – Fire Protection	Renewal	An allowance has been made in the renewal plan for replacement extinguishers and fire blankets.

\$2,053	2028
F003	External - Fire Tank	Repair	Minor corrosion at base of tank cladding.

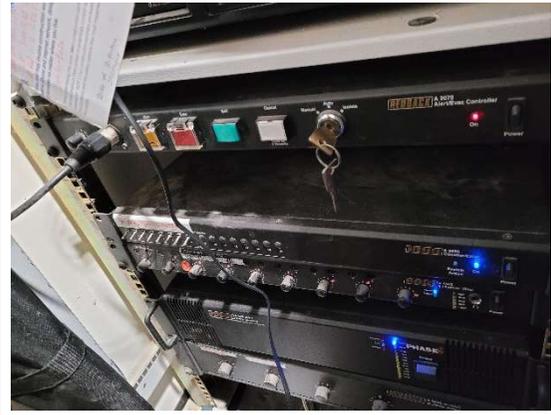
Reference No	Location/Element	Works Type	Description	Photographs	Cost Est.	Year
F004	Administration Office – Alert/Evacuation Controller	Capital - Optional	Though, as stated, not a National Construction Code - Building Codes Australia requirement should consideration be given to installation of a fire detection system an optional cost has been included within Capital Costs section.

\$87,292	2024

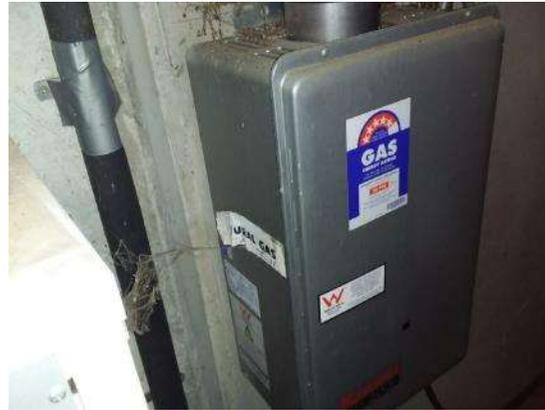
Reference No	Location/Element	Works Type	Description	Photographs	Cost Est.	Year
H001	Hot water systems	Observation	A domestic type Gas Boiler was installed circa 2010 and is in good condition. However, the Boiler appears undersized for the potential hot water duty required. There are no reported problems or complaints regarding the hot water provision. There is however no capacity for future growth or development.

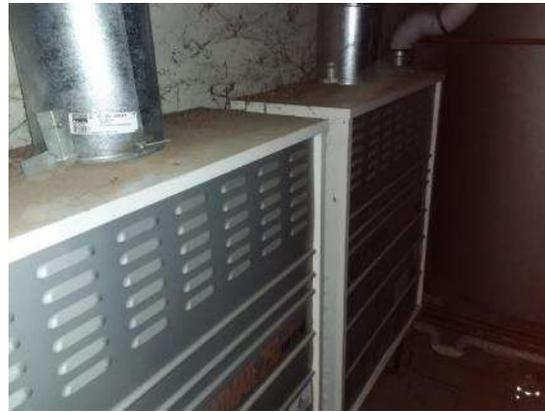
N/A	N/A
H002	Hot water systems	Renewals	Original Edward Boilers. Boilers appear decommissioned as part of the overall Solar Hot Water System. Note cost for renewal/recommission including replacement of Solar Collectors.

\$51,900	2021

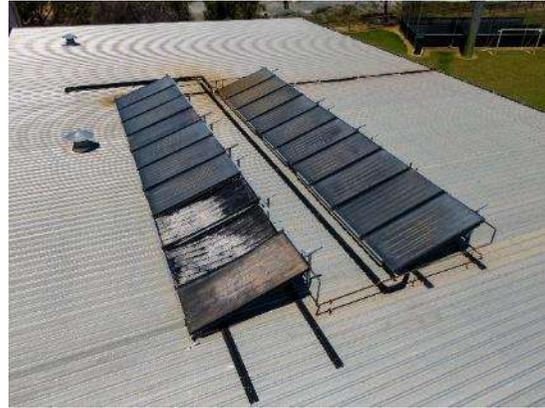
Reference No	Location/Element	Works Type	Description	Photographs	Cost Est.	Year
H003	Hot water systems	Renewals	<p>Original Solar Hot Water Collectors are out of service and are in very poor condition having been subject to vandalism.</p> <p>Cost, as stated, has been included for renewal/recommission of the system. This should include as previously discussed provision of security to prevent intruder access to the roof.</p> <p>If renewal is not desired the old Hot Water Collectors should be removed and the roof made good.</p>

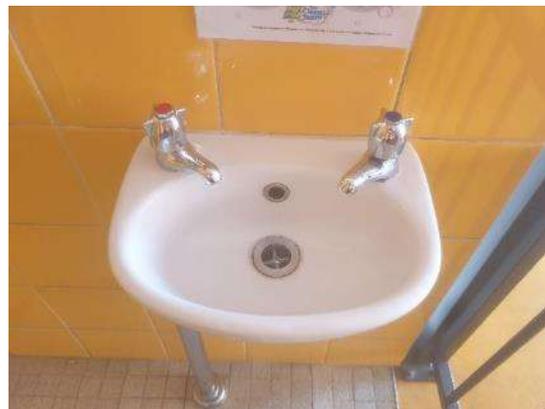
Cost included above as part of renewals	2021
H004	Creche - Hot water systems	Repair	Hot water at time of inspection was not available.

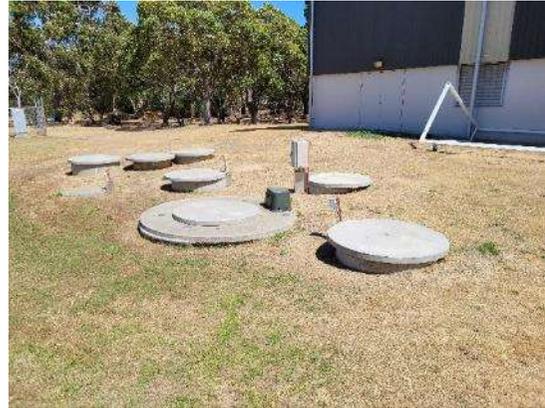
Reference No	Location/Element	Works Type	Description	Photographs	Cost Est.	Year
H005	External – Water Treatment Plant	Observation	The BioMax type water treatment plant is out of service. It is assumed that the equipment is redundant. Possibly connection to recently installed town wastewater system? To be confirmed.

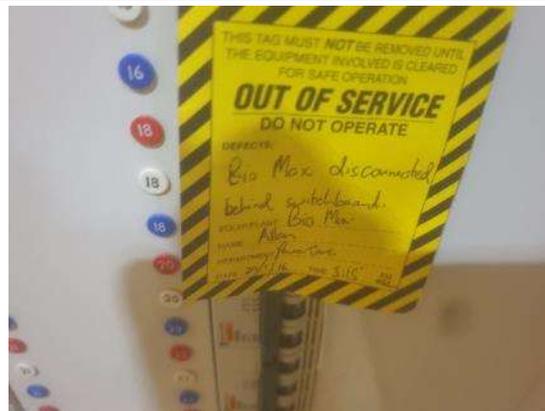
N/A	N/A
		Observation	Isolation point for BioMax at Building Main Switchboard.

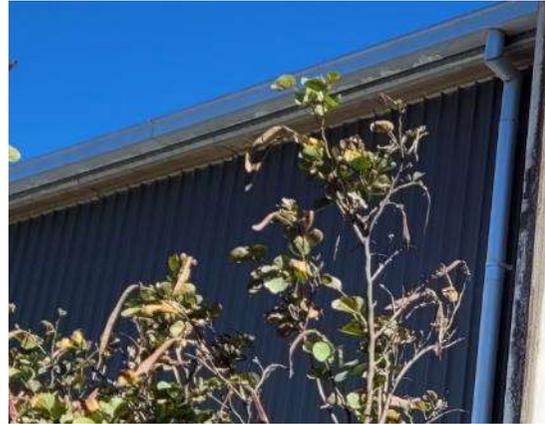
Reference No	Location/Element	Works Type	Description	Photographs	Cost Est.	Year
H006	Extreme Sports Court - Gutters	Repair	Signs of corrosion on the underside of the extreme sport court gutters and at joints on gutter downpipes.

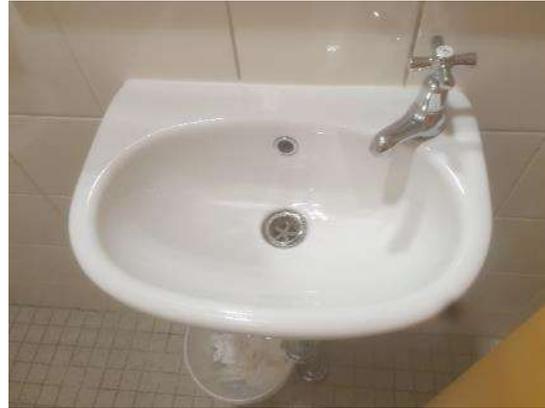
Reference No	Location/Element	Works Type	Description	Photographs	Cost Est.	Year
H008	Toilet (General)	Renewal	Toilet and changing room area basins throughout are in average condition. Components however are beginning to show signs of wear and tear including deterioration to chrome and ear to taps, etc. Allowance has been made for renewal of all hand basins in 2029.

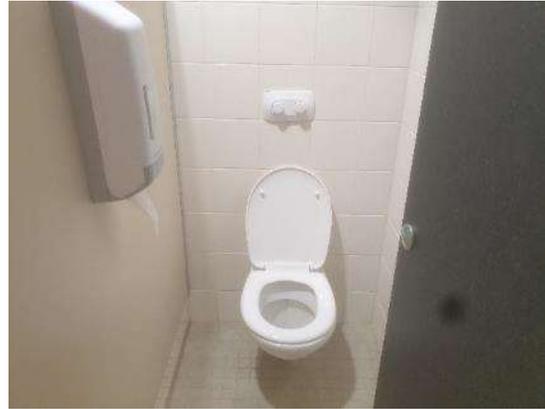
\$9,219	2029
H009	Toilet (General) – Sanitary Plumbing	Repair	The WCs are visibly in good condition. The WCs in the multipurpose area are overflowing when flushing.

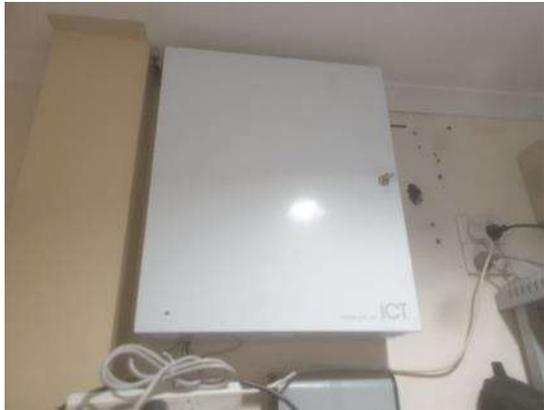
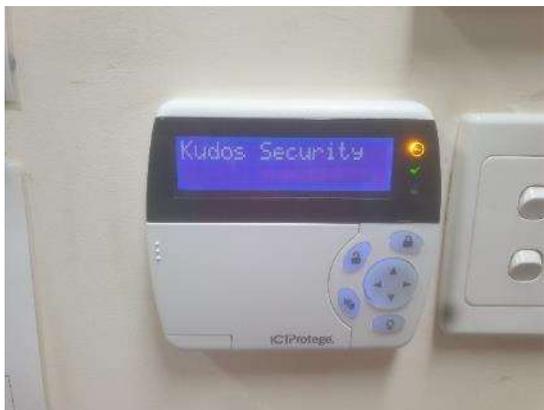
Reference No	Location/Element	Works Type	Description	Photographs	Cost Est.	Year
S001	Administration – Security System	Renewal	There is an ICT Intruder Detection System installed. The system is in good operational condition. Due to the relatively low quoted life of a security system (quoted as 7 years) and allowance has been included for renewal.

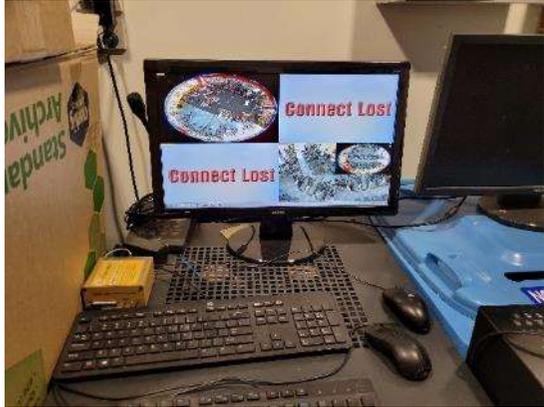
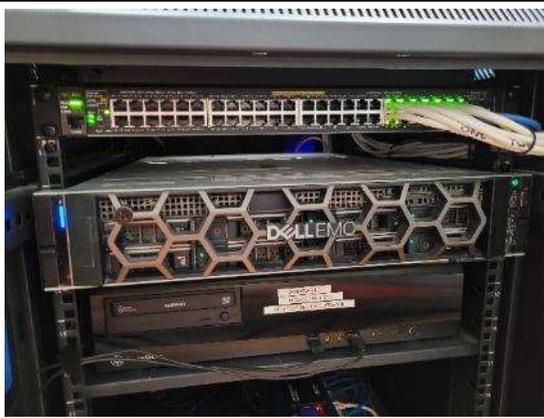
Reference No	Location/Element	Works Type	Description	Photographs	Cost Est.	Year
S002	Administration – CCTV System	Renewal	<p>There is an CCTV System installed. The system is in good operational condition.</p> <p>An allowance has been made in renewals for replacement in 2025</p>

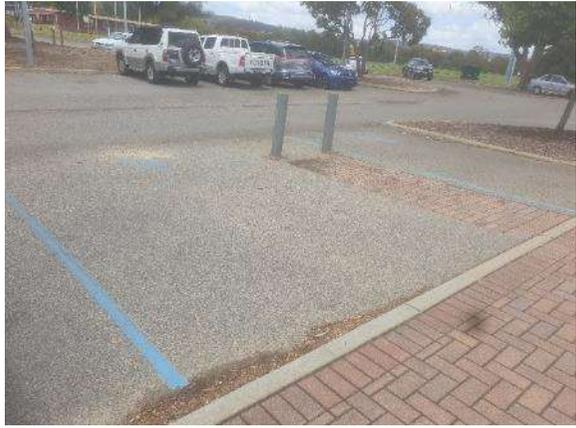
Reference No	Element	Works Type	Description	Photographs	Cost Est.	Year
EX001	Accessible Car Parking	Renewal	The road line markings are in average condition. Accessible carparking bays have been provided. An allowance has been made in renewals for line marking.

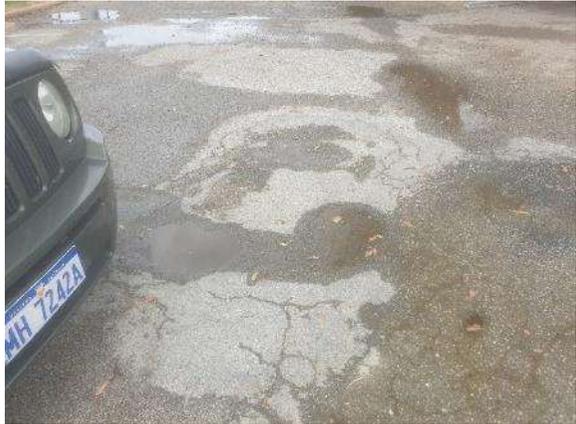
Reference No	Element	Works Type	Description	Photographs	Cost Est.	Year
EX002	Carpark	Renewal / Repair	Carpark road surface is in average condition. There is however surface deterioration and potholes present. An allowance for repair is included with a view to skim and renewal of top surface in 2030.

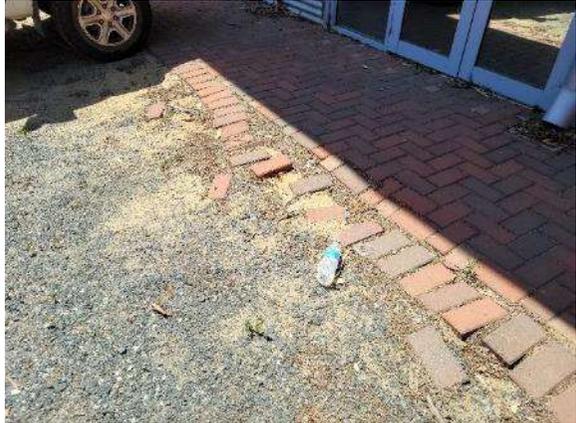
Reference No	Element	Works Type	Description	Photographs	Cost Est.	Year
EX004	Paving	Repair	The brick paving adjacent to the Multipurpose Room 1 is loose and breaking away where it meets the road.

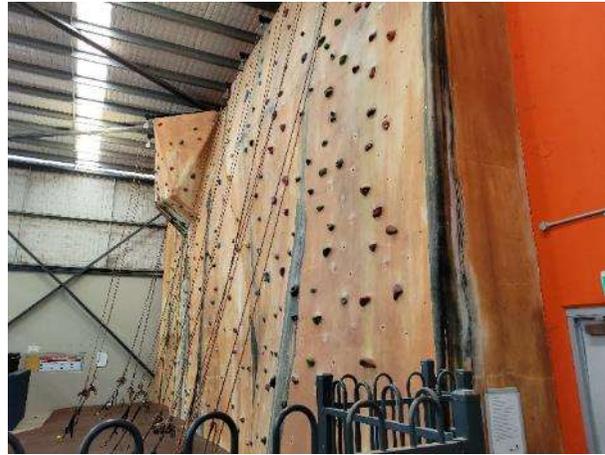
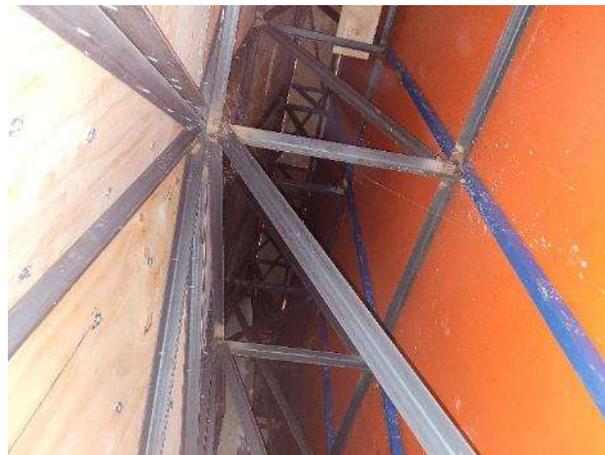
The Climbing Wall is in good condition though has been out of service for the past two to three years. Only minor deterioration was observed to the steel structure and component elements. However, to bring back into service the following is required:

Reference No	Element	Works Type	Description	Photographs	Cost Est.	Year
OT001	Equipment – Climbing Wall	Planned Repair	<p>Climbing Wall is in good condition. The Climbing Wall structure appears in good condition with only minor deterioration observed to the surface coatings.</p> <p>To facilitate the use of this equipment, the Climbing Wall and associated hardware will require the Annual Audit to be reinstated as per AS 2316.1-2009 (Australian Standard; Artificial Climbing Structures and Challenge Courses. Part1: Fixed and Mobile artificial climbing and abseiling walls).</p> <p>The recommendations as per the previous Annual Audit additionally will require action. This is summarised as below.</p> <p>Pulleys: Service by manufacturer \$160 +GST per pulley Suitable technician to uninstall and then reinstall pulleys Budget \$500 +GST (2 x Site Visits)</p> <p>Rope replacing: Rope (360m) \$1500 +GST Measure, Cut, Tag, Enter into Log Book and install onsite Budget \$450 +GST</p> <p>Belay station slings replacing: Budget \$48.59 +GST Each</p> <p>Tube tape for vertical challenge activities require replacing:</p>

- Pulleys will require servicing
- Ropes will require replacement
- Belay station slings require replacement
- Tube tape for vertical challenge activities require replacing
- Harnesses will replacing
- Helmets will require replacing

<p>Annual Audit Cost \$2,000 (Planned) Budget a further \$8,500 to bring back into service (Repair) Budget cost for training \$1,800 (Operational)</p>	2021

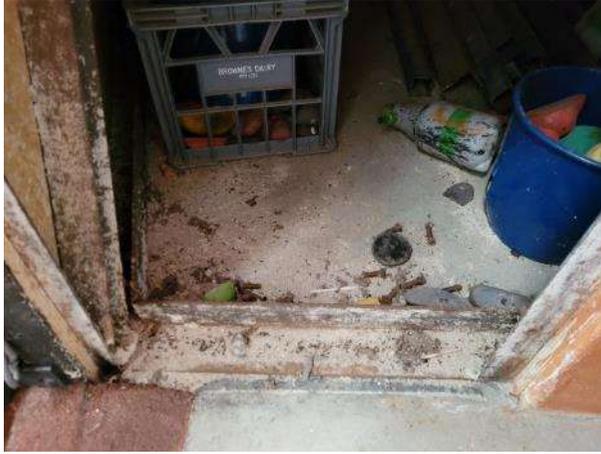
Reference No	Element	Works Type	Description	Photographs	Cost Est.	Year
			<p>8m @ \$24 +GST inc cutting and setting up</p> <p>Harnesses replacing: Ferno Gym Harness @ \$45.36 +GST ea = Total of 14 units Budget \$635.04 +GST</p> <p>Helmets replacing: 100 +GST ea = Total of 16 units \$1600 +GST</p> <p>In addition, staff Professional Development Training will be required.</p>			
OT002	Equipment – Climbing Wall	Repair	Corrosion evident at entrance hatch

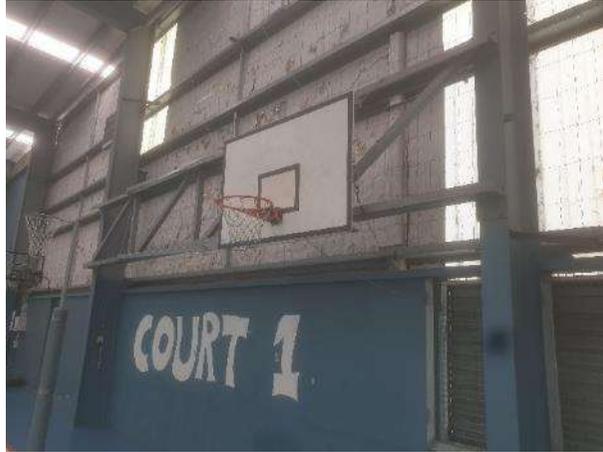
There are four wall mounted basketball backboards installed. The backboards and support structure are in average condition. It is suspected however the backboards do not comply with International Basketball Federation (FIBA) requirements though this is subject to confirmation of the levels of competition.

Reference No	Element	Works Type	Description	Photographs	Cost Est.	Year
OT003	Equipment – Basketball Backboard	Renewal	<p>The basketball back boards are in average condition though it is suspected they do not comply with FIBA Guide to Basketball Facilities (2018). Note that this is subject to confirmation of the level of competition undertaken.</p> <p>Additionally, the existing backboards are not height adjustable.</p> <p>An allowance has been included for replacement with floor mounted items that are to FIBA requirements.</p>
